# Native Vegetation Removal Report

NVRR ID: 319\_20240617\_464

**Address:** 12 PUNT ROAD JOHNSONVILLE 3902

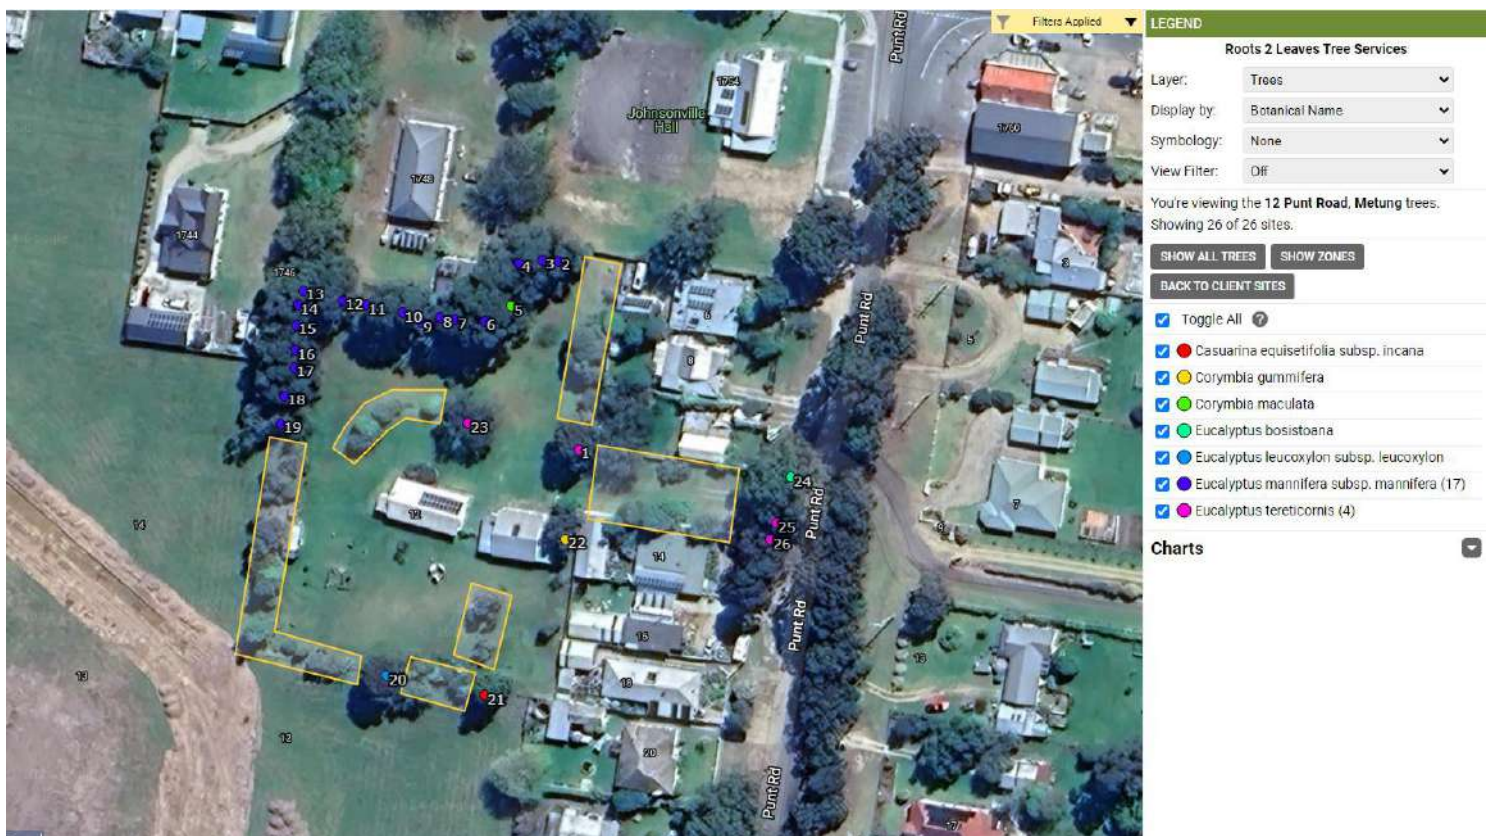
image 1 – Site map – Sub meter Accuracy.

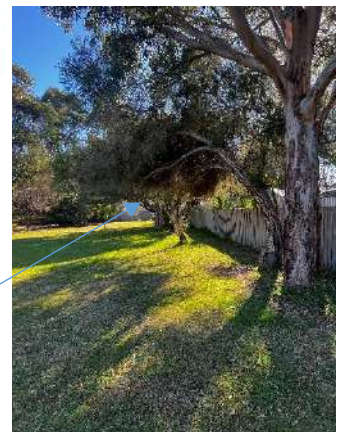
The image to the right is an example of the trees found on site, majority are fence line, straight line grown trees of varying originating regions and countries.

Almost all trees on property are fence line trees

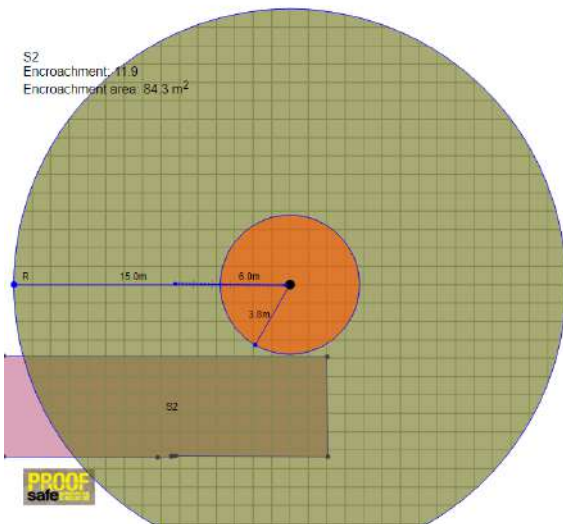
TPZ radius = 15.0m  
TPZ area = 706.9m<sup>2</sup>  
SRZ radius = 3.8m (R)

S2  
Encroachment: 11.9  
Encroachment area: 84.3 m<sup>2</sup>

image 3 – encroachment if driveway is run to edge of road

Both options are considered acceptable however it is advised that the following guidelines are followed.

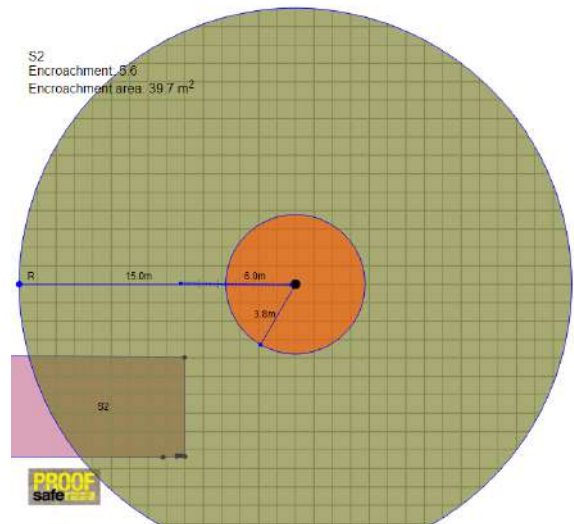
**Tree 24**

TPZ radius = 15.0m  
TPZ area = 706.9m<sup>2</sup>  
SRZ radius = 3.8m (R)

S2  
Encroachment: 5.6  
Encroachment area: 39.7 m<sup>2</sup>

image 2- encroachment if driveway is stopped at concrete channel.
