AMBULANCE VICTORIA MALLACOOTA BRANCH
82 BETKA ROAD, MALLACOOTA, VIC 3892

Arboricultural Report

Construction Impact Assessment with Tree Management Protection Plan

82 Betka Road,
Mallacoota VIC 3892

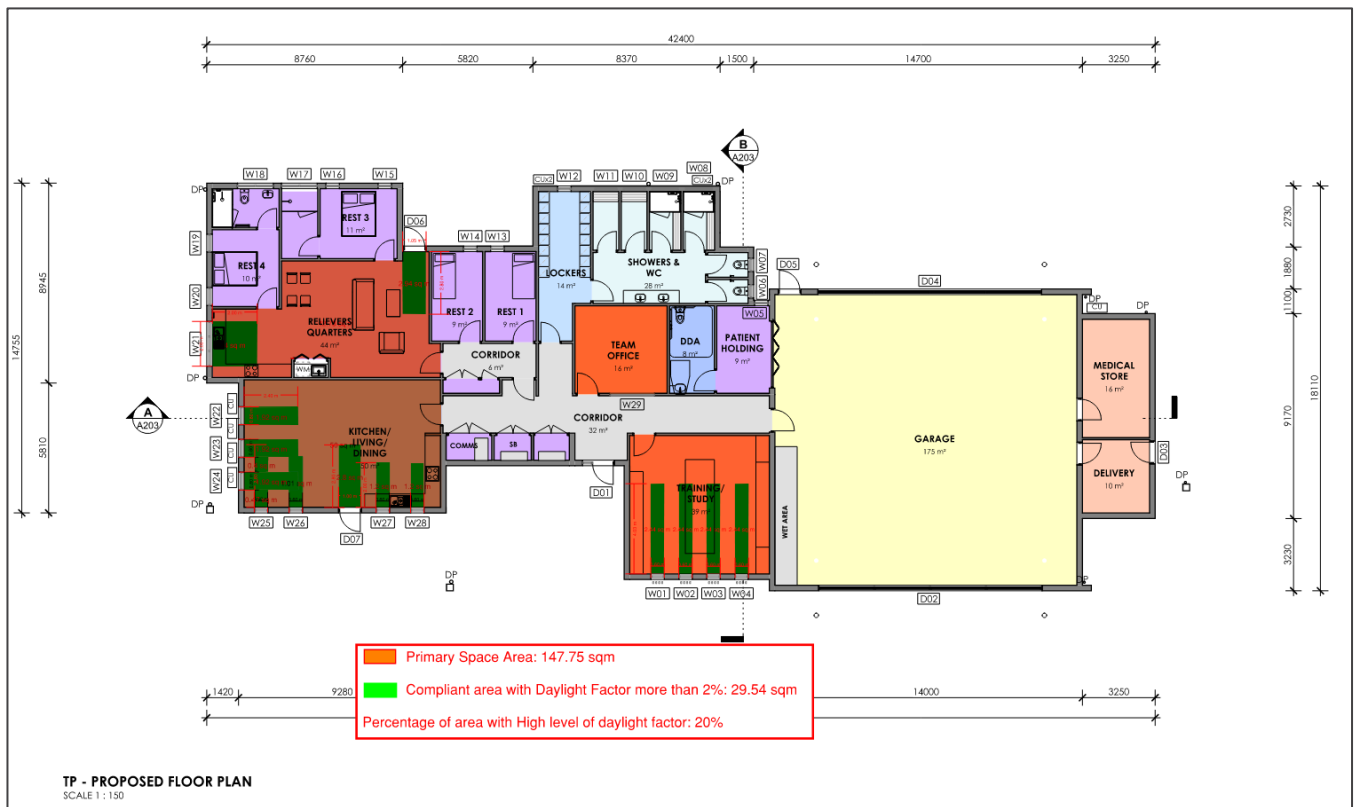
Figure 3. – Ground Floor daylight map

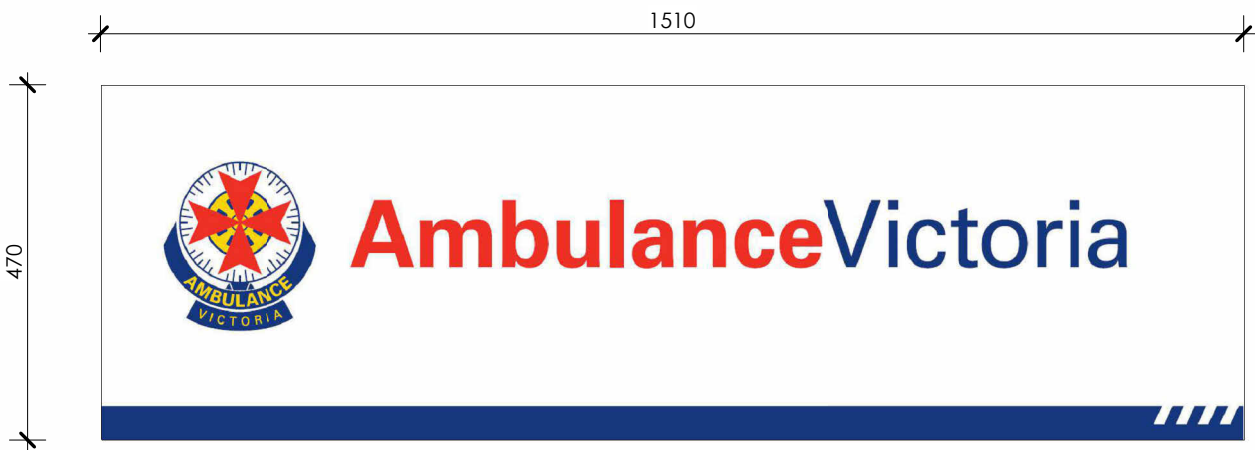
NOTE:
BUILDING IDENTIFIER AMBULANCE LETTERING
ID CODE: TYPE C ID-WM-150-C. REFER TO AV
PROPERTY SIGN SUITE MAY 2018 ISSUE 2.0

AV SIGNAGE DETAIL 02
SCALE 1 : 10

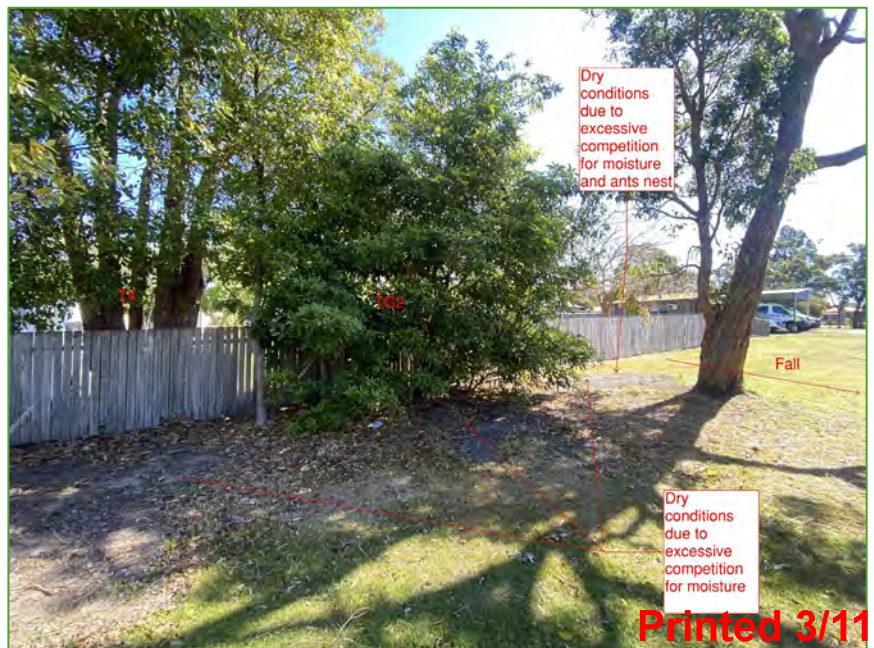
Image 2: Image of site conditions noted in dot points

- The topography of the area to the east towards Bucknall St will have encouraged root growth into this area. The land slopes down to the road where a small drainage culvert exists. With excess moisture in this area after rainfall, roots will opportunistically grow to take advantage of additional moisture

Allowing for the above points, the orange area is the only high impact incursion which is 14.9%. Whilst still considered a major incursion, provided that this tree is protected as specified in the site's Tree Management Protection Plan (TMPP). Removal of the surrounding trees will improve conditions for this tree

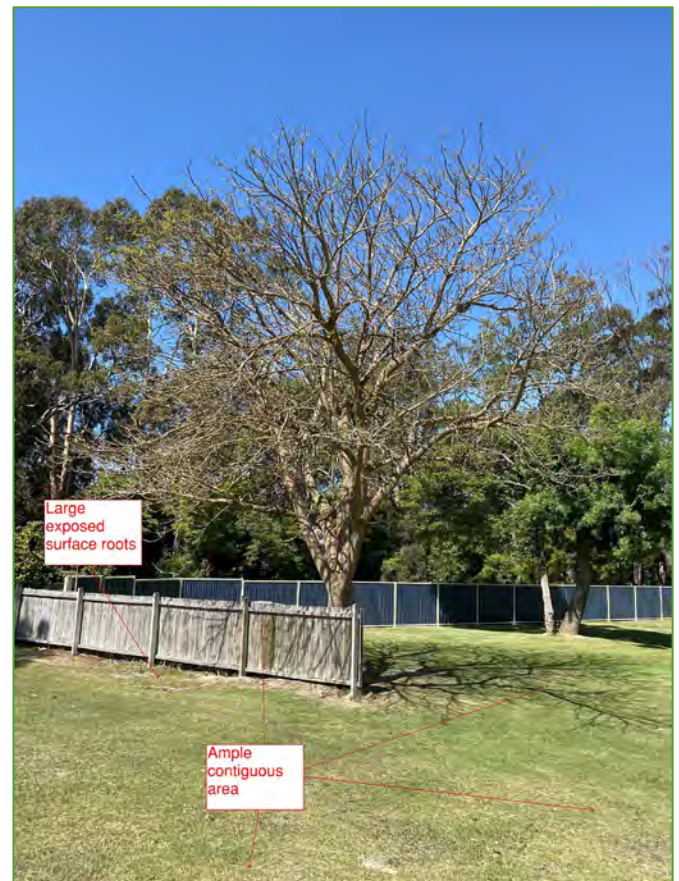
- The large surface roots exposed north of the tree will be protected within the lawn area and the incursion is several metre's away from there
- A large open contiguous area to the south and west allow for ample root growth for any lost roots which is the grassed areas in the caravan park
- The grade has minor falls south and west where water will pool, suggesting roots will be drawn to these areas, away from the development
- The removal of T4 will reduce competition below ground for water and nutrients, improving conditions for T3 remaining

Image 5: Image of site conditions noted in dot points
