EAST GIPPSLAND SHIRE COUNCIL
JOHNSTONS ROAD, BAIRNSDALE
LANDFILL REDEVELOPMENT
COMPOSTING FACILITY
FEATURE SURVEY

GEOTECHNICAL INVESTIGATION REPORT

EGSC COMPOST FACILITY, FORGE CREEK

Prepared for SMEC Australia (Docklands, VIC)

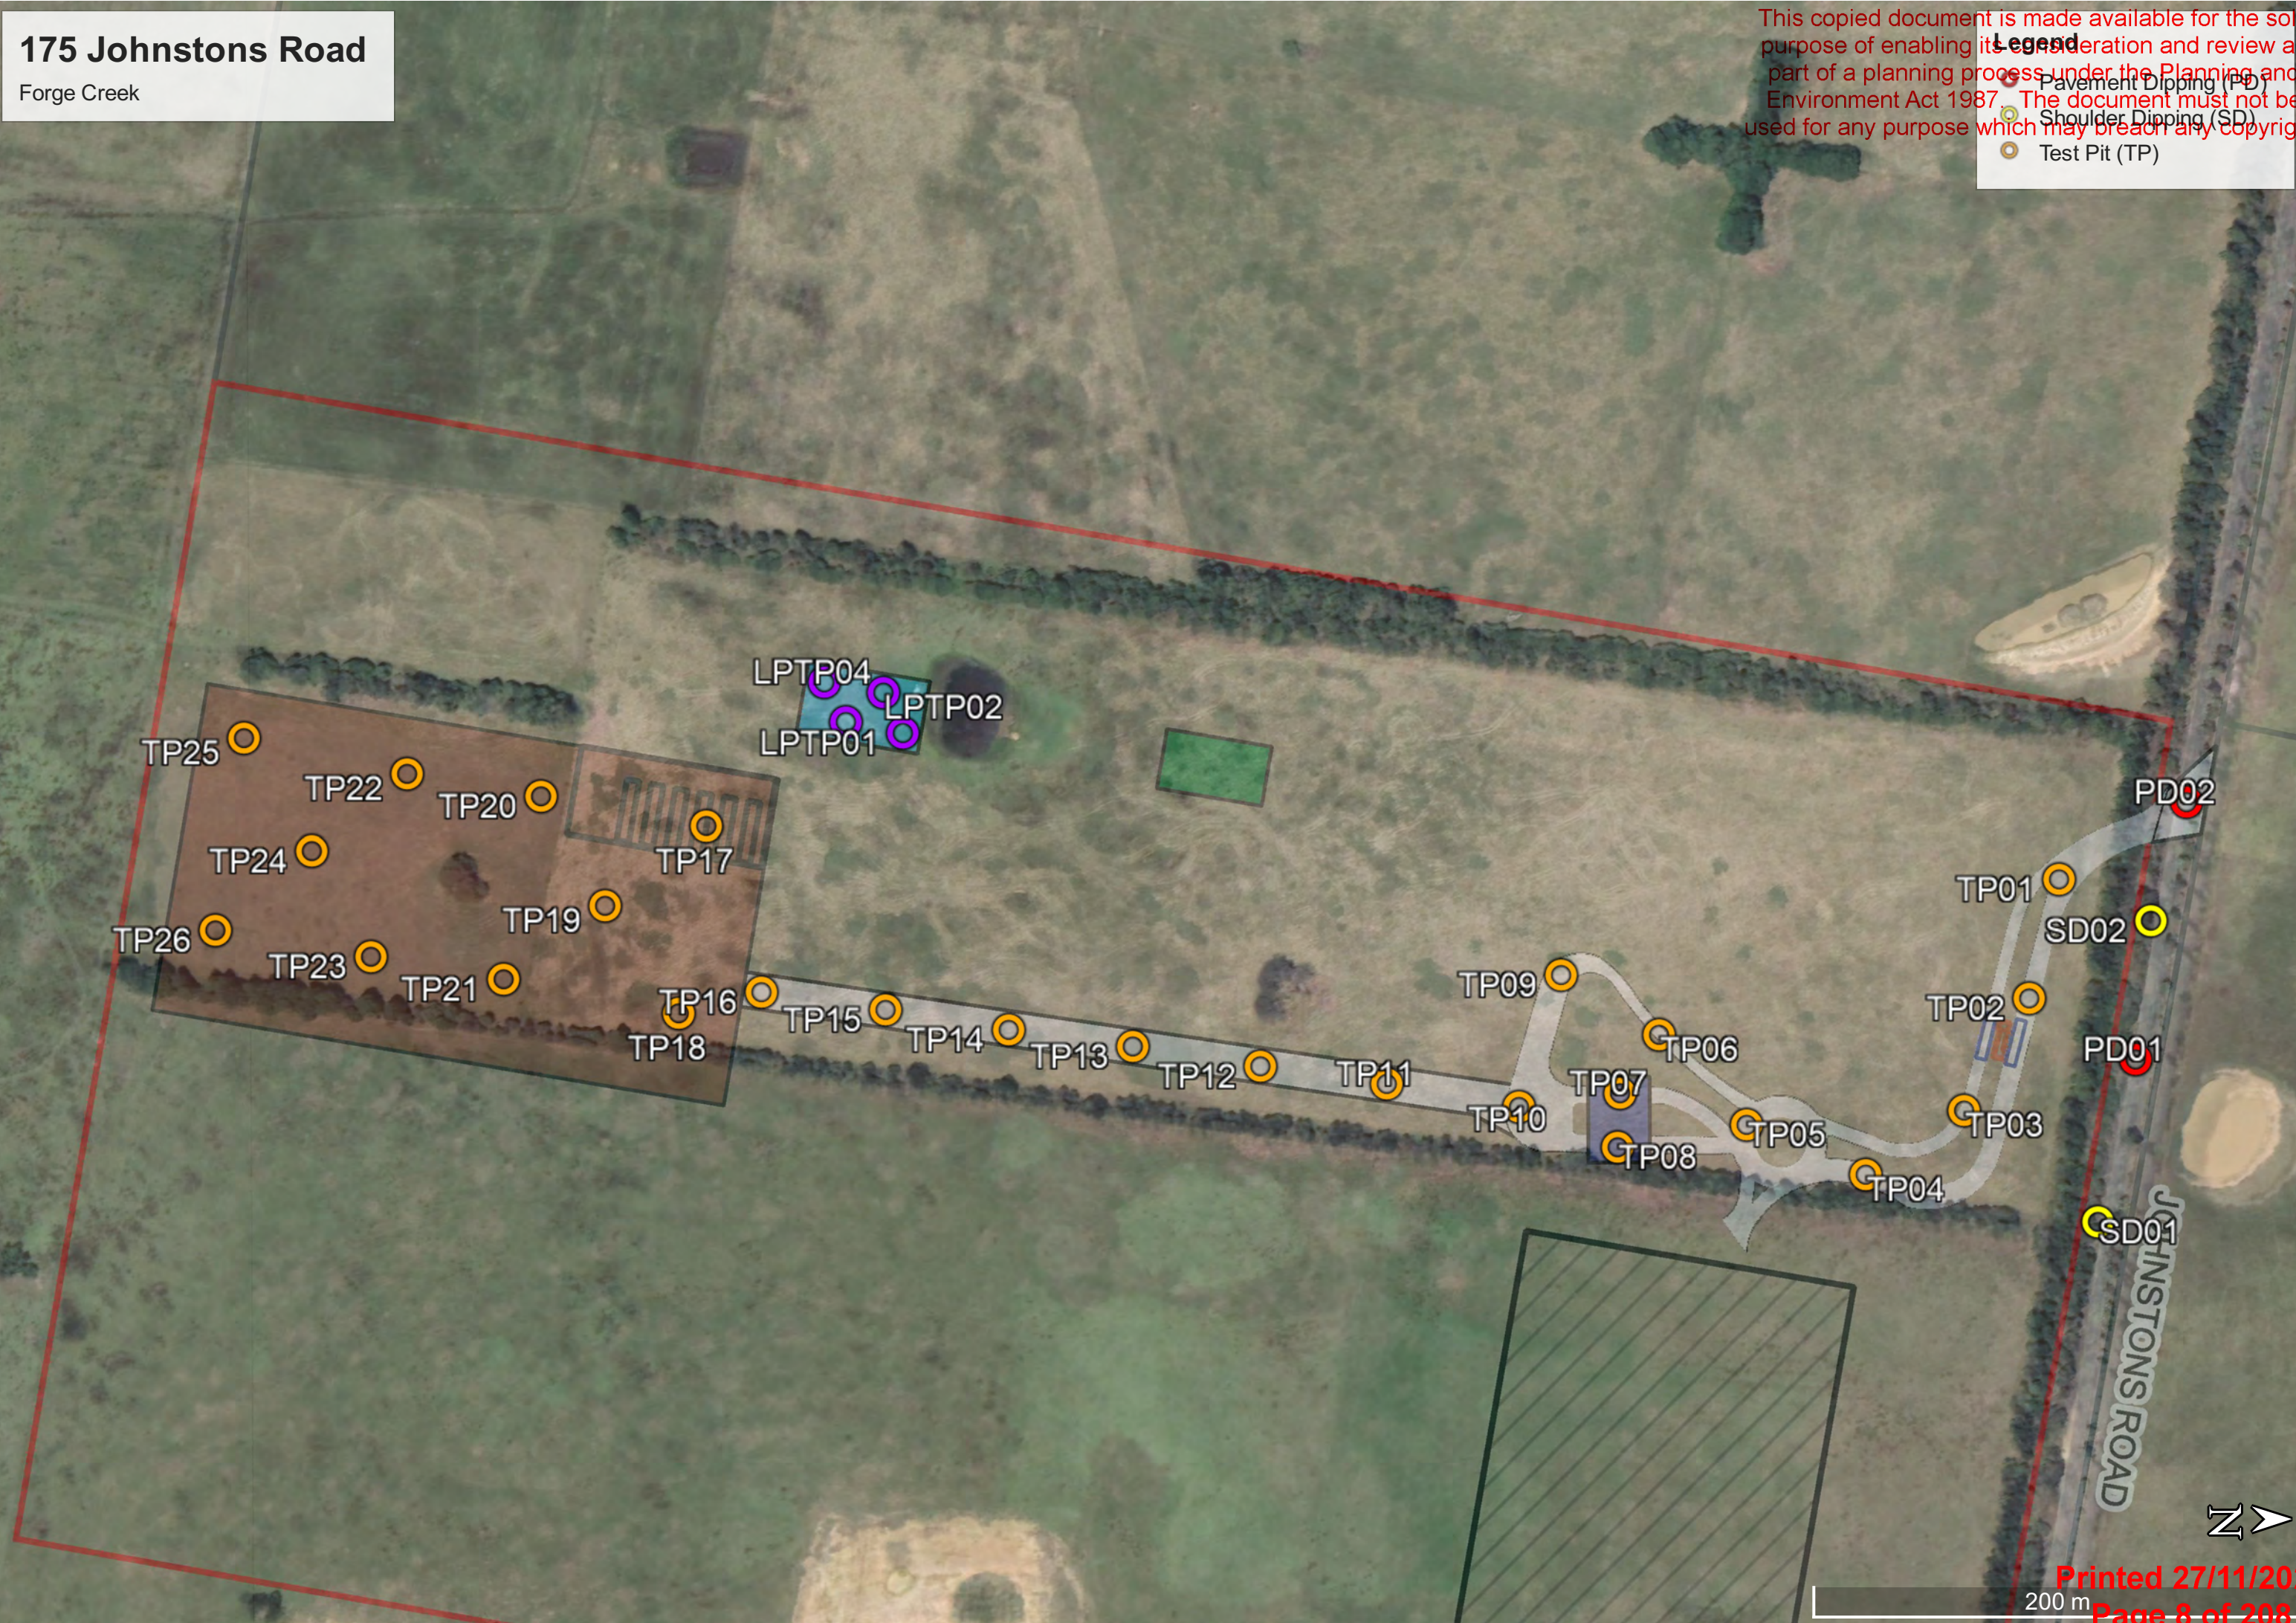
Legend

- Pavement Dipping (PD)
- Shoulder Dipping (SD)
- Test Pit (TP)

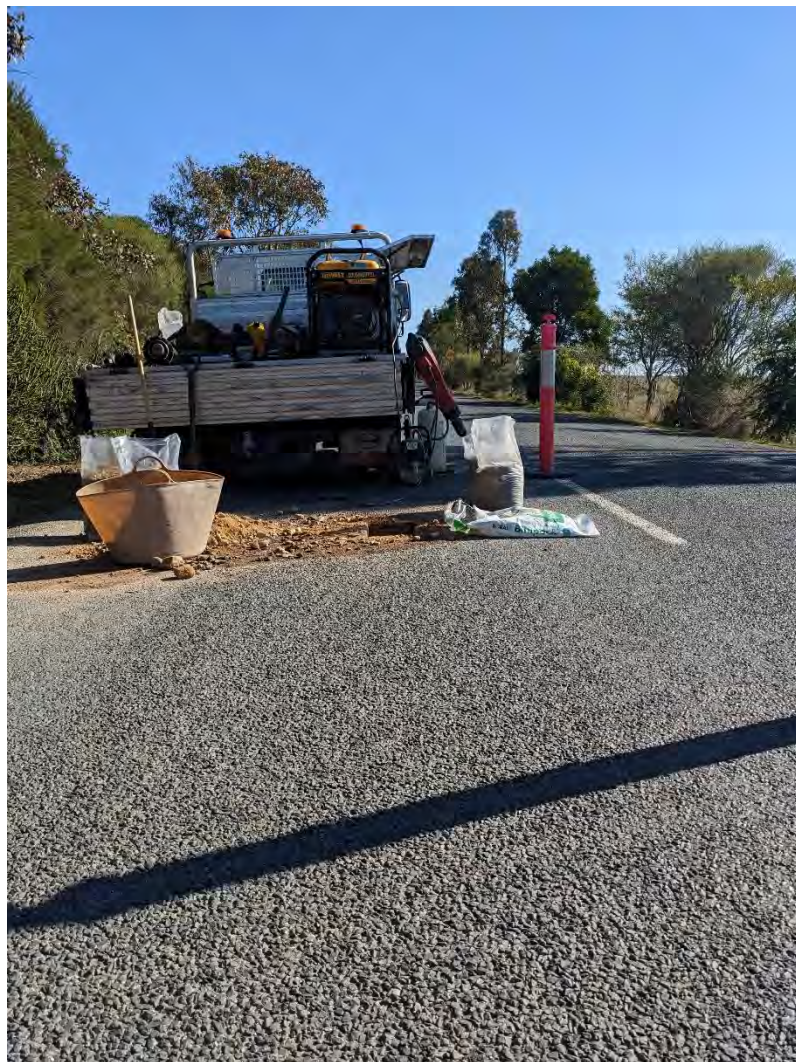
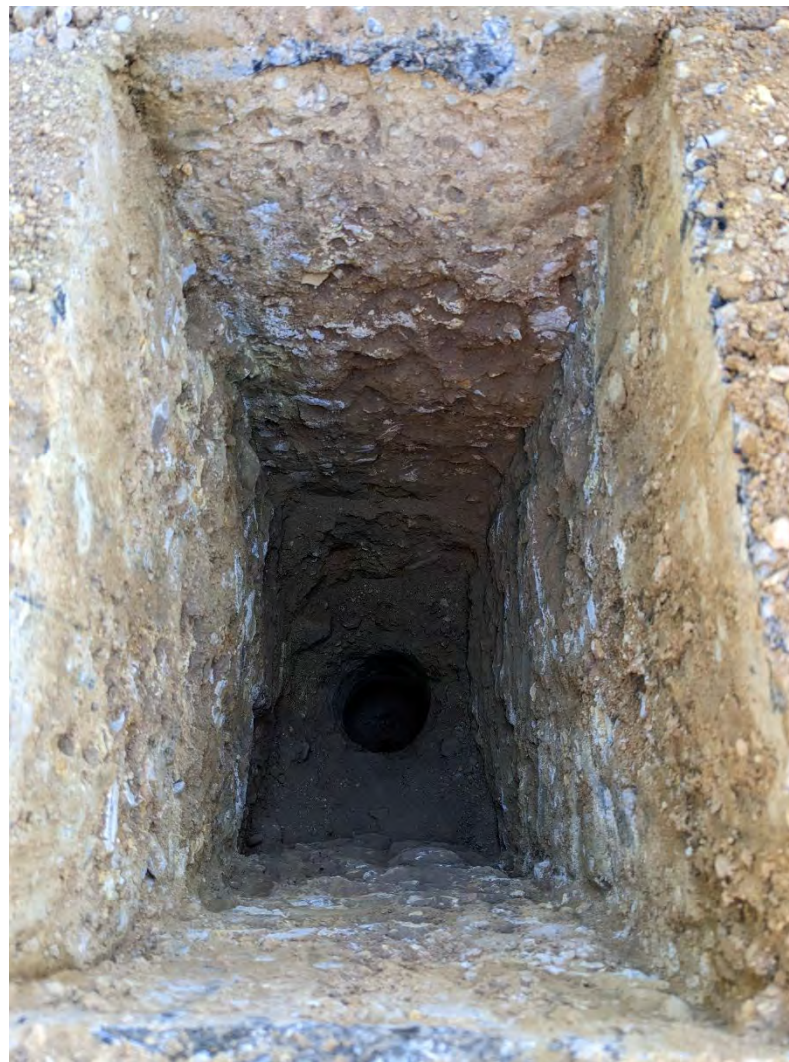
Site Photographs

Topography	In General – Undulating Locally – Dip	Trees	Shrubs, Small to Large
		Site Code	MS
Drainage	In General – Fair Locally – Fair, Vegetation	Drainage Type	RHS: Spoon Drain LHS: Spoon Drain
		Width of Seal	5.3m
Surface Condition	In General – Fair, Transverse Shape – Fair, Longitudinal Shape – Fair Faults – Rutting <10mm, Slick/Flushing & Edge Drop Off	Formation Width	7.2m

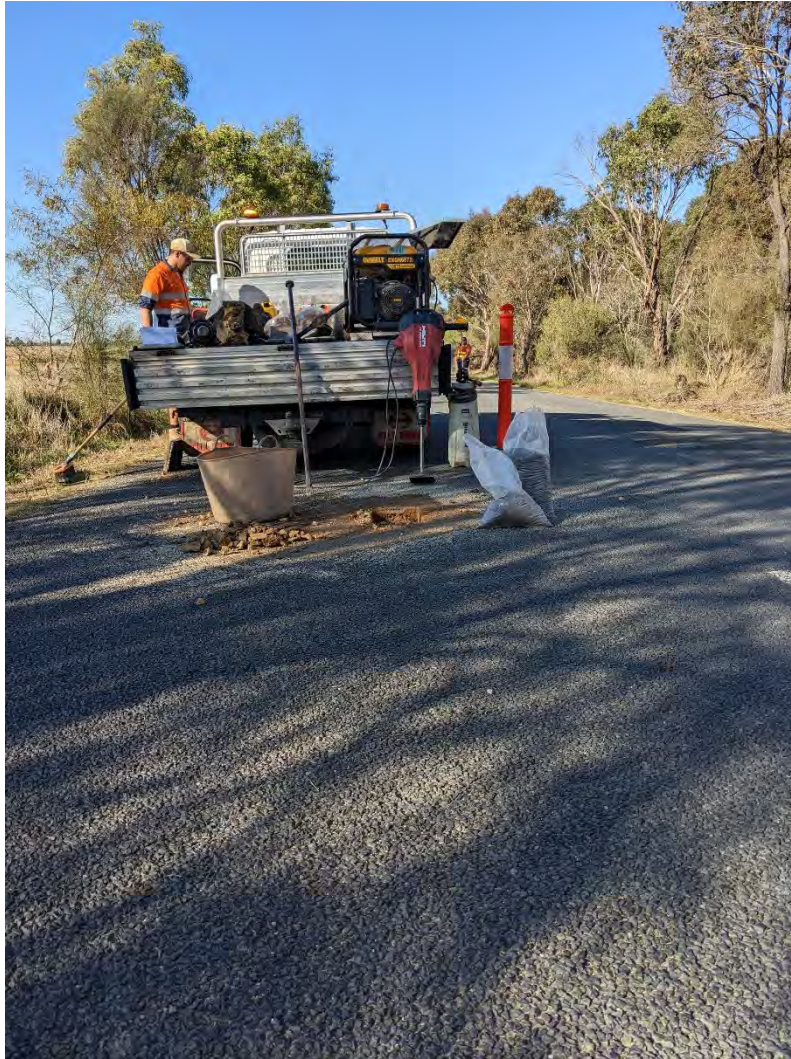
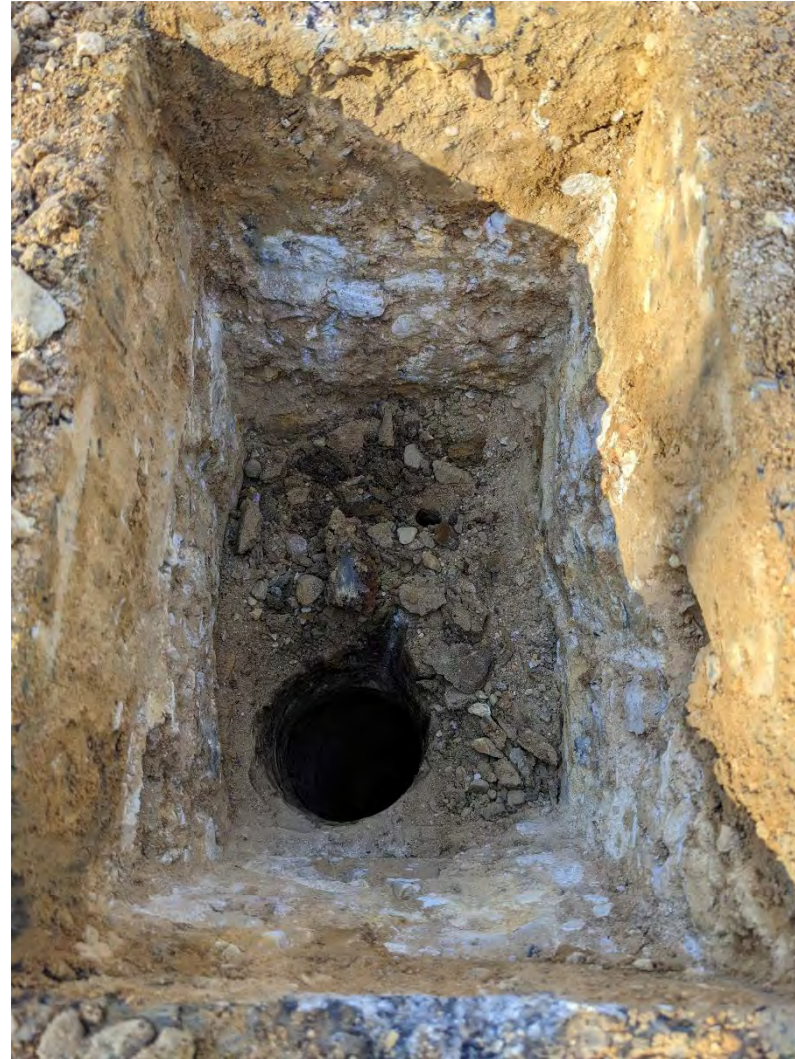
Site Photographs

Topography	In General – Undulating Locally – Steep Slope	Trees	Shrubs, Small to Large
		Site Code	MS
Drainage	In General – Fair Locally – Fair, Vegetation	Drainage Type	RHS: Spoon Drain LHS: Spoon Drain
Surface Condition	In General – Fair, Transverse Shape – Fair, Longitudinal Shape – Fair Faults – Rutting <10mm, Slick/Flushing & Edge Drop Off	Width of Seal	5.2m
		Formation Width	7.4m

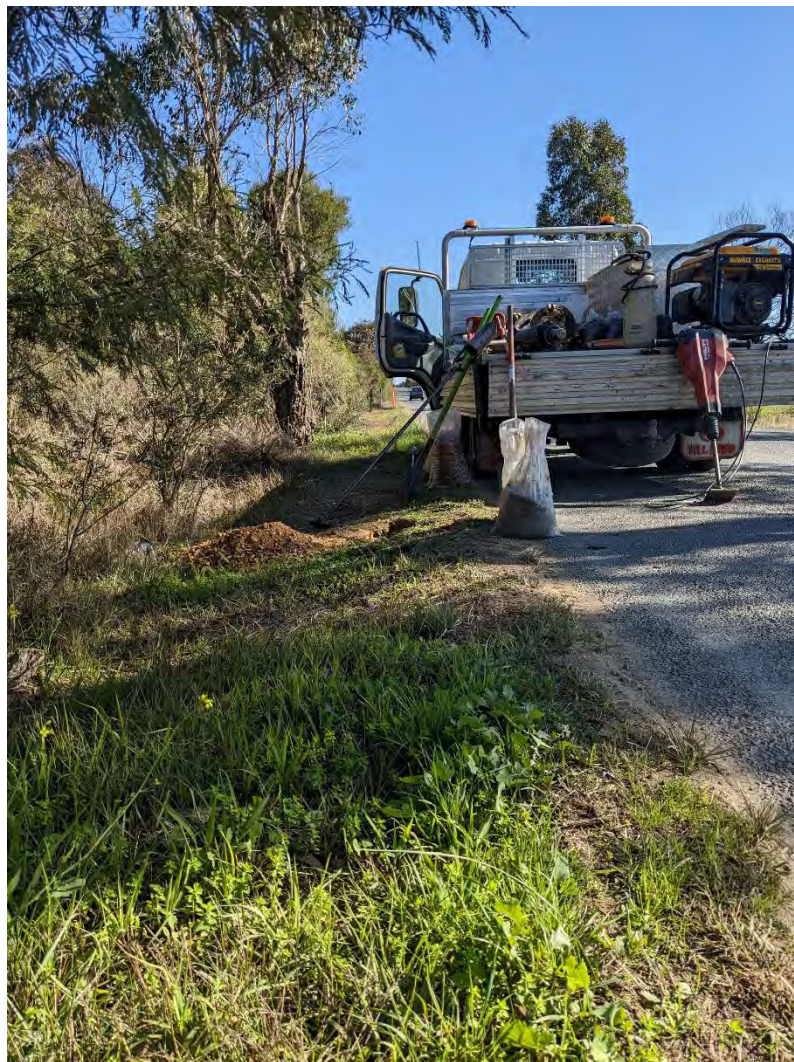
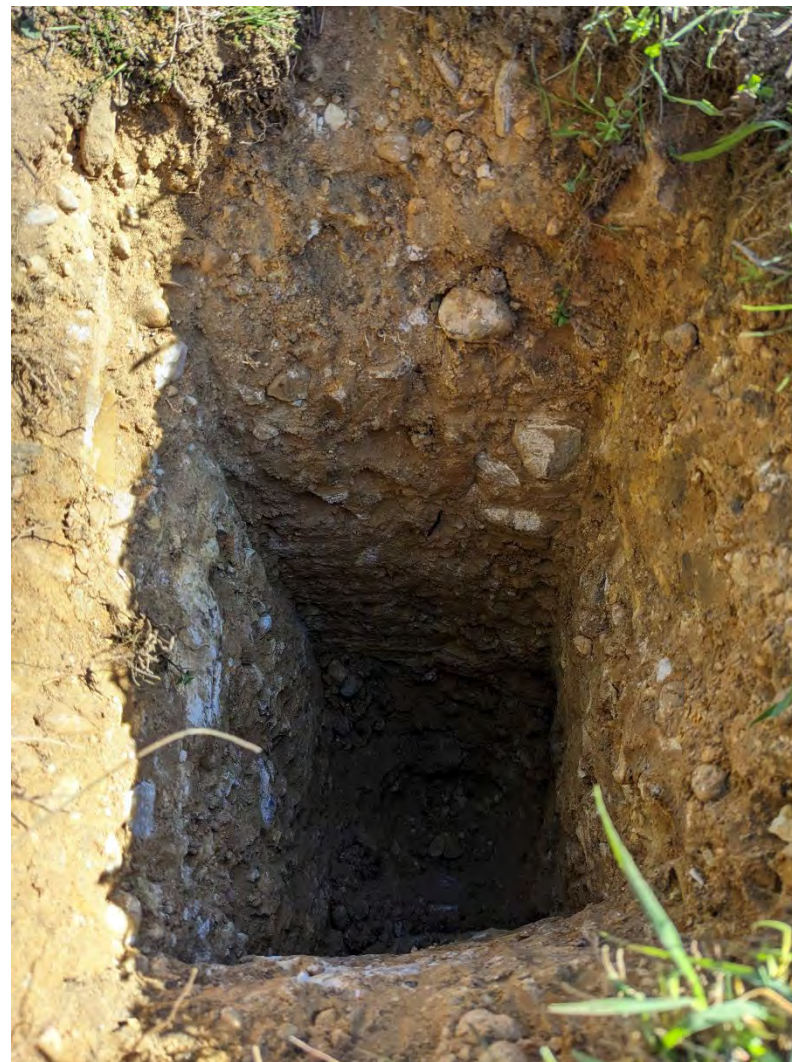
Site Photographs

Topography	In General – Undulating Locally – Dip	Trees	Shrubs, Small to Large
		Site Code	SH
Drainage	In General – Fair Locally – Fair, Vegetation	Drainage Type	RHS: Spoon Drain LHS: Spoon Drain
Surface Condition	In General – Fair, Transverse Shape – Fair, Longitudinal Shape – Fair Faults – Rutting <10mm, Slick/Flushing & Edge Drop Off	Width of Seal	5.3m
		Formation Width	7.3m

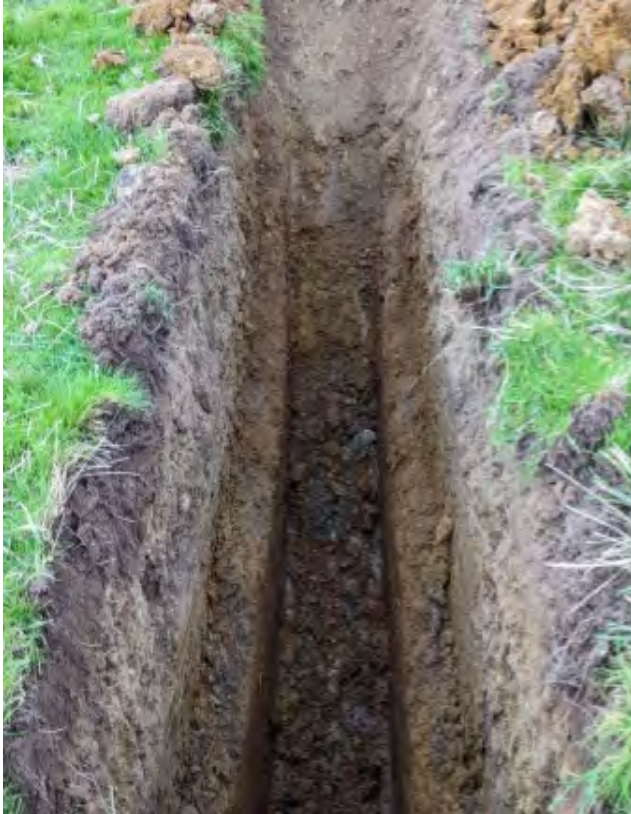
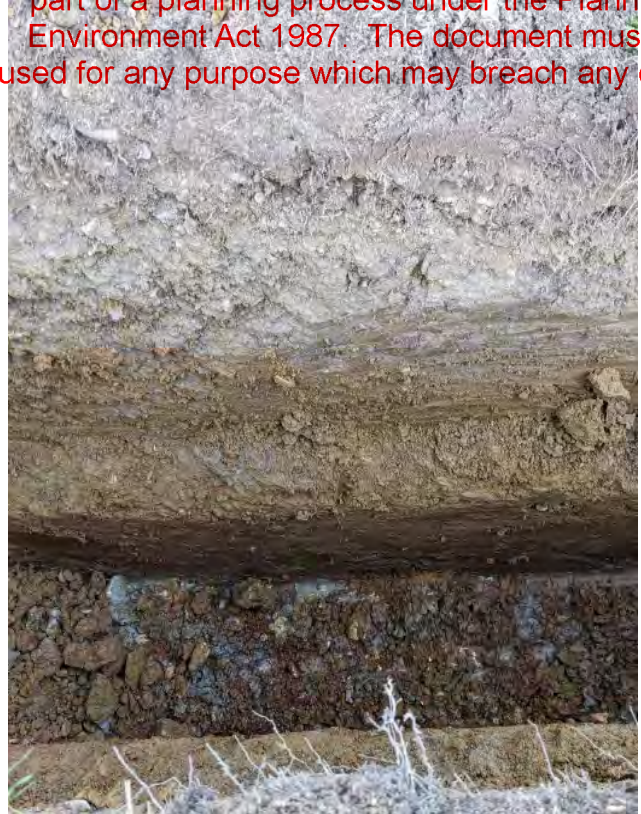
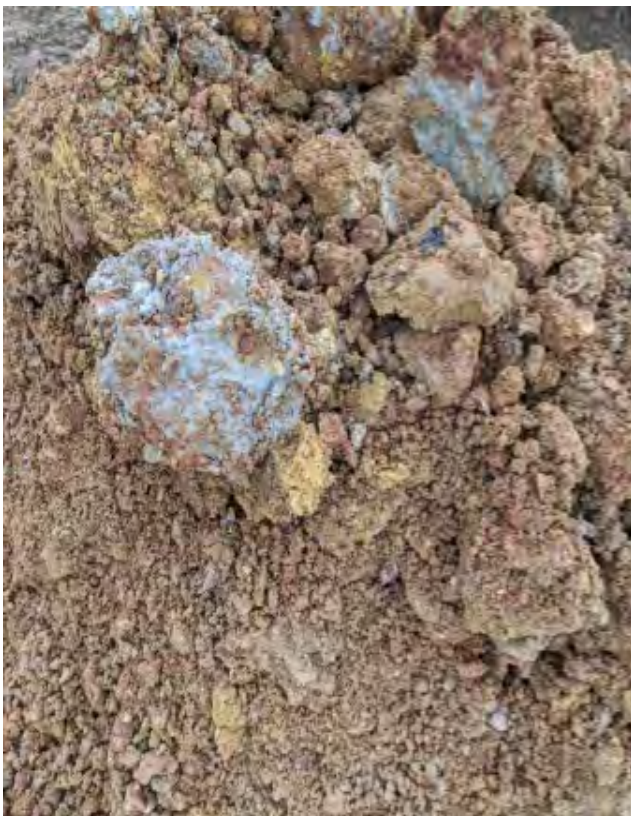
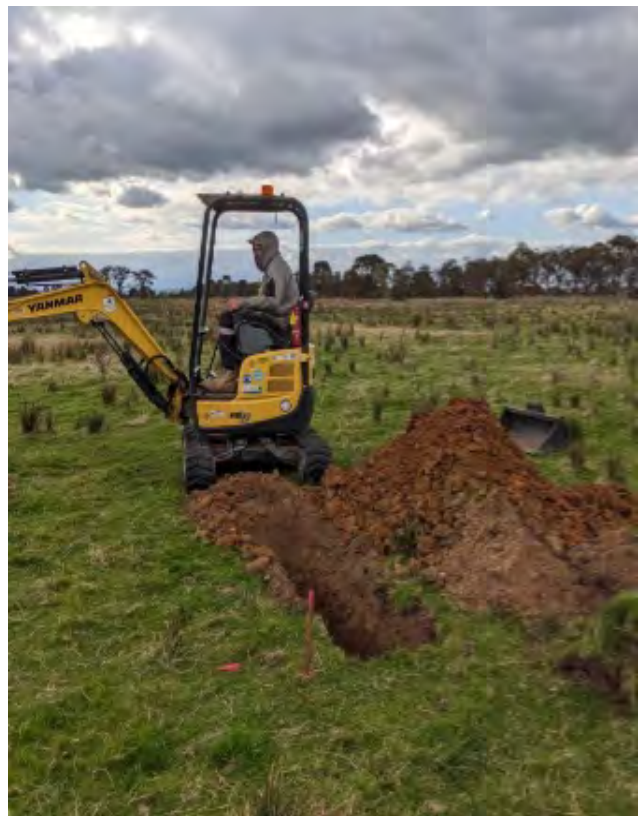
20									
R		1.5			TP19 refusal at 1.4m				
		2.0							
		2.5							
		3.0

DCP graph		Depth (m)	Graphic Log	Classification Code	Material Description	Consistency	Moisture	Samples	
								Bulk Sample	
2		0.2		CL	TOPSOIL: gravelly, sandy, silty CLAY, brown, low plasticity, sand fine to coarse grained, gravel sub angular to sub rounded fine, firm, dry to moist, organics.	F	D-M		
2									
3		0.4		CL	As above, fine to coarse sized gravel, stiff, moist.	St	M		
3									
4		0.5		CH	CLAY, trace sand & gravel, orange mottled brown, high plasticity, sand fine to medium grained, gravel fine, stiff, moist (inferred alluvial deposits).	St	M		
3									
3									
3		1.2		CI	CLAY, trace sand, orange mottled grey, medium plasticity, sand 14% fine to medium grained, stiff to very stiff, moist (inferred alluvial deposits).	St-VSt	M		
4									
5									
7									
7									
16		2.0		CH	CLAY, with sand & gravel, grey mottled orange/red, high plasticity, sand fine to coarse grained, gravel sub angular medium to coarse, hard, moist (inferred Haunted Hills Formation residual soil).	H	M	1879-S16

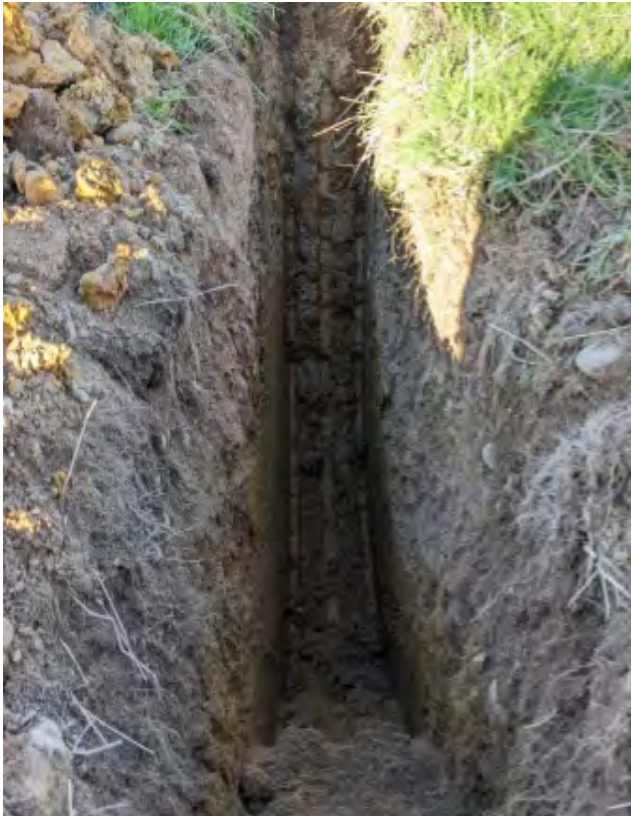
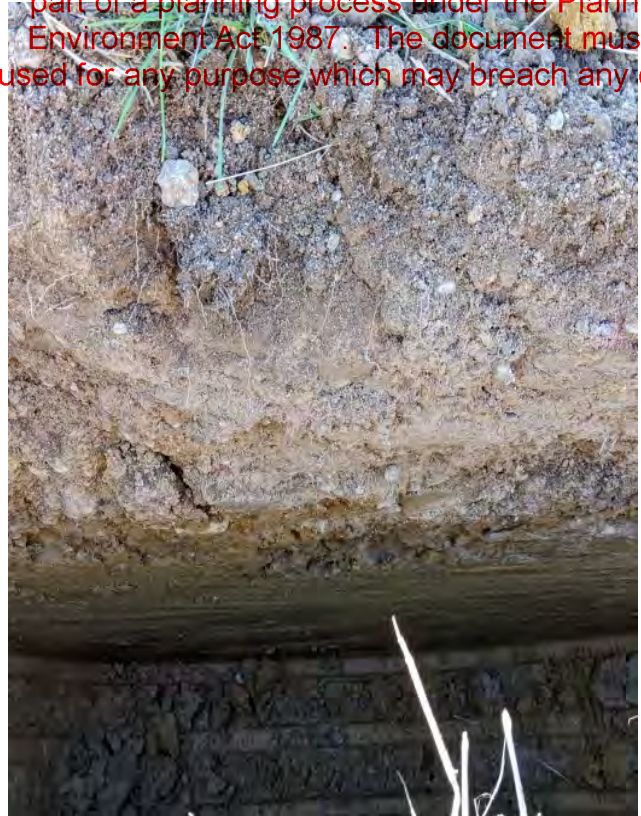
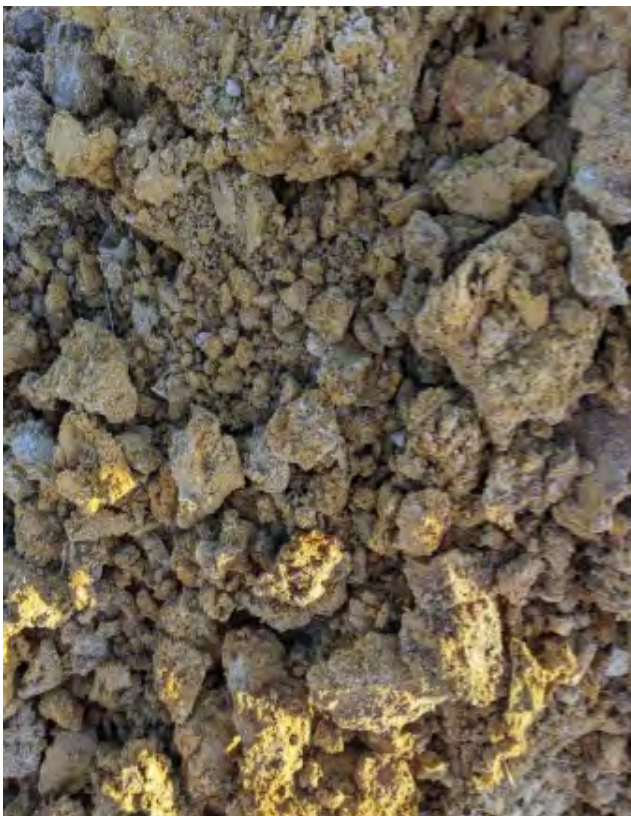
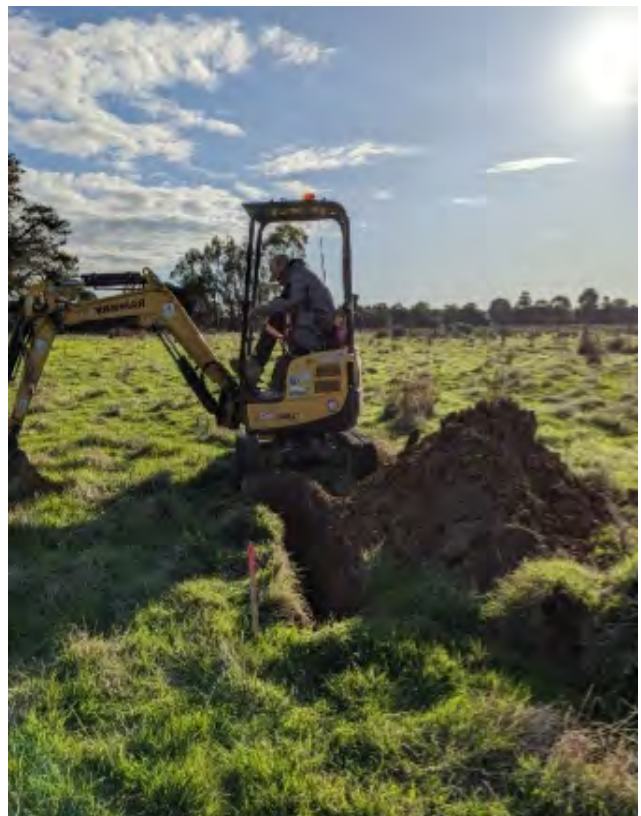
TP21 Terminated at 1.5m

CL	TOPSOIL: gravelly, sandy, silty CLAY, brown, low plasticity, sand fine to coarse grained, gravel sub angular to sub rounded fine, soft, moist, organics.	S	M	
1							
3	0.4

CH	CLAY, trace sand & gravel, orange mottled brown, high plasticity, sand fine to medium grained, gravel fine, stiff, moist (inferred alluvial deposits).	St	M

CI	CLAY, trace sand, orange mottled grey, medium plasticity, sand fine to medium grained, stiff, moist (inferred alluvial deposits).	St	M-D	
4							
3	1.2

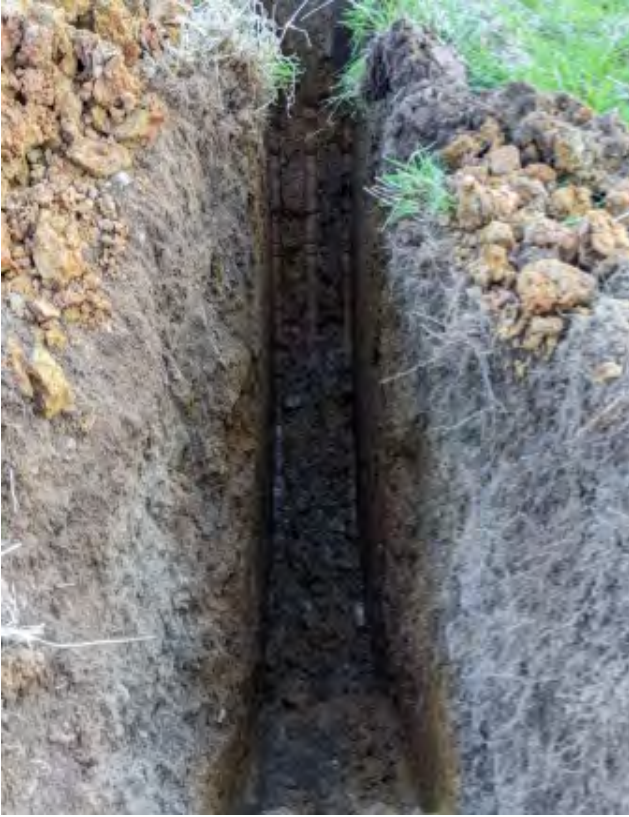
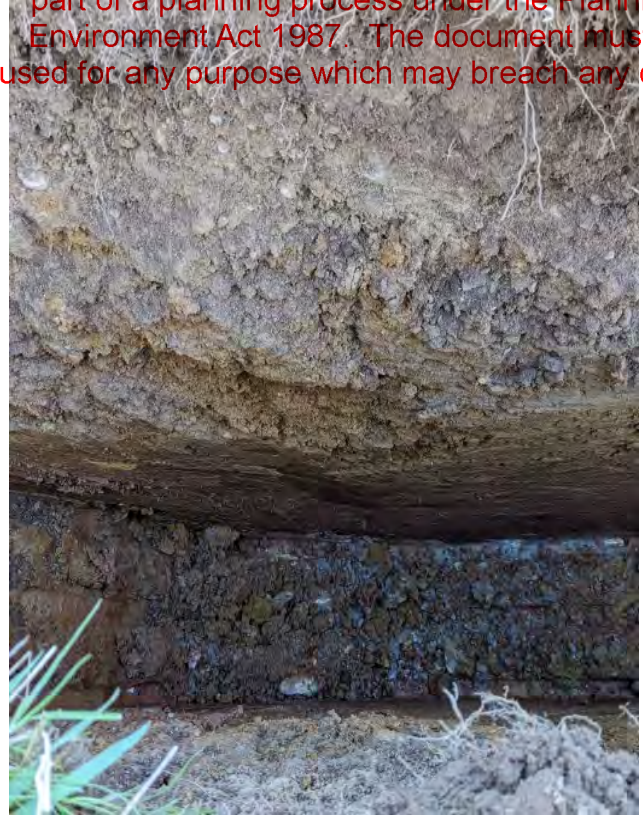
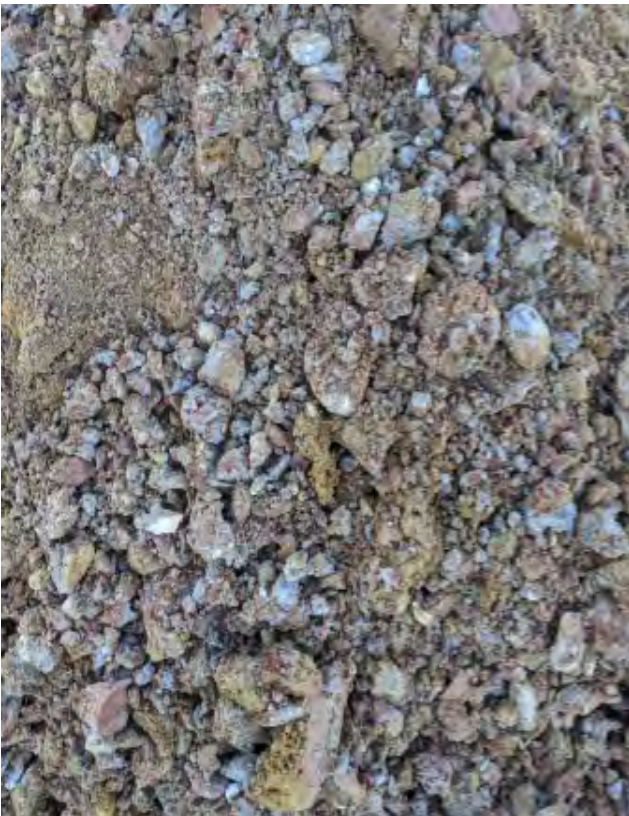
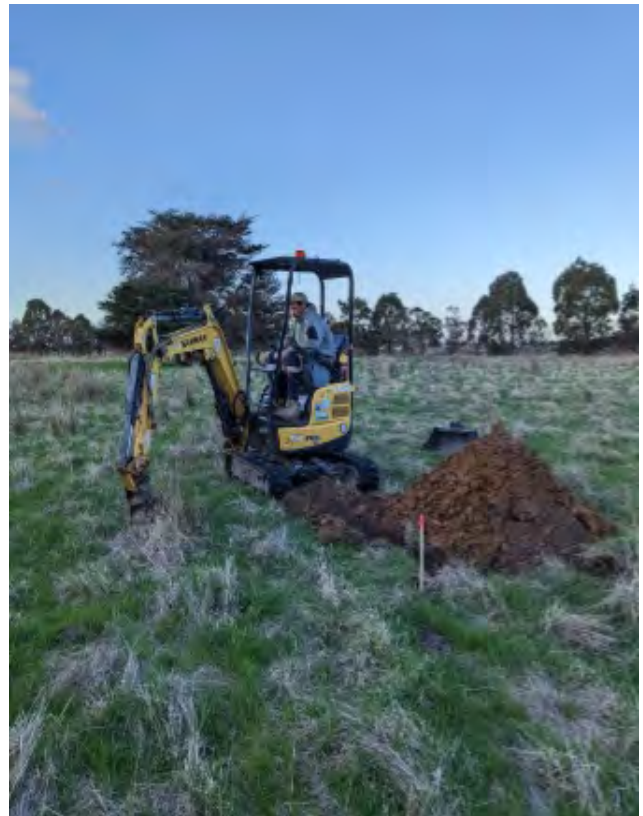
6							
TP22 Terminated at 1.5m							
2 2.5 3

CL	TOPSOIL: gravelly, sandy, silty CLAY, brown, low plasticity, sand fine to coarse grained, gravel sub angular to sub rounded fine, soft to firm, moist, organics.	S-F	M	
2			CL	As above, grey brown, fine to coarse sized gravel, firm to stiff, dry to moist.	F-St	D-M	
2	0.4

CH	CLAY, trace sand & gravel, orange mottled brown, high plasticity, sand fine to medium grained, gravel fine, stiff, moist (inferred alluvial deposits).	St	M

CH	CLAY, with sand & gravel, grey mottled orange/red, high plasticity, sand fine to coarse grained, gravel sub angular medium to coarse, stiff, moist (inferred Haunted Hills Formation residual soil).	St	M	
4							
4	1.5

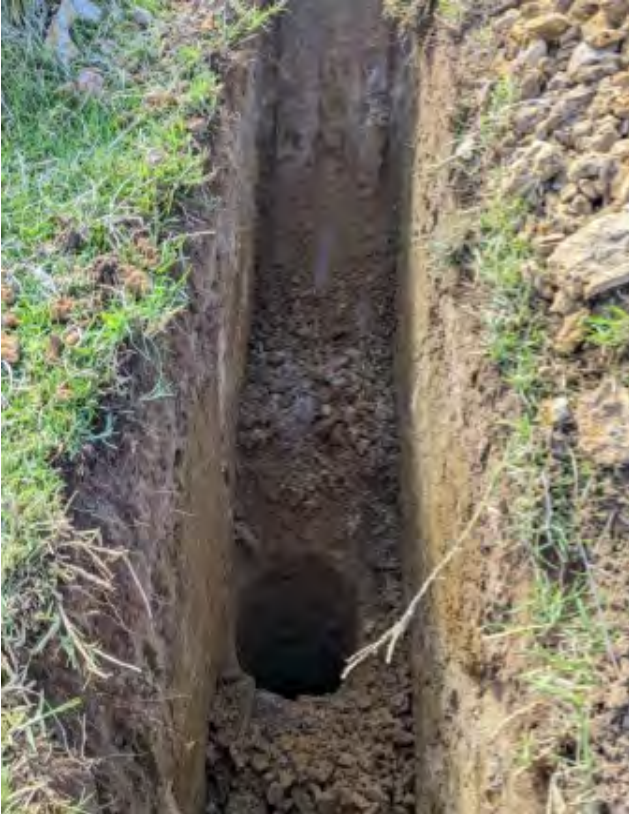
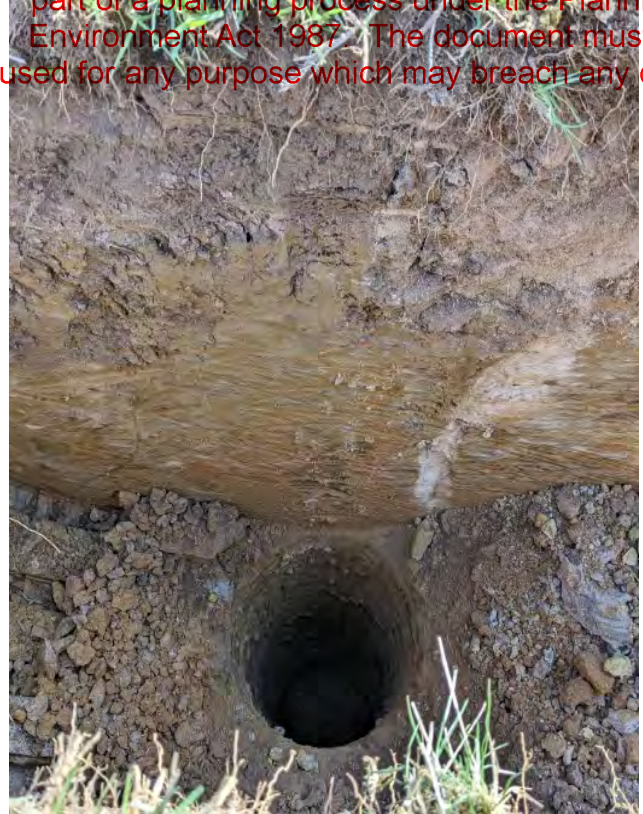
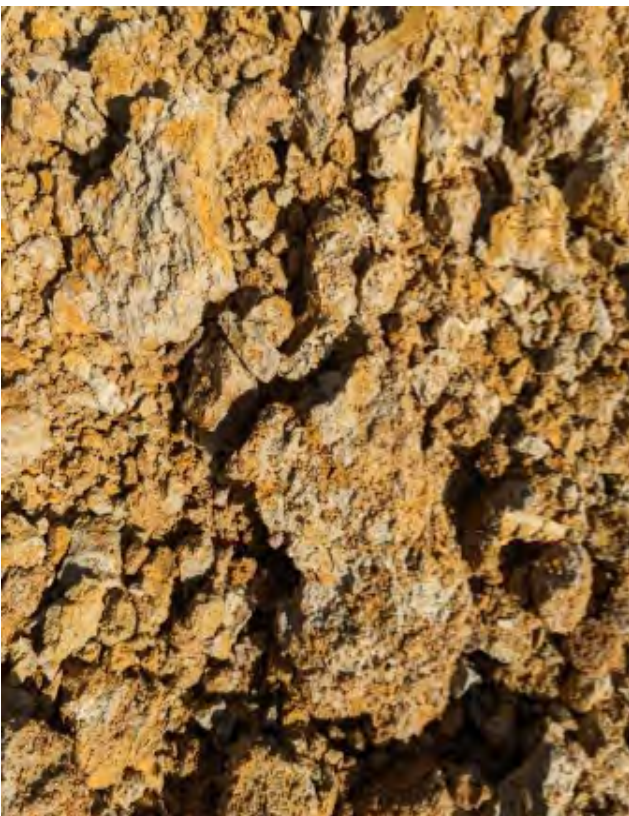
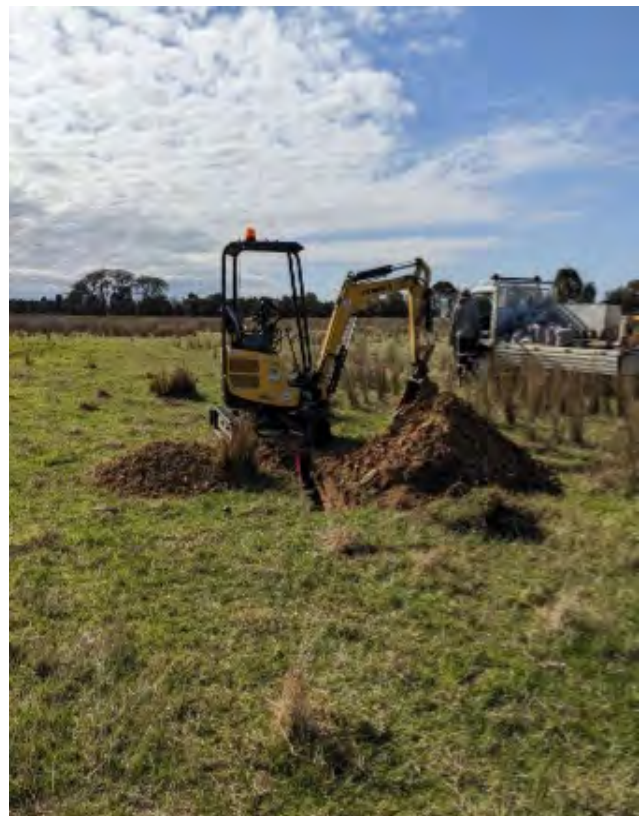
1.5						
	2						
	2.5						
	3						
	3.5						
				PTP02 Terminated at 3m			1879-S22

CH	sandy CLAY, grey mottled red/orange, high plasticity, sand 56% fine to coarse grained, stiff, dry to moist (inferred Haunted Hills Formation residual soil).	St	D-M	
4							
5
