Development Plan

10 Marlo Road, Marlo

Reference – 16273

Version 7
21 February 2020

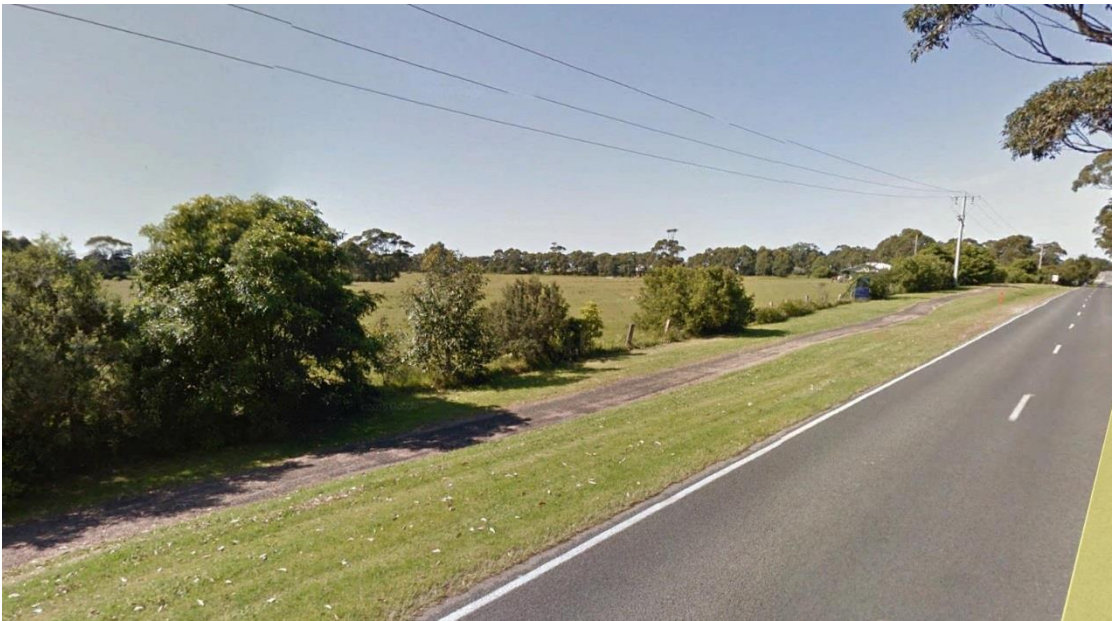
View across the north-west corner of the subject land from Marlo Road

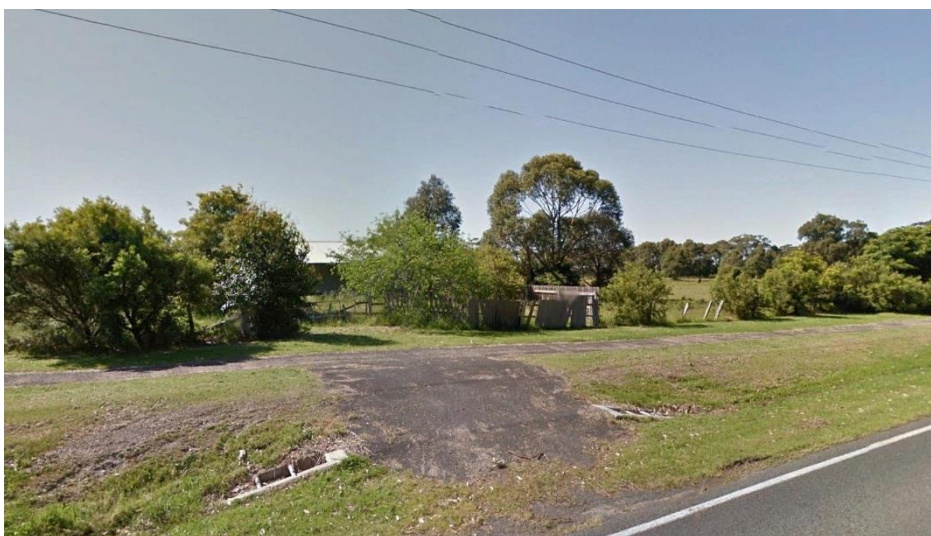
There are two existing locations for access to the property from Marlo Road. The northern access is located adjacent to the existing dwelling. A second informal access exists approximately 120 metres south of the primary driveway.

View of existing access to dwelling from Marlo Road

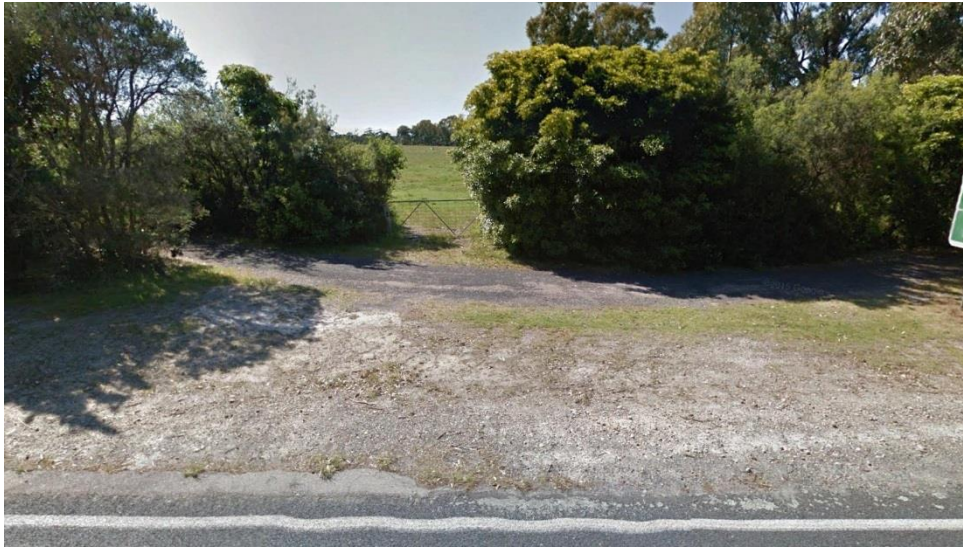
View of southern access from Marlo Road

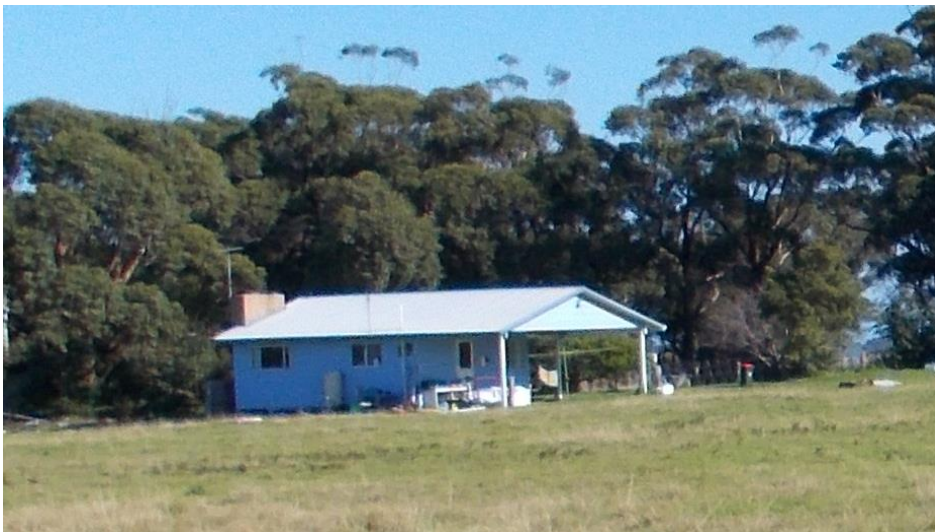
A modest single storey weatherboard dwelling is sited on the property adjacent to the western boundary. The land does not contain any other buildings or structures.

Existing dwelling

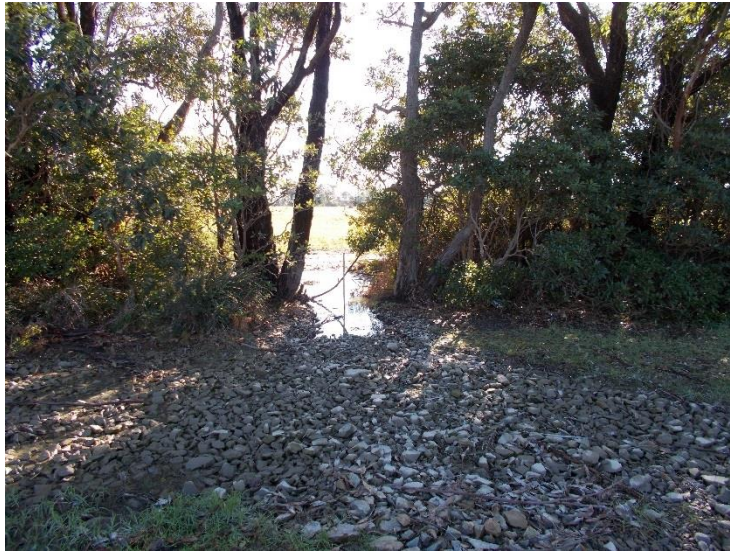
The land contains some scattered trees, but for the most part is otherwise open and clear of vegetation with minimal development constraints. The land is slightly undulating, with the highest point being in the north-west corner. From the north-west corner the land gently falls in a southerly direction across the front of the site and in a south-easterly direction to the head of a shallow ephemeral watercourse situated in the centre of the property. Runoff from much of the land is captured by the watercourse that discharges into Ward Street.

View of runoff discharging into Ward Street

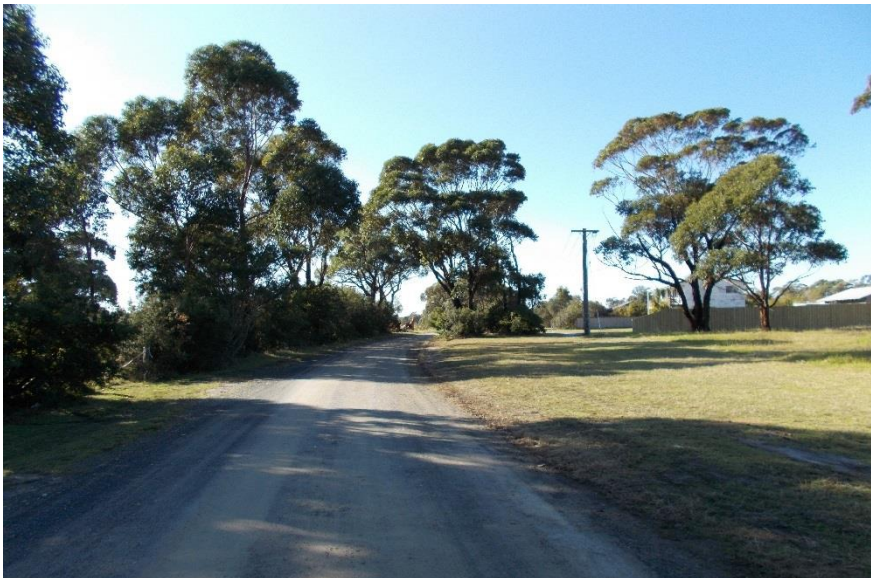
The southern boundary of the land adjoins Ward Street for a length of approximately 333 metres. Ward Street is a gravel road with a wide grassed verge on the south side. Properties on the south side of Ward Street comprise of typical residential allotments varying in size generally between 330m² and 1450m². Property frontages also vary in width from 14 metres to 30 metres. Overhead powerlines are also present in Ward Street

View east on Ward Street

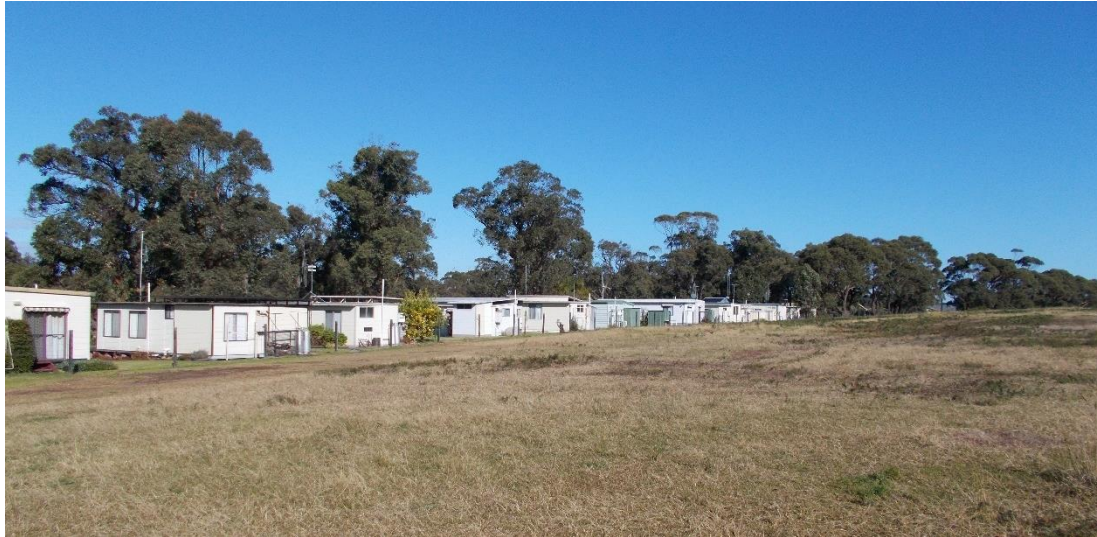
The south-east corner of the subject land adjoins a caravan park. A recent survey of the property boundaries has determined a proportion of the subject land is in fact occupied by the caravan park and contains a number of caravans and associated structures.

View of caravans from the south-east corner of the subject land

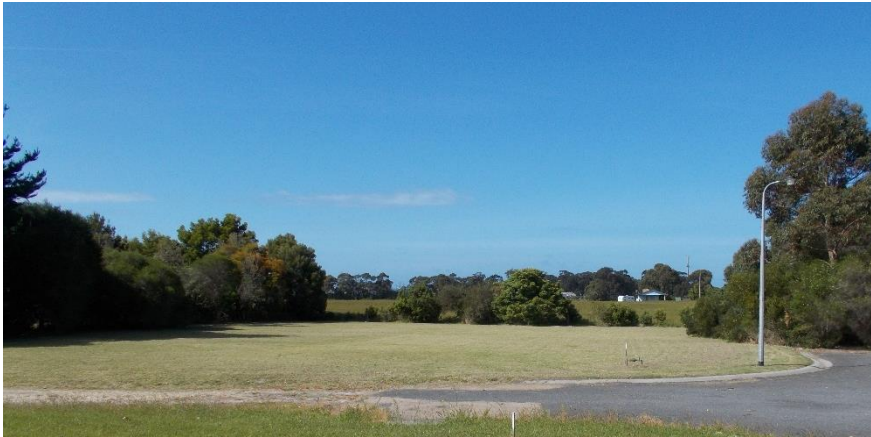
The land to the north is contained within the General Residential Zone. Two properties known as 20 and 20A Couper Drive immediately adjoin the northern boundary of the subject land. The property at 20 Couper Drive is a regular shaped lot having an area of approximately 2000m² and is vacant. The land is flat and clear of vegetation other than grass which is well maintained.

View south of 20 Couper Drive, Marlo

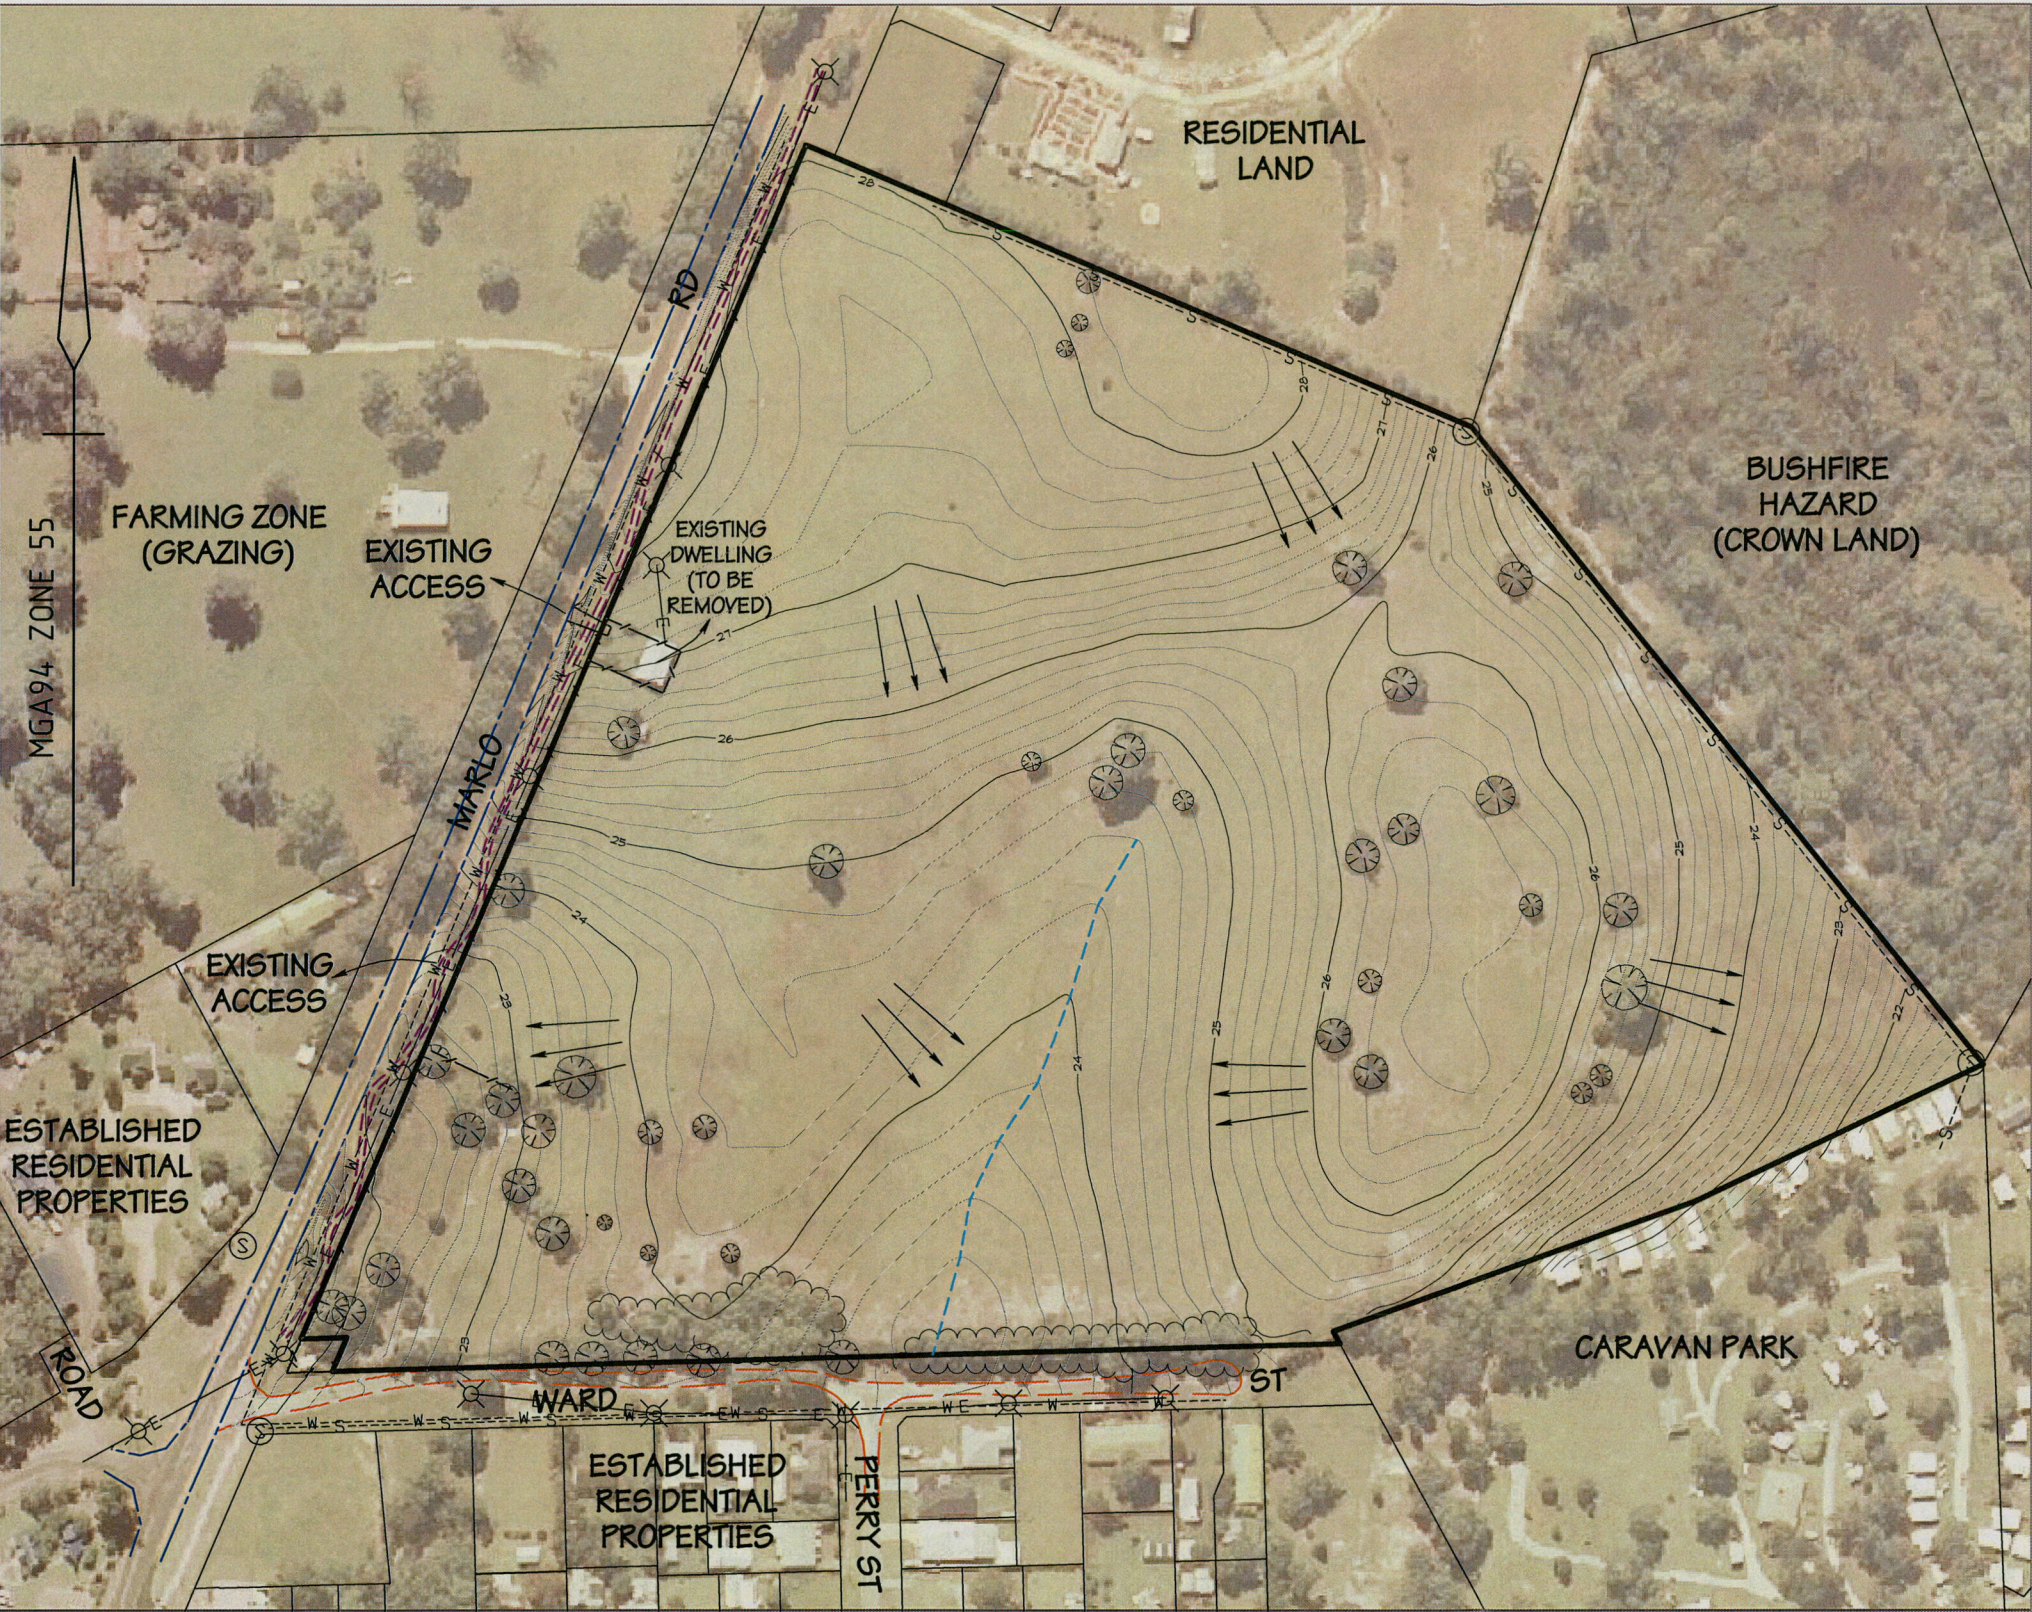
- EXISTING MAIN ROAD (MARLO ROAD)
- EXISTING LOCAL ROAD (WARD STREET)
- EXISTING FOOTPATH
- EXISTING TREE
- SLOPE OF LAND
- EXISTING WATER
- EXISTING SEWER
- EXISTING OVERHEAD POWERLINE
- EXISTING SEWER
- DRAINAGE LINE (WATER WAY)

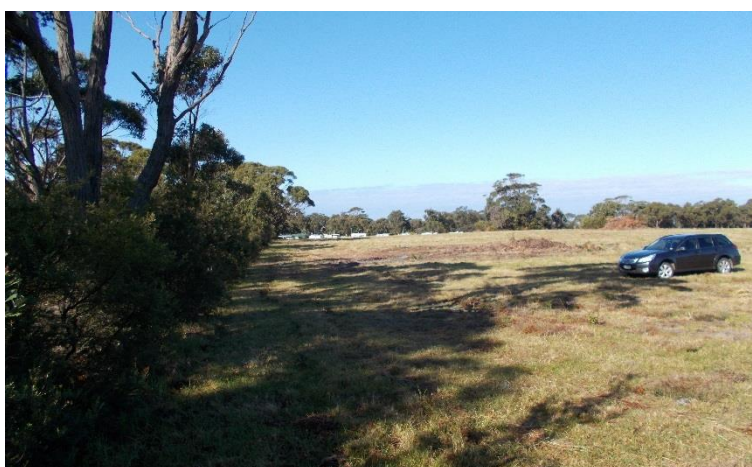
Reserve No. 1 is proposed at the east side of the subject land having an area of approximately 1.562ha. The site for this reserve is substantially cleared of trees and consists of exotic grasses. A mature native tree is currently located at the south-west corner of the proposed reserve and will be retained if possible. It is noted that for the purpose of native vegetation controls this tree is presumed to be removed due to the close proximity of the internal road network.

View south from northern corner of proposed Reserve #1

Minimal improvement is proposed for the land contained within Reserve No. 1. Some minor earthworks may be required for the establishment of a minor recreation facility and for footpaths to provide connection to the existing trail within the adjoining Marlo State Forest (the State Forest). Footpath connections to the State Forest are proposed at the north east corner and south east corner of Reserve No. 1.

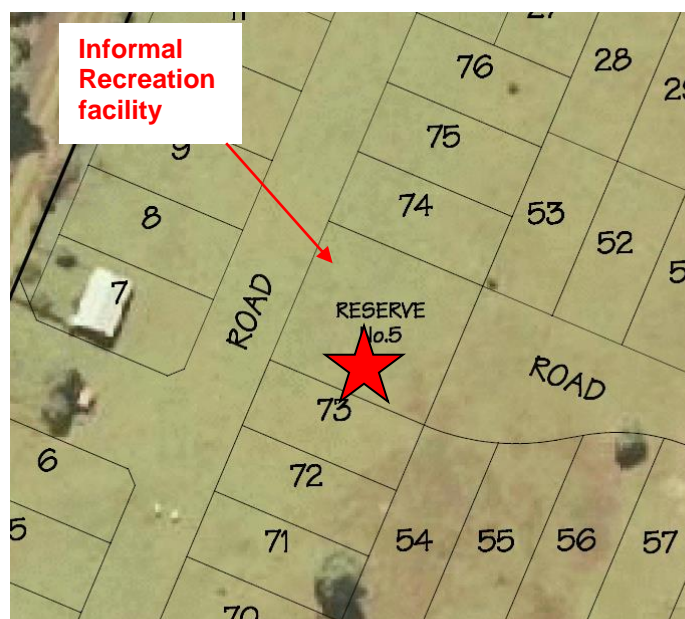
Proposed children's playground Reserve #5

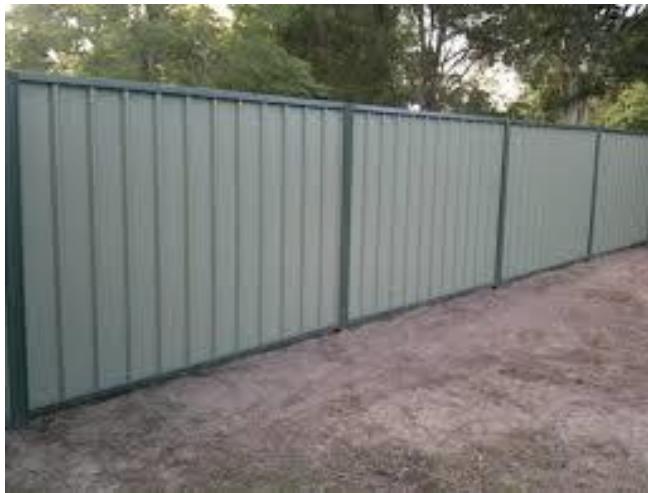
Image of Colorbond style fence proposed

It is proposed that fencing of the boundary between Reserves 2, 3 and 4 and the adjoining allotments have a consistent height, colour and materials. It is proposed a *Colorbond* type steel fence to a height of 1.8m be constructed as part of Stage1 and Stage 2 at full cost to the Developer.

The fence will be an intrinsic element to the Marlo Road streetscape. To ensure the fence remains contiguous after the development is complete it will be necessary to ensure future owners are informed of their obligation to maintain the same consistent style of fence adjacent to the Reserves. It will therefore be necessary to include a condition on a subsequent Planning Permit requiring the Developer to enter into an agreement under Section 173 of the *Planning and Environment Act 1987* providing for the fence to be maintained by future adjoining property owners in accordance with the approved landscape plan.

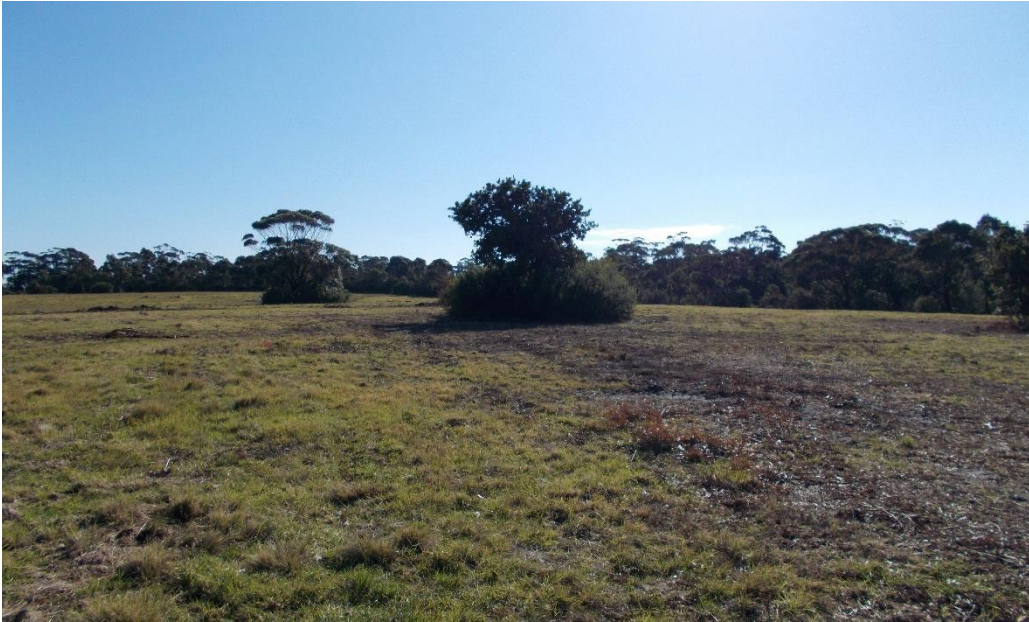
The land contains some scattered trees, but for the most part otherwise comprises open *Grassland* vegetation. The topography of the land is slightly undulating, with the highest point being in the north-west corner. Overall the land is characterised by downslopes of $>0-5^{\circ}$.

View north at eastern end of the subject land

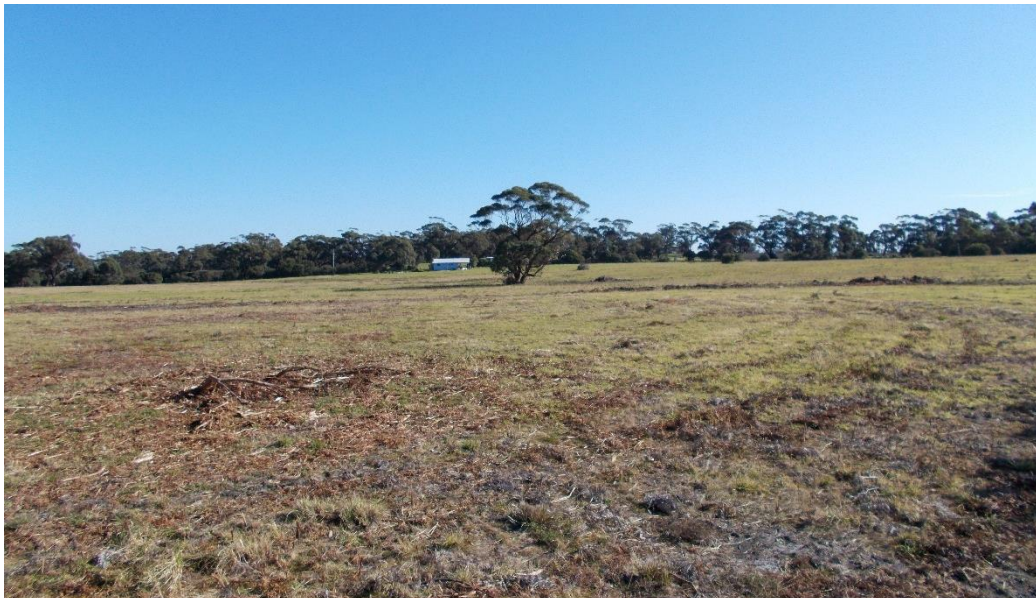
View west across subject land

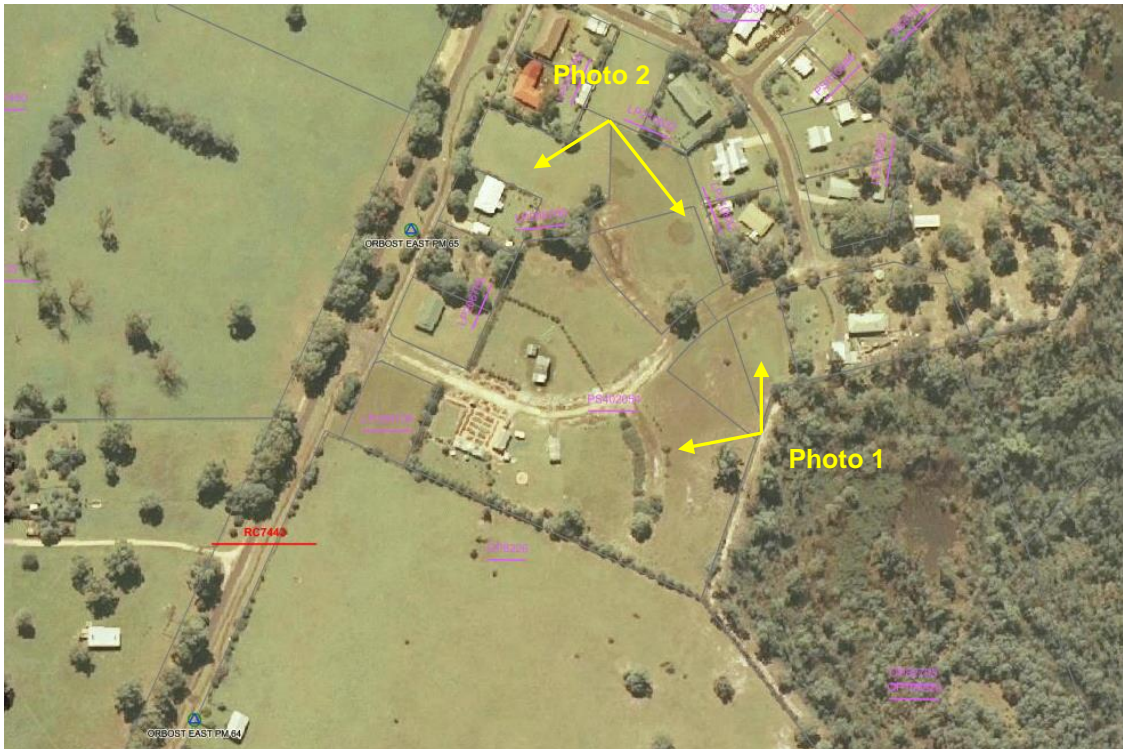
Land to the north and south of the subject land has been developed for residential purposes. Residential properties appear regularly maintained with minimal landscaping. Adjoining land to the north is considered to contain *Modified* vegetation.

Aerial image northern aspect (Saleni Drive neighbourhood)

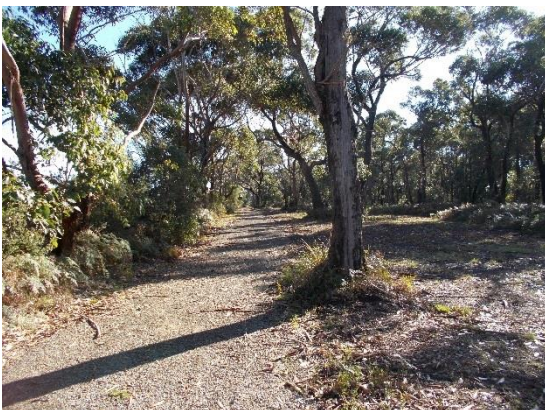
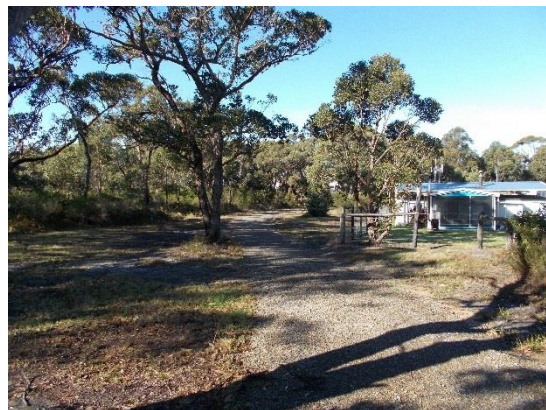
The State Forest is managed by Parks Victoria (DELWP). A gravel trail has been established adjacent to the south-west and western boundary of the State Forest. On inspection of properties surrounding the subject land it appears the gravel trail was in good condition and regularly maintained. It was also found that understorey adjacent to the trail was also maintained. The width of the trail together with the area of managed vegetation provides a 15m wide buffer between the boundary with the subject land and classifiable *Forest* vegetation.

View north and south of gravel trail within the Marlo State Forest adjacent to the subject land

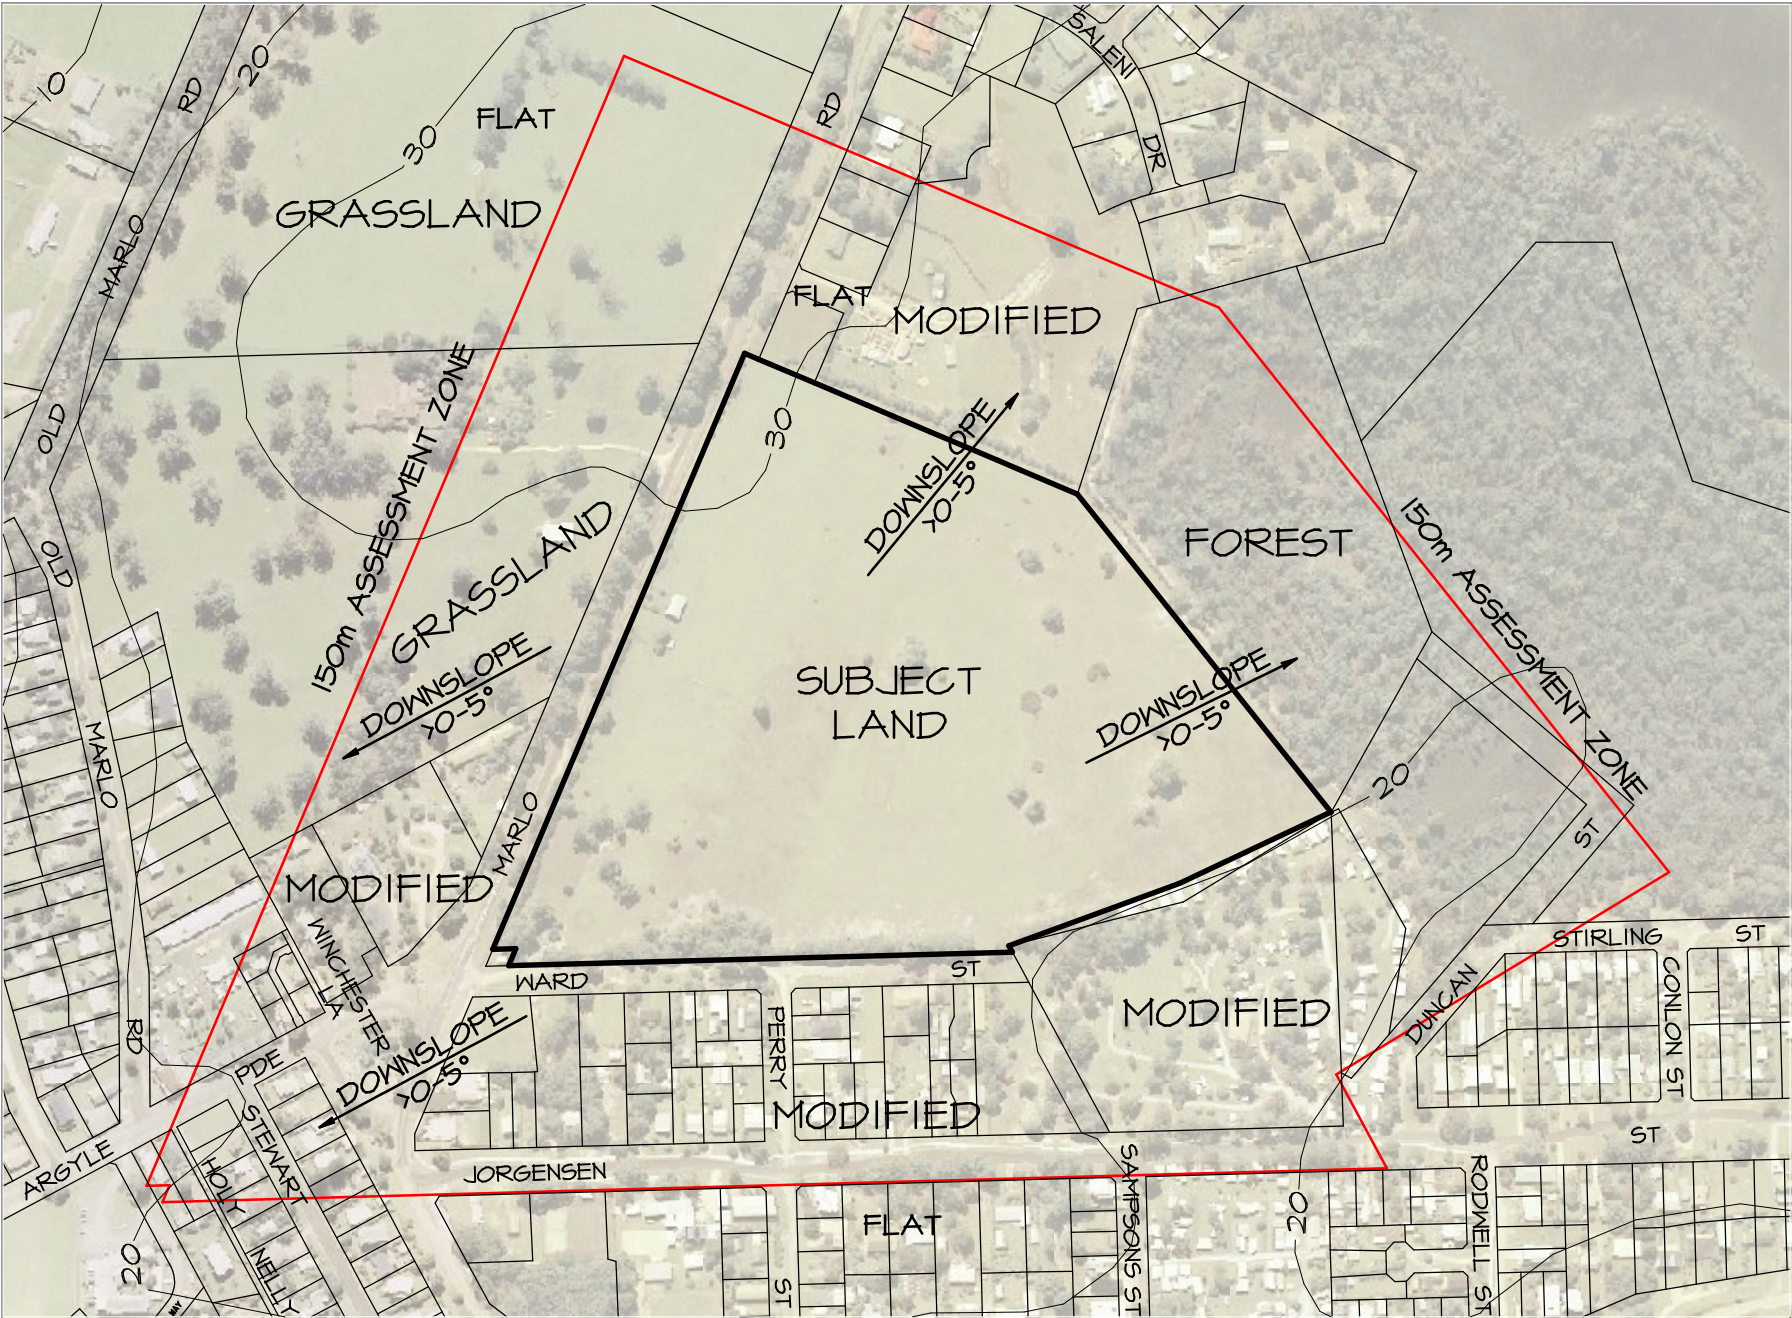
FIGURE 7

BUSHFIRE HAZARD SITE
ASSESSMENT PLAN

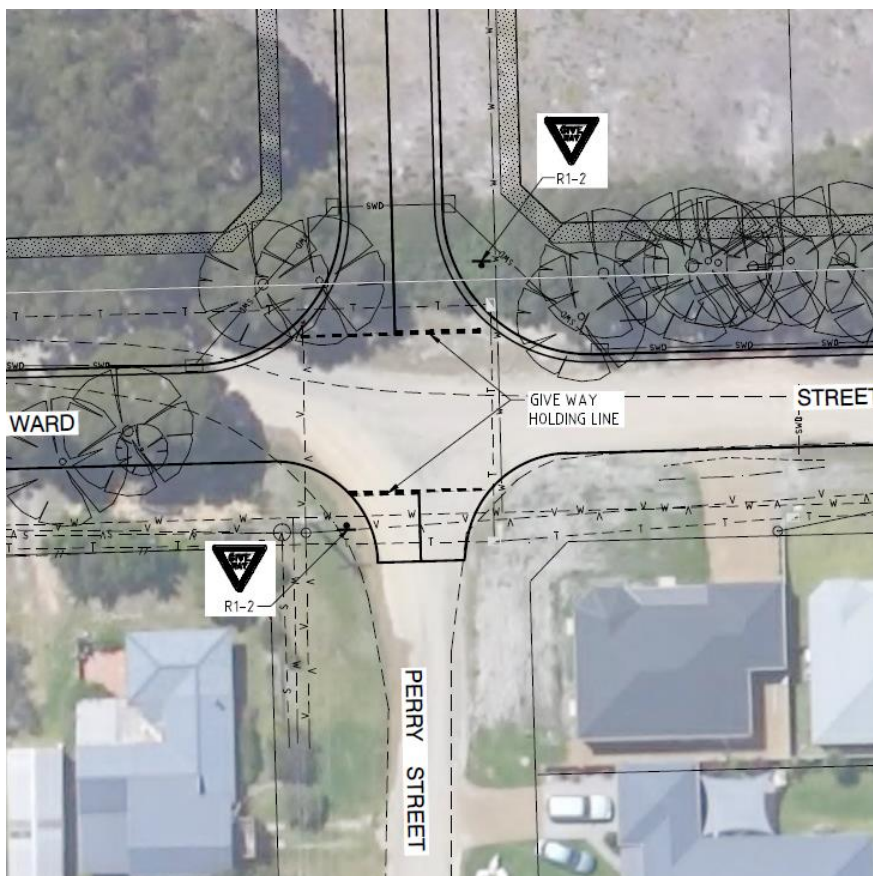
*Extract from Conceptual Ward St & Marlo Road Intersection Layout
(Source: Crossco Consulting Drawing No 1918/014-A)*

Plans for the detailed design of the intersection will be required as a condition within the Planning Permit. The design must also include provision for pedestrian crossing point on Marlo Road. The upgrade to the intersection of Marlo Road and Ward Street must be completed as part of Stage 1 of the development.

The full upgrade to Ward Street will also necessitate construction of the intersection at Ward Street and Perry Street.

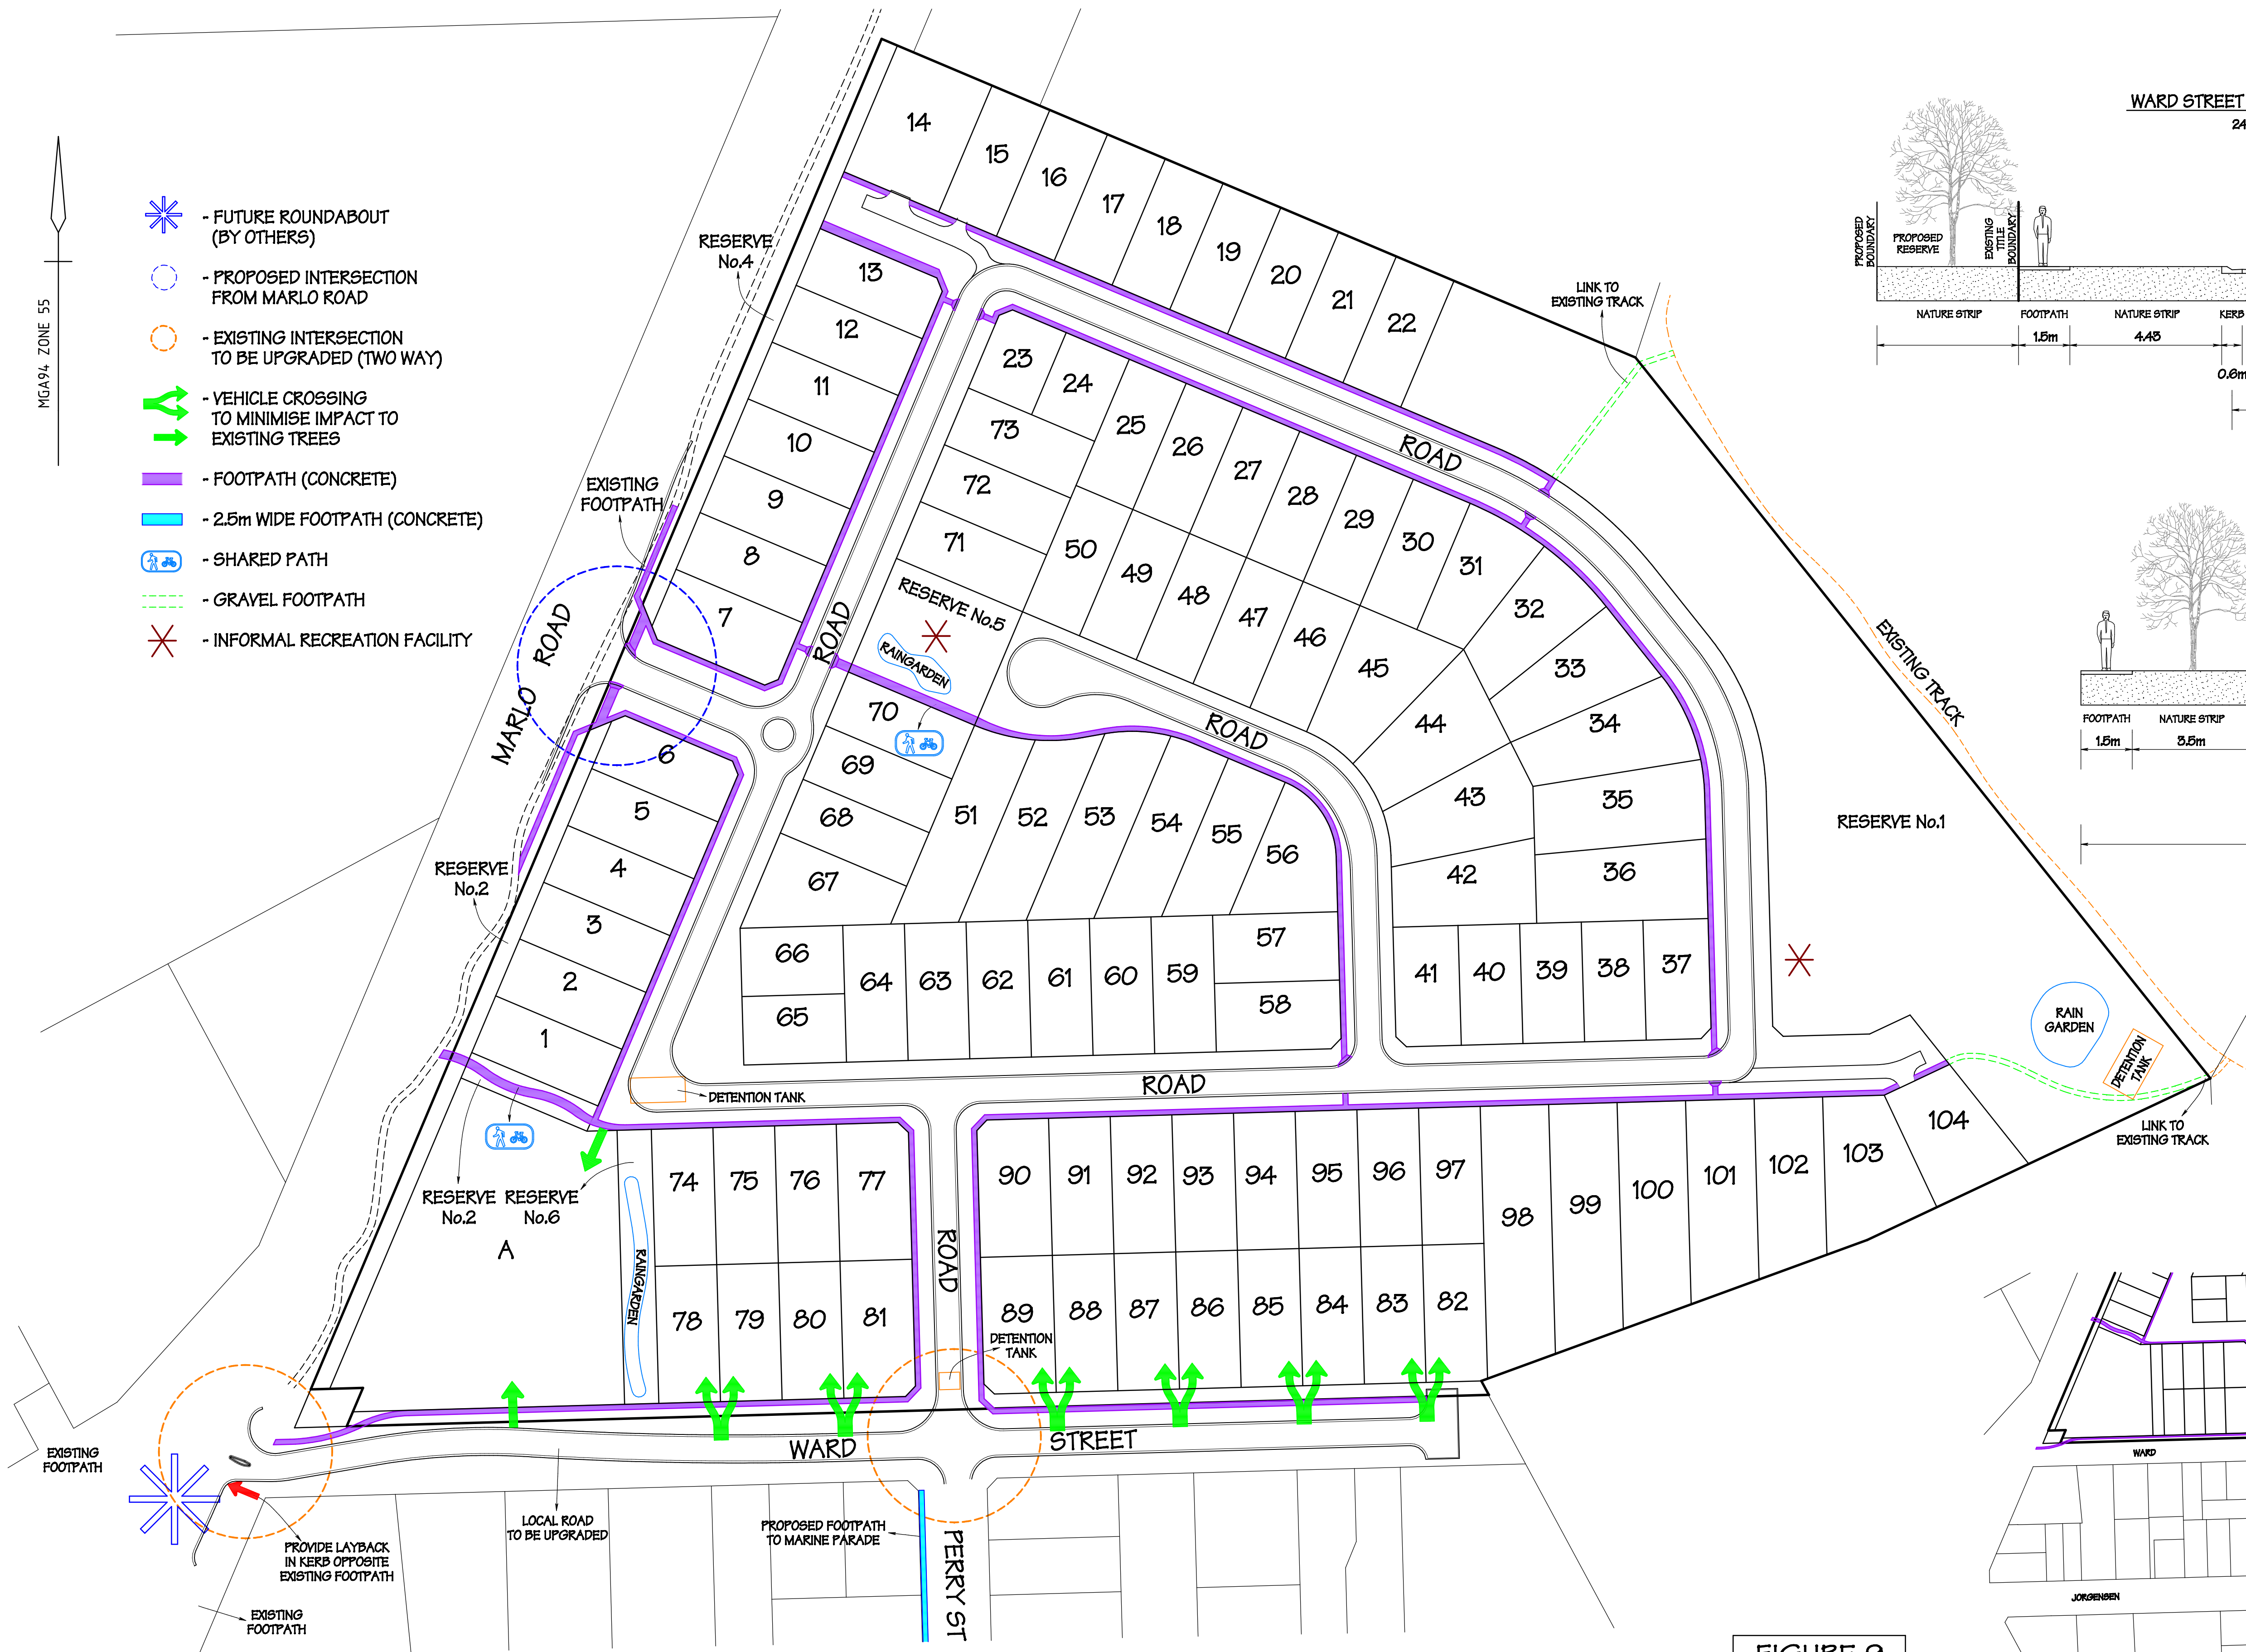
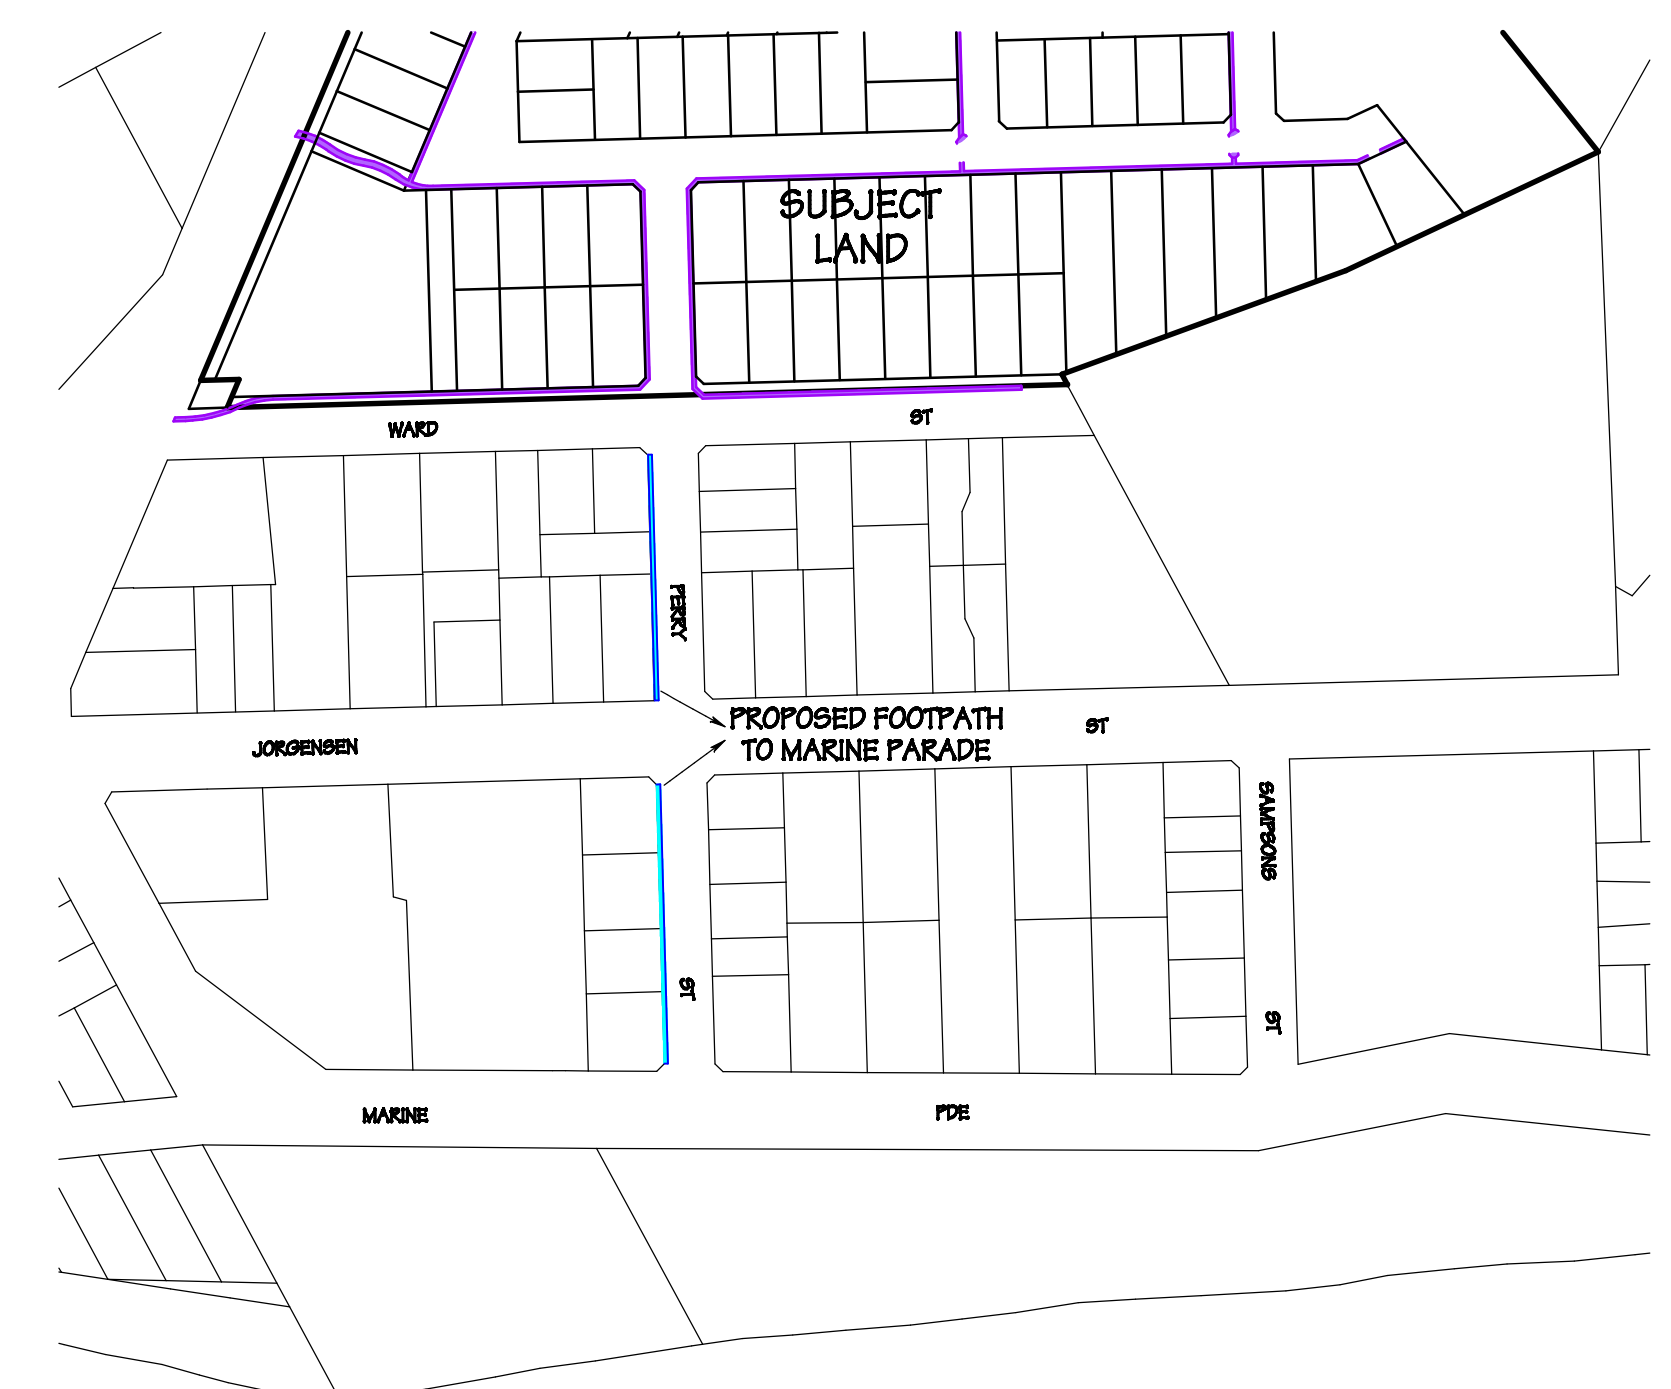
FIGURE 9

- INFORMAL RECREATION FACILITY

An Infrastructure Plan has been prepared and is contained at Figure 9. The Infrastructure Plan sets out the extent of roadworks, development of proposed Reserves within the subject land as well as the upgrade to Ward Street, the intersection at Ward Street and Marlo Road, the intersection of Ward Street and Perry Street, the proposed access from the subject land to Marlo Road and a new footpath in Perry Street between Ward Street and Marine Parade.

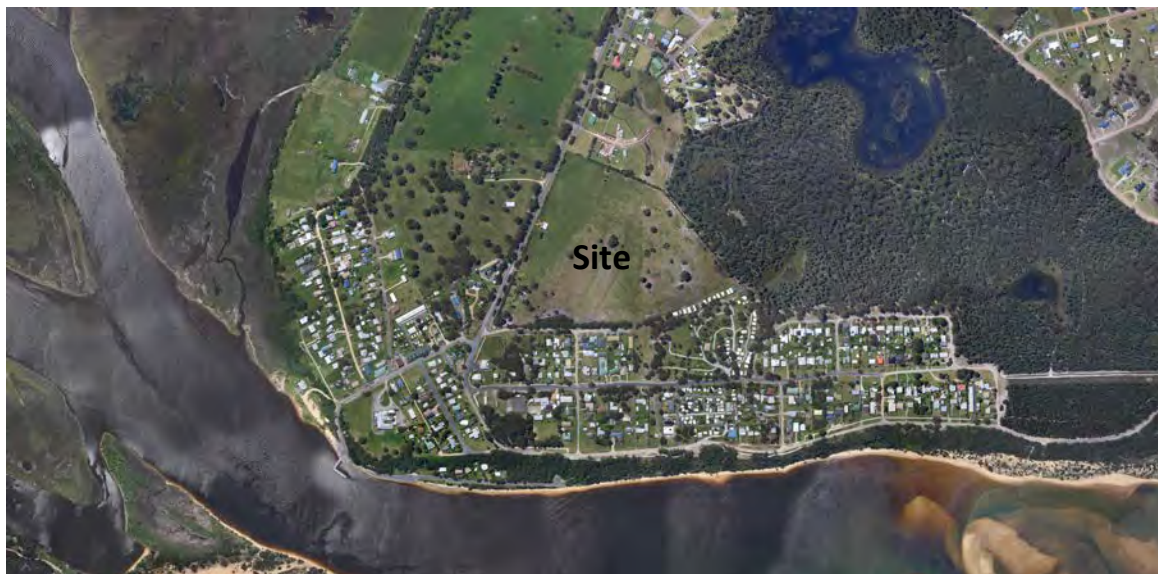
Figure 2: Site Overview

The site is located within the township of Marlo, with existing adjacent development to the north and south. Figure 2 shows the location of the site and surrounding existing development.

The site varies in elevation from a maximum of 28.5m AHD to a minimum of 22m AHD.
