Development Plan

10 Marlo Road, Marlo

Reference – 16273

Version 7
21 February 2020

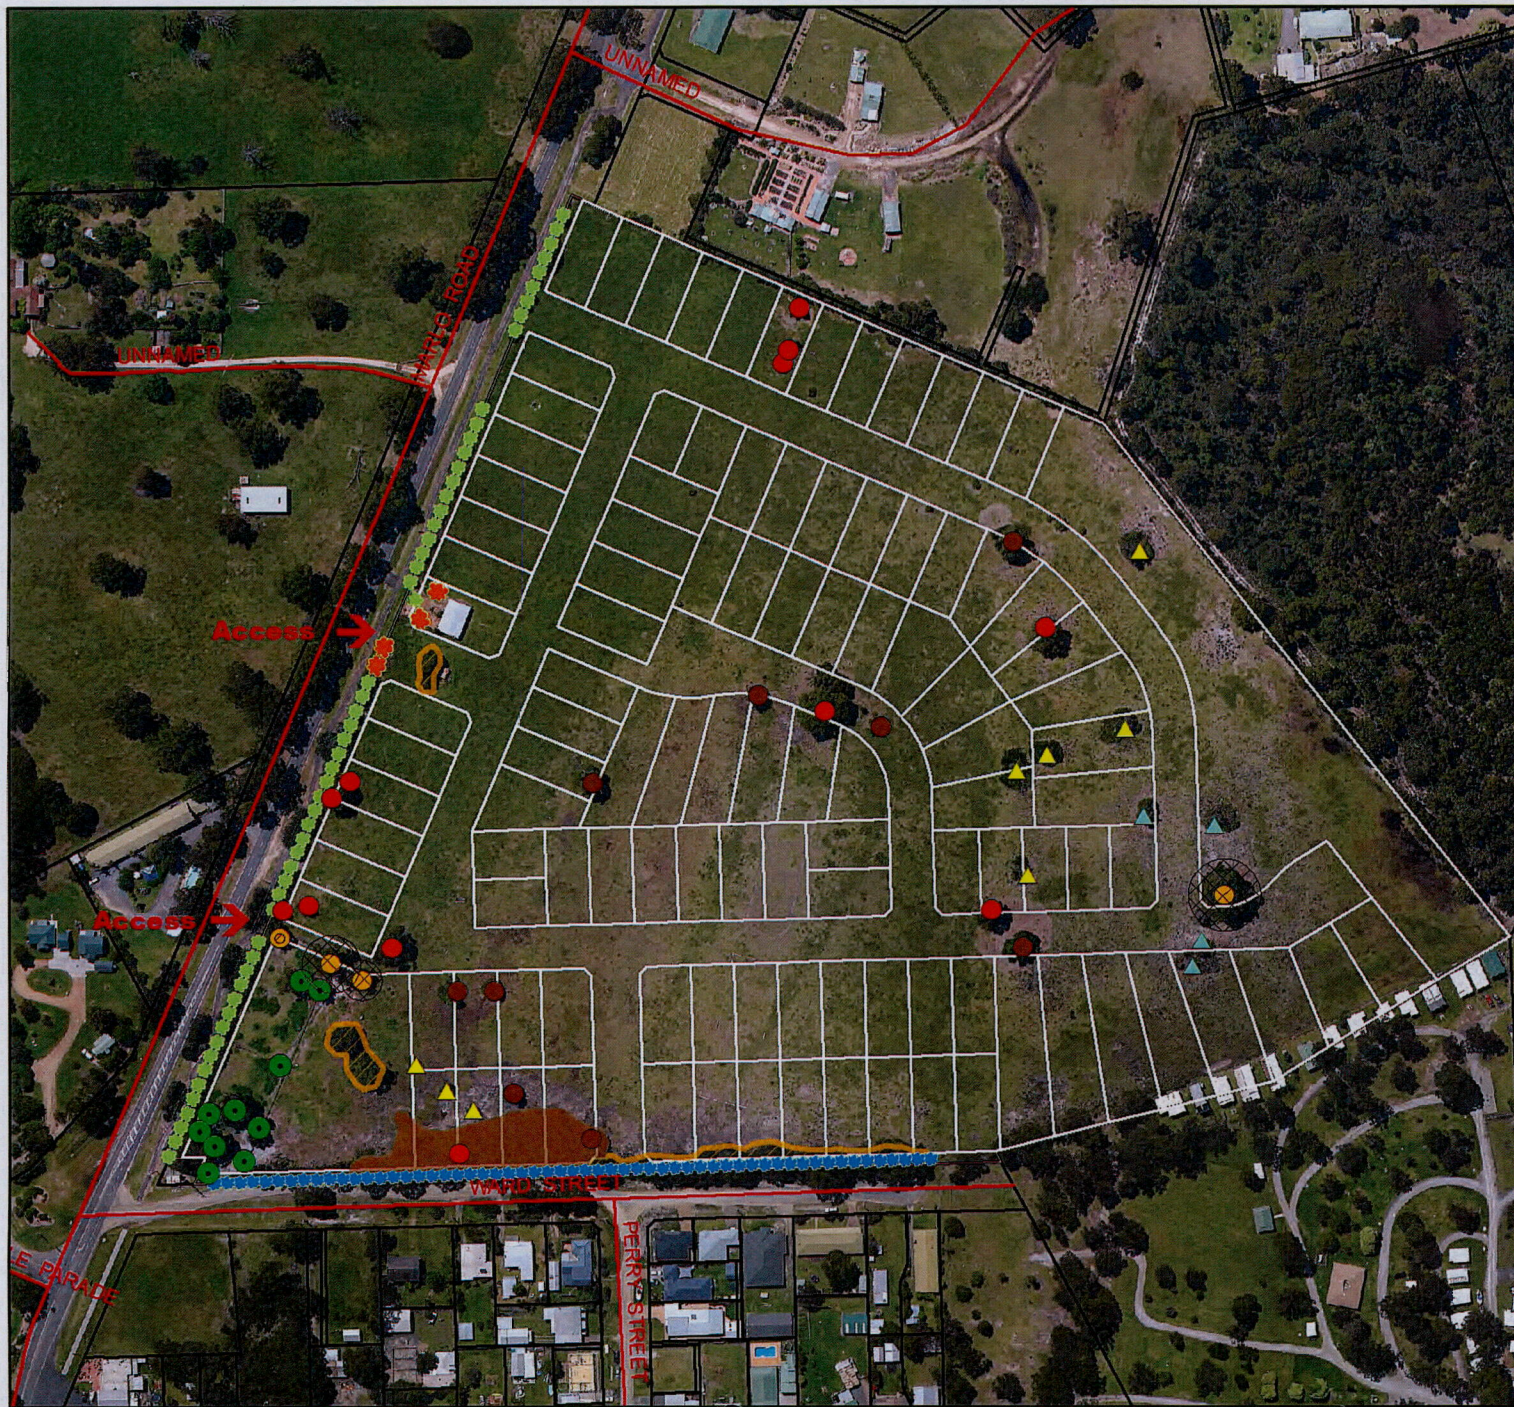
Figure 2.
Vegetation Assessment
10 Marlo Road, Marlo

The vegetation marked on **Figure 2** has been assessed by Ethos NRM as planted vegetation, hence there is no permit or offset requirement.

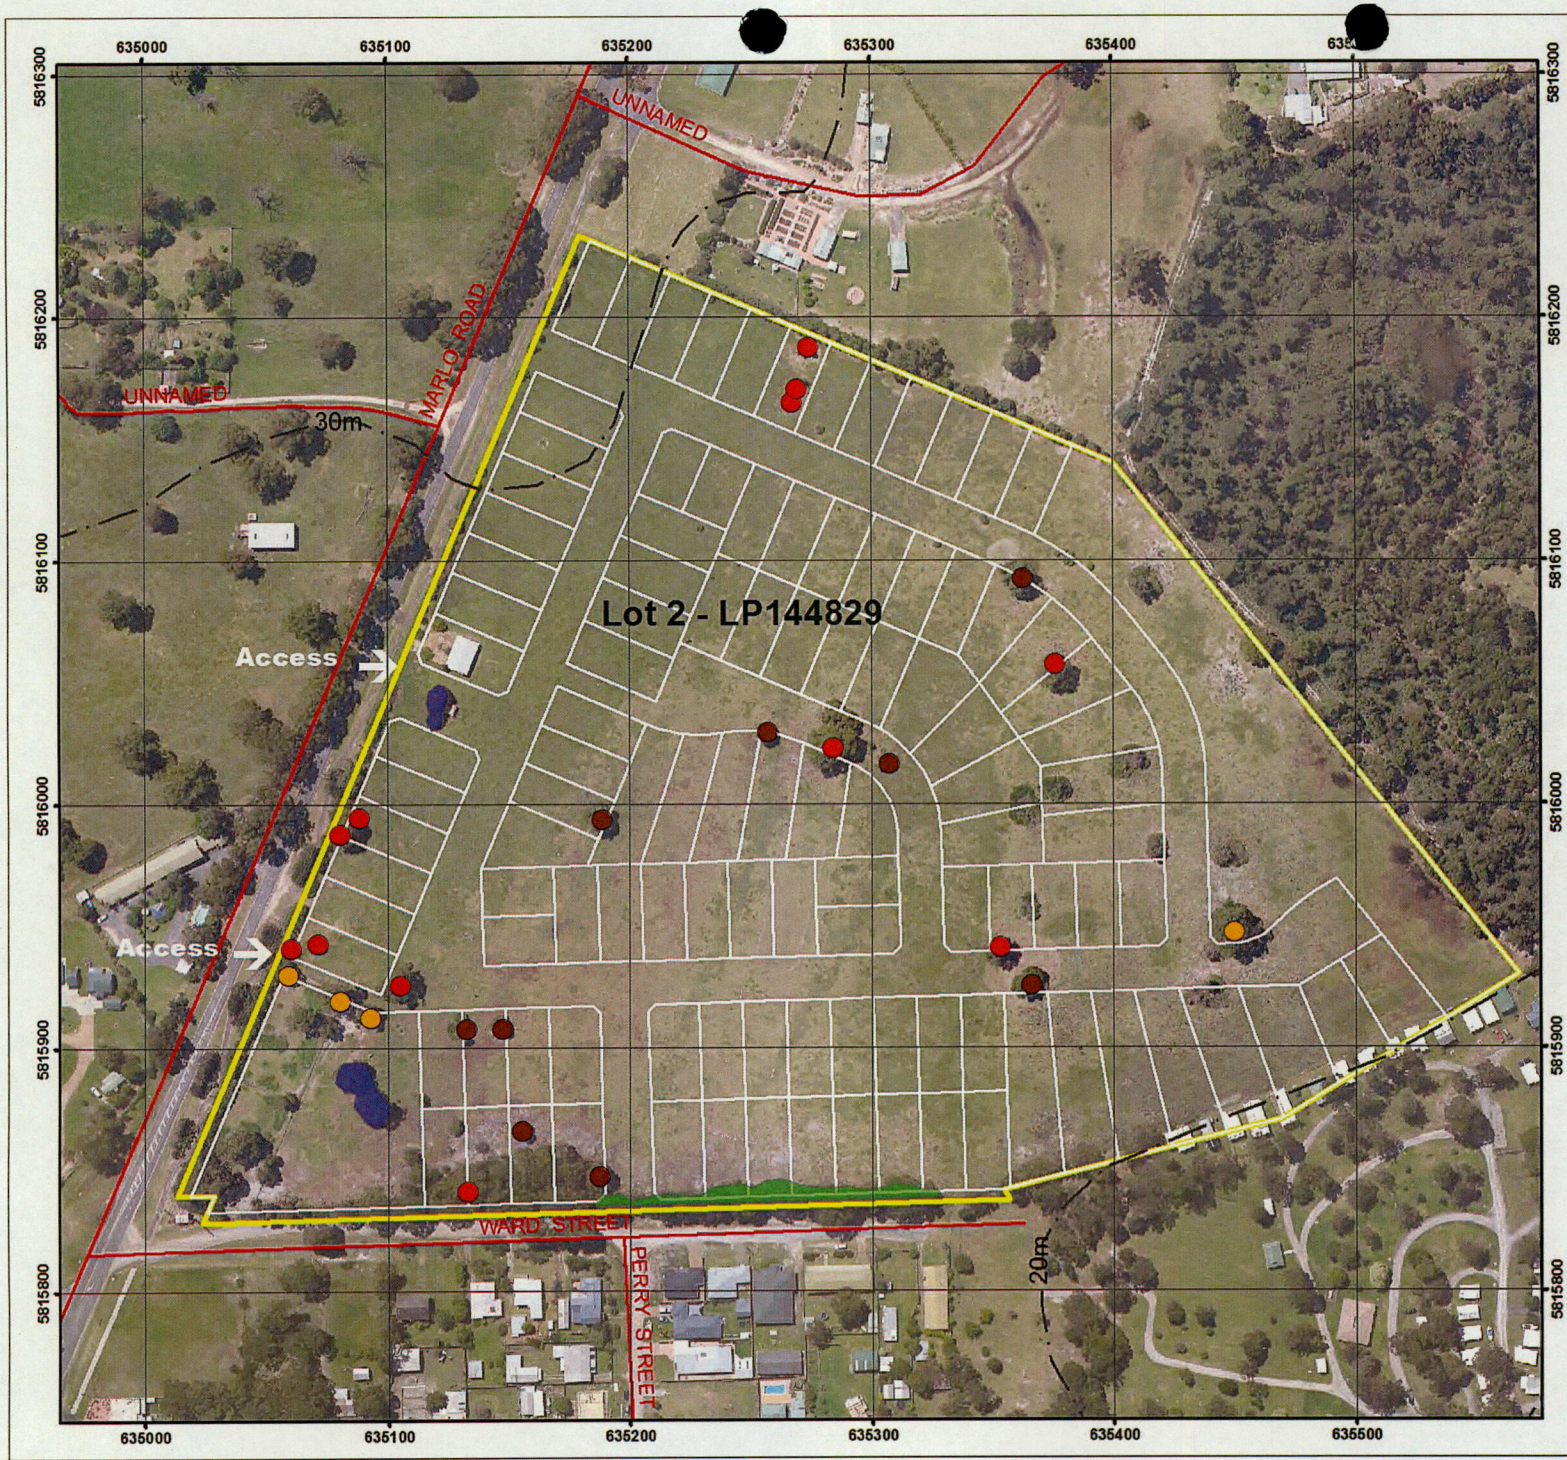
Figure 3. Vegetation Removal Site Plan 10 Marlo Road, Marlo

Ethos NRM has been advised by the landholder that some areas of vegetation recently removed along the southern fence-line is in accordance these exemptions, including areas of regrowth, fence-line clearing and firewood collection. Other areas of vegetation removed which were not exempt from planning permit requirements have been included within this report (see **Table 4** and the following sections). Refer to **Figure 2** for areas of vegetation which have been removed and are exempt from planning permit requirements.

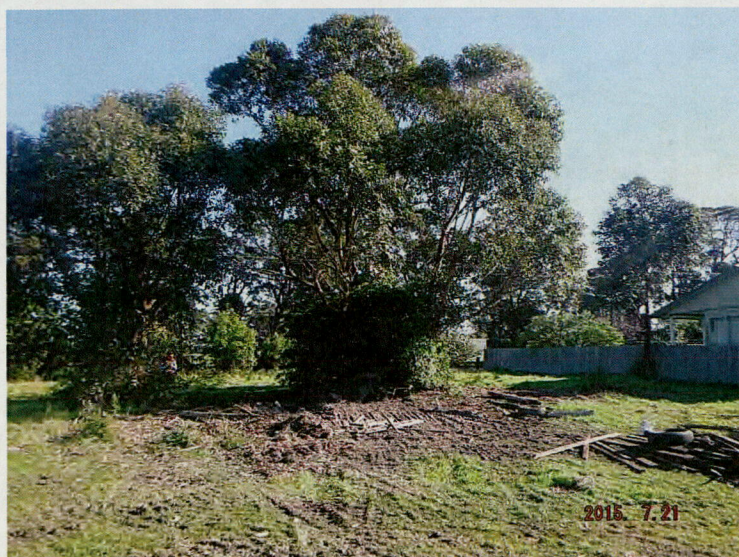
Plate 1. Habitat Zone A – near dwelling

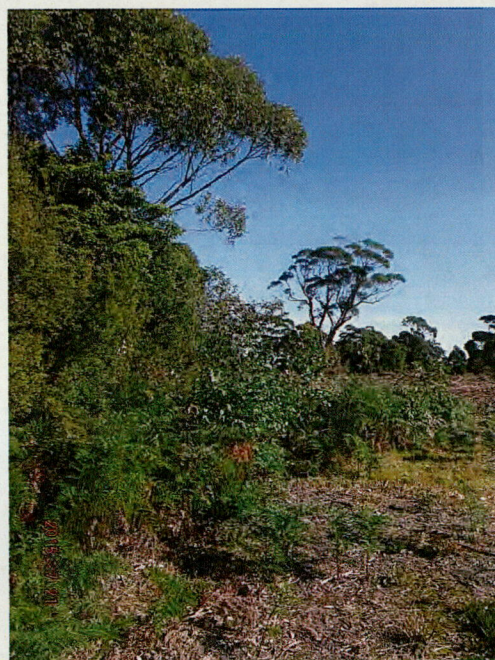
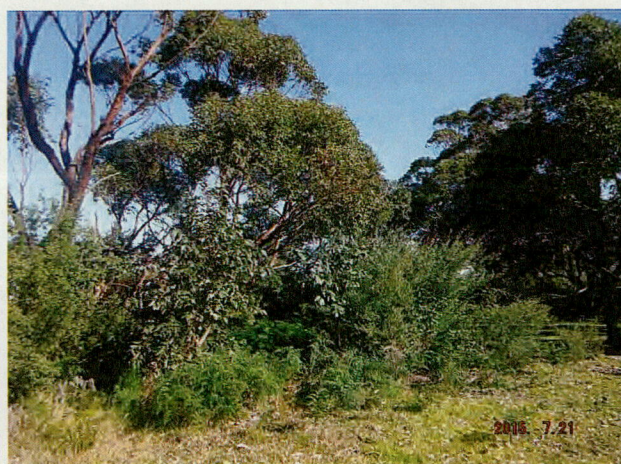
Plate 2. Habitat Zone B – southern property boundary

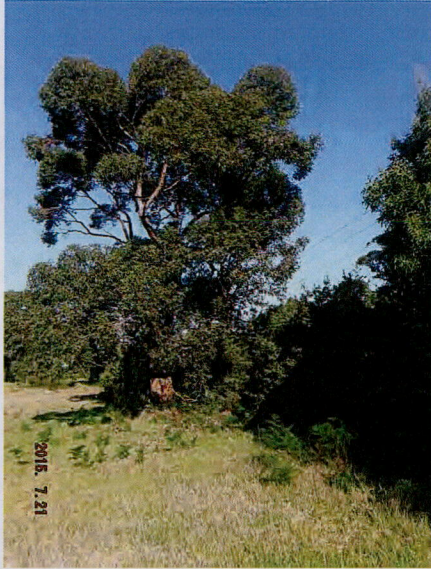
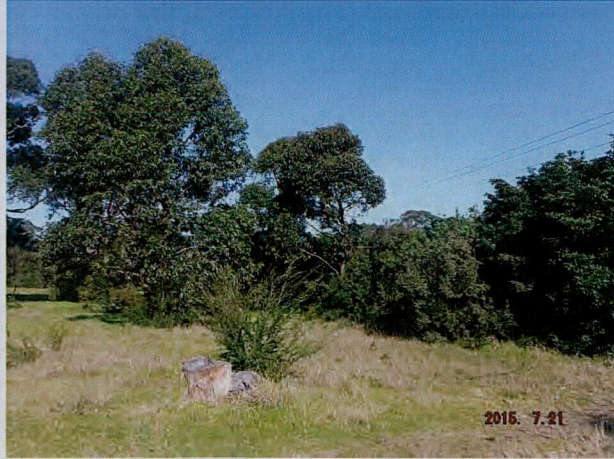
Plate 3. Scattered Trees to be removed on western boundary adjoining Marlo Rd.

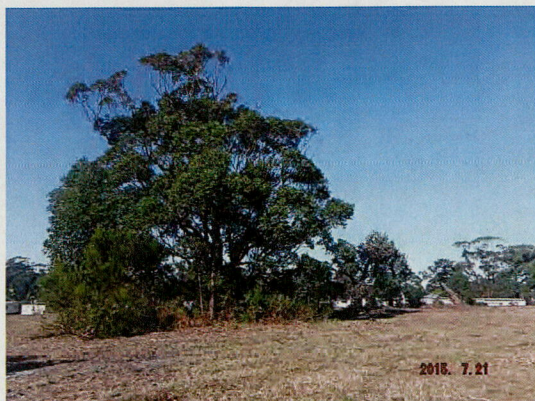
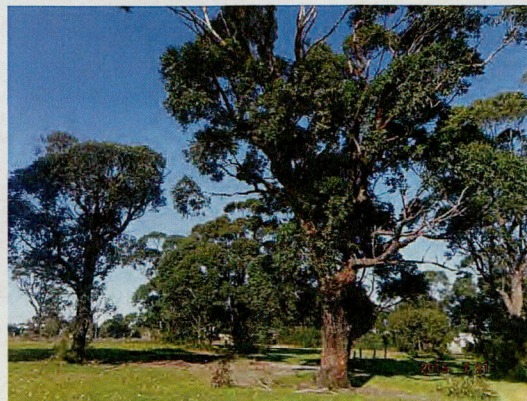
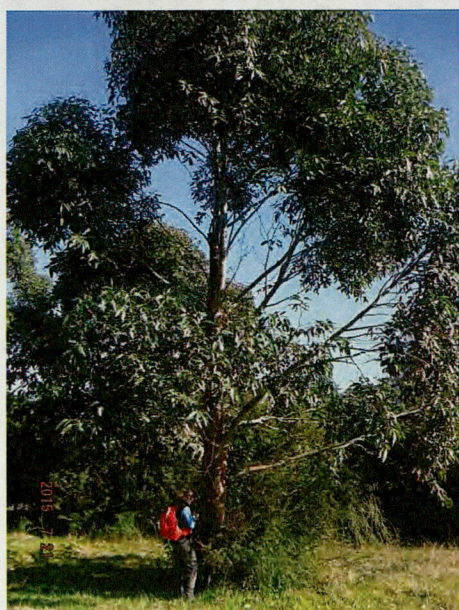
Plate 4. Canopy Tree assumed loss due to encroachment in TRZ

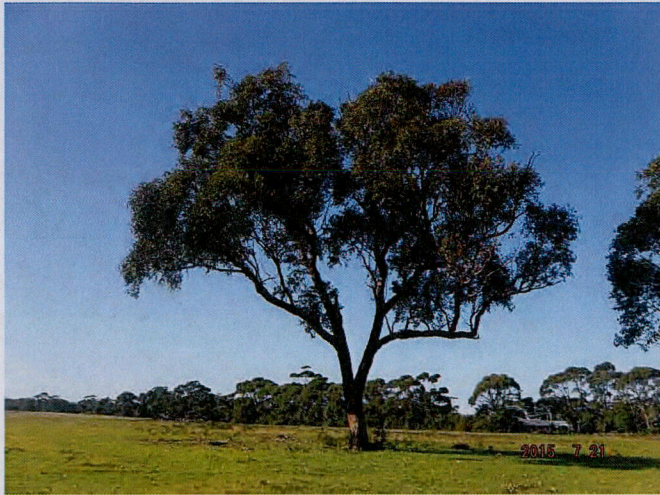
Plate 5. Scattered Trees within paddock to be removed

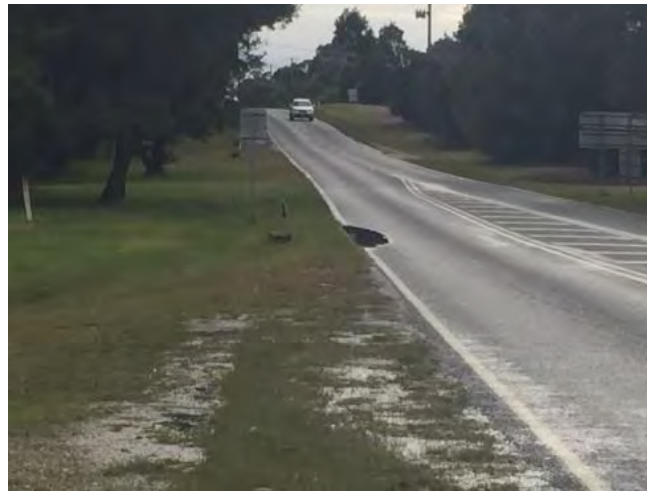
Figure 3: Marlo Road

Figure 3 shows Marlo Road, and is taken from the west side of Marlo Road looking to the north.
Note:

- the culvert under the road.
- pavement marking which can also be seen in Figure 4.
- no shoulder on Marlo Road

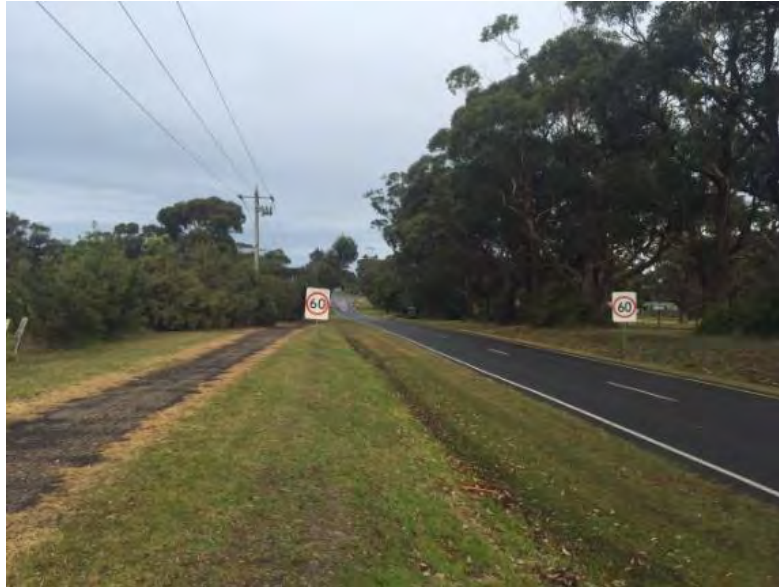
Figure 5: Marlo Road & Walking Track

Figure 3 shows Marlo Road, and is taken from the east side of Marlo Road looking to the south toward Marlo adjacent to the existing dwelling at proposed Lot 7. Note:

- the location of the 60 km/h signs immediately adjacent to the proposed intersection with Marlo Road.
- pavement marking in the distance at Ward Street intersection
- walking track to the left
- proximity of trees and embankment on the west side of Marlo Road
- no shoulder on Marlo Road

- the existing 60km/h signs as shown in Figure 5.
- driveway to the existing dwelling.
- batter and vegetation on the west side of Marlo Road.
- no gravel shoulder.

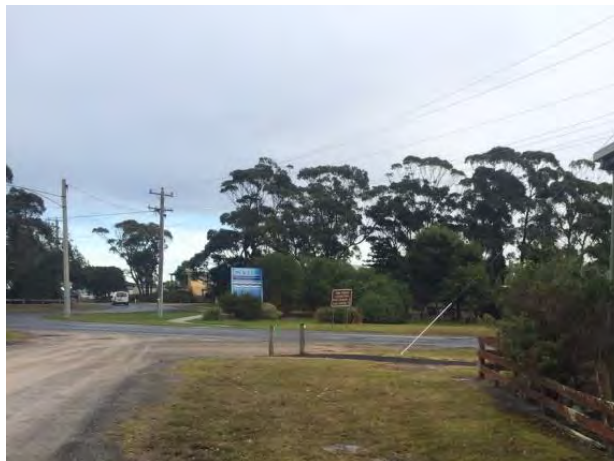
Figure 6: Marlo Road / Ward Street Intersection

Figure 3 shows Marlo Road / Ward Street intersection, and is taken from the north side of Ward Street adjacent to the existing Telstra installation. Note:

- vehicle travelling south along Argyle Parade
- gravel surface on Ward Street extend to edge of seal on Marlo Road
- a number of electricity poles / light posts / pole stay in proximity to the intersection
- turning moves are uncontrolled

It is noted that any change to the intersection of Ward Street and Marlo Road will require VicRoads approval as VicRoads administers Marlo Road. As shown in Figure 6 and Figure 7 above, Ward Street is a gravel road.

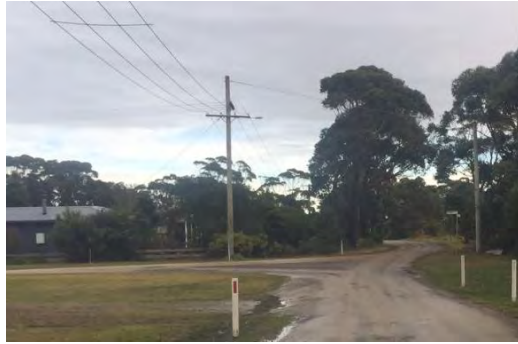
Figure 7: Ward Street / Perry Street intersection

Figure 3 shows the Ward Street and the intersection with Perry Street, and is taken from Ward Street east of the intersection with Perry Street. Note:

- gravel road
- no formed drainage
- existing vegetation in the road reserve

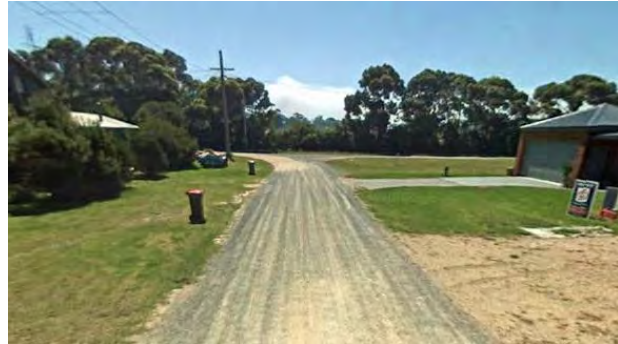
Figure 8: Perry Street

Figure 3 shows Perry Street and the intersection with Ward Street, and is taken from Perry Street. Note that Perry Street is a gravel road with no formal drainage or footpath.

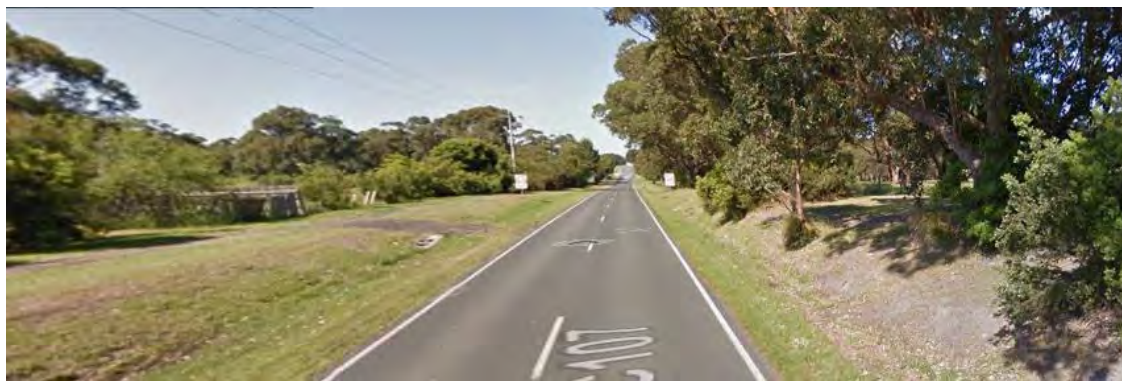
Figure 9: Marlo Road to south

Figure 3 is taken from google maps street view and is taken adjacent to the existing dwelling at proposed Lot 7. Of note is:

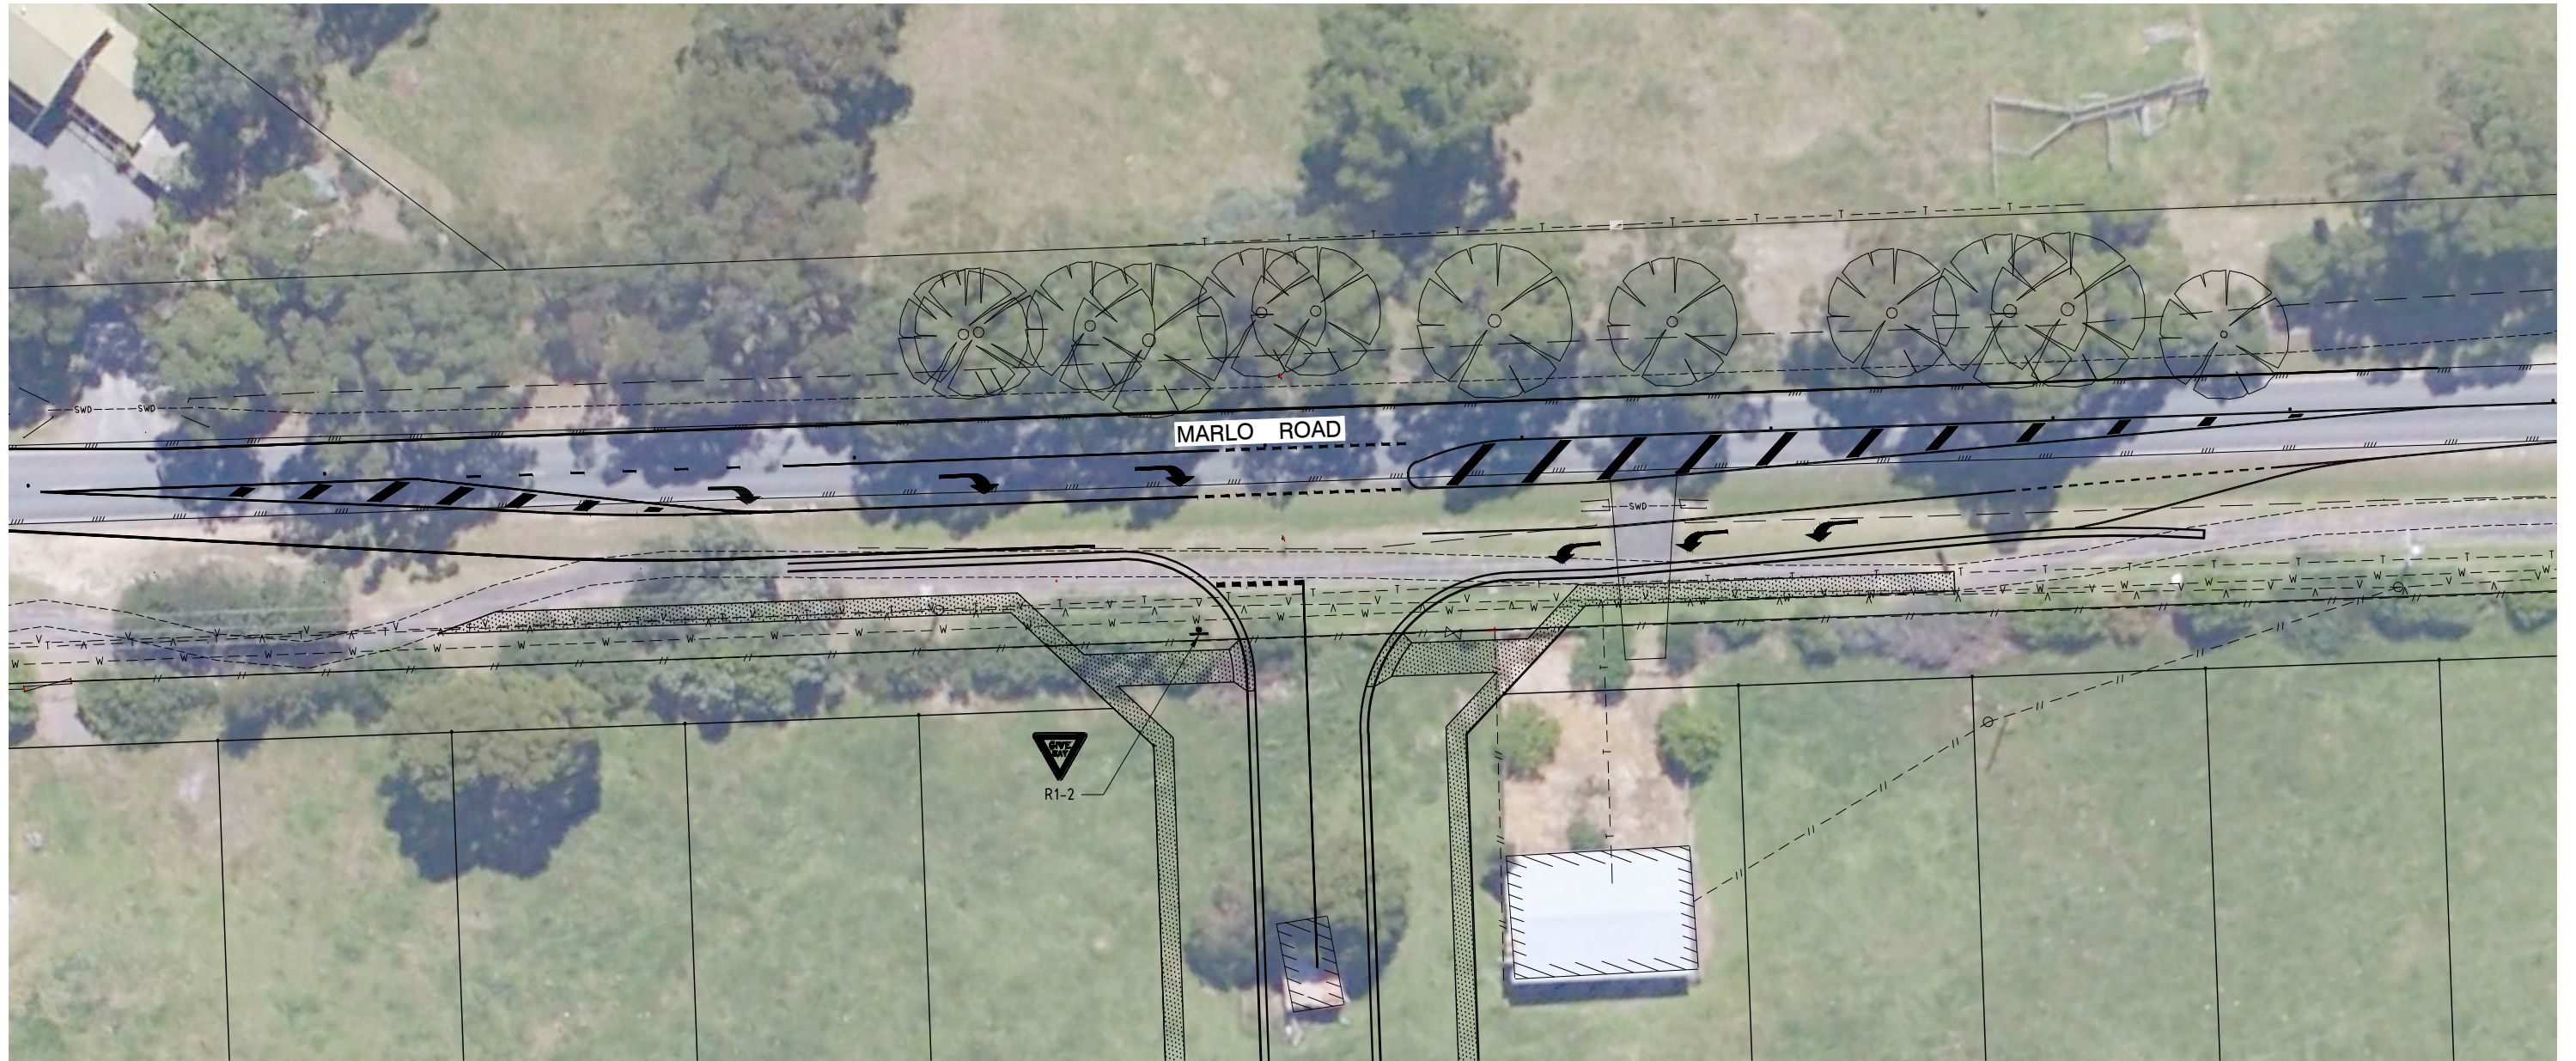
M & K GRECH
10 MARLO ROAD, MARLO
CONCEPTUAL MARLO ROAD
INTERSECTION LAYOUT

Marlo Road / Ward Street – Crossco Drawing 1918/014-B

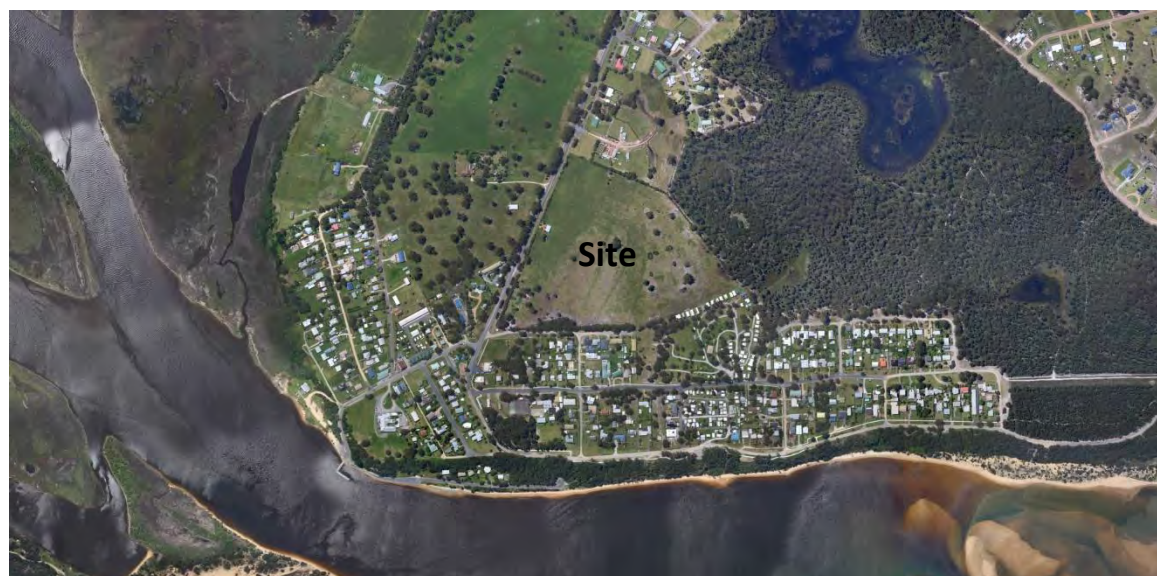
Figure 2: Aerial Overview

Figure 2 provides an overview of the location of the site in relation to existing development at Marlo. The waterways associated with the town are also shown.

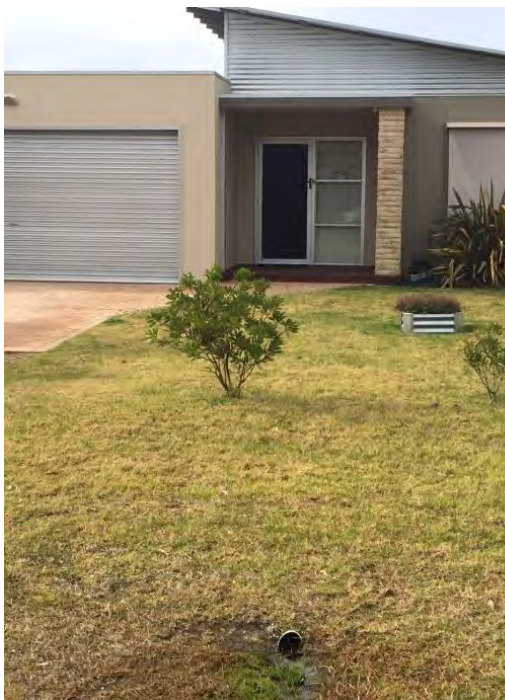
Figure 4: Perry Street house drain

1. There was no apparent municipal drainage infrastructure in Ward Street or Perry Street. House drains in Perry Street were observed to discharge to the edge of the Perry Street which is a gravel road.

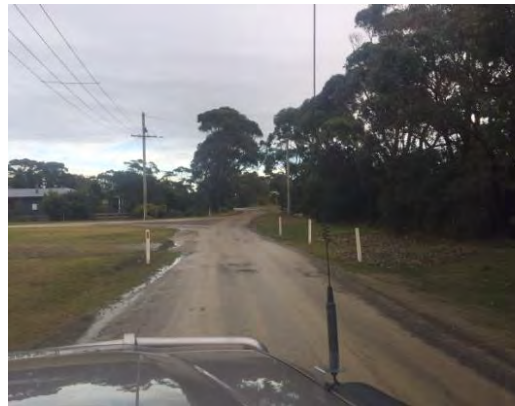
Figure 7: Ward Street

The Ward Street road formation has been graded with a minimal crown at some locations to provide some modest drainage of the road surface. There is no formal drainage.

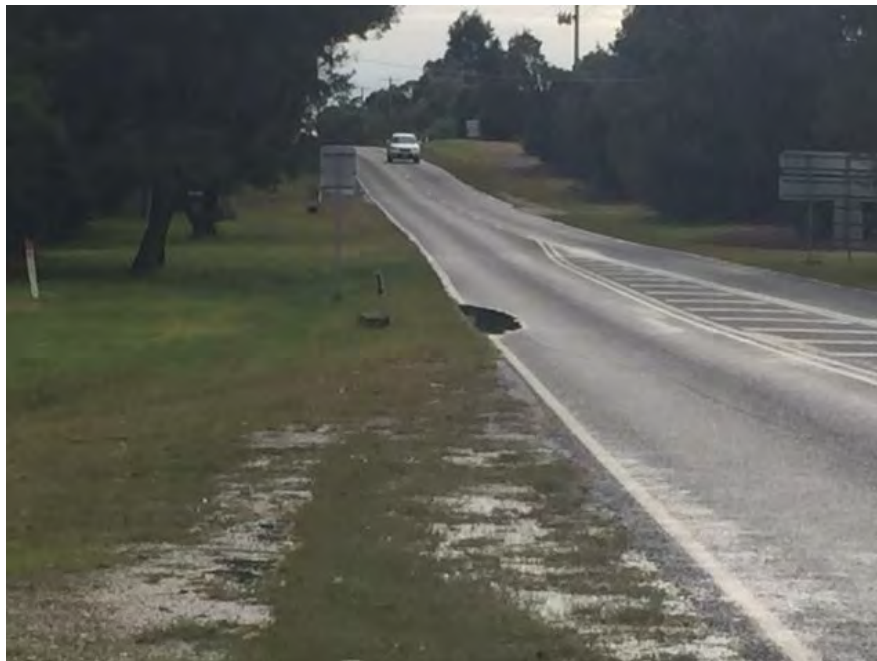
Figure 11: Marlo Road

Some pooling of water is evident at the edge of Marlo Road at the culvert.

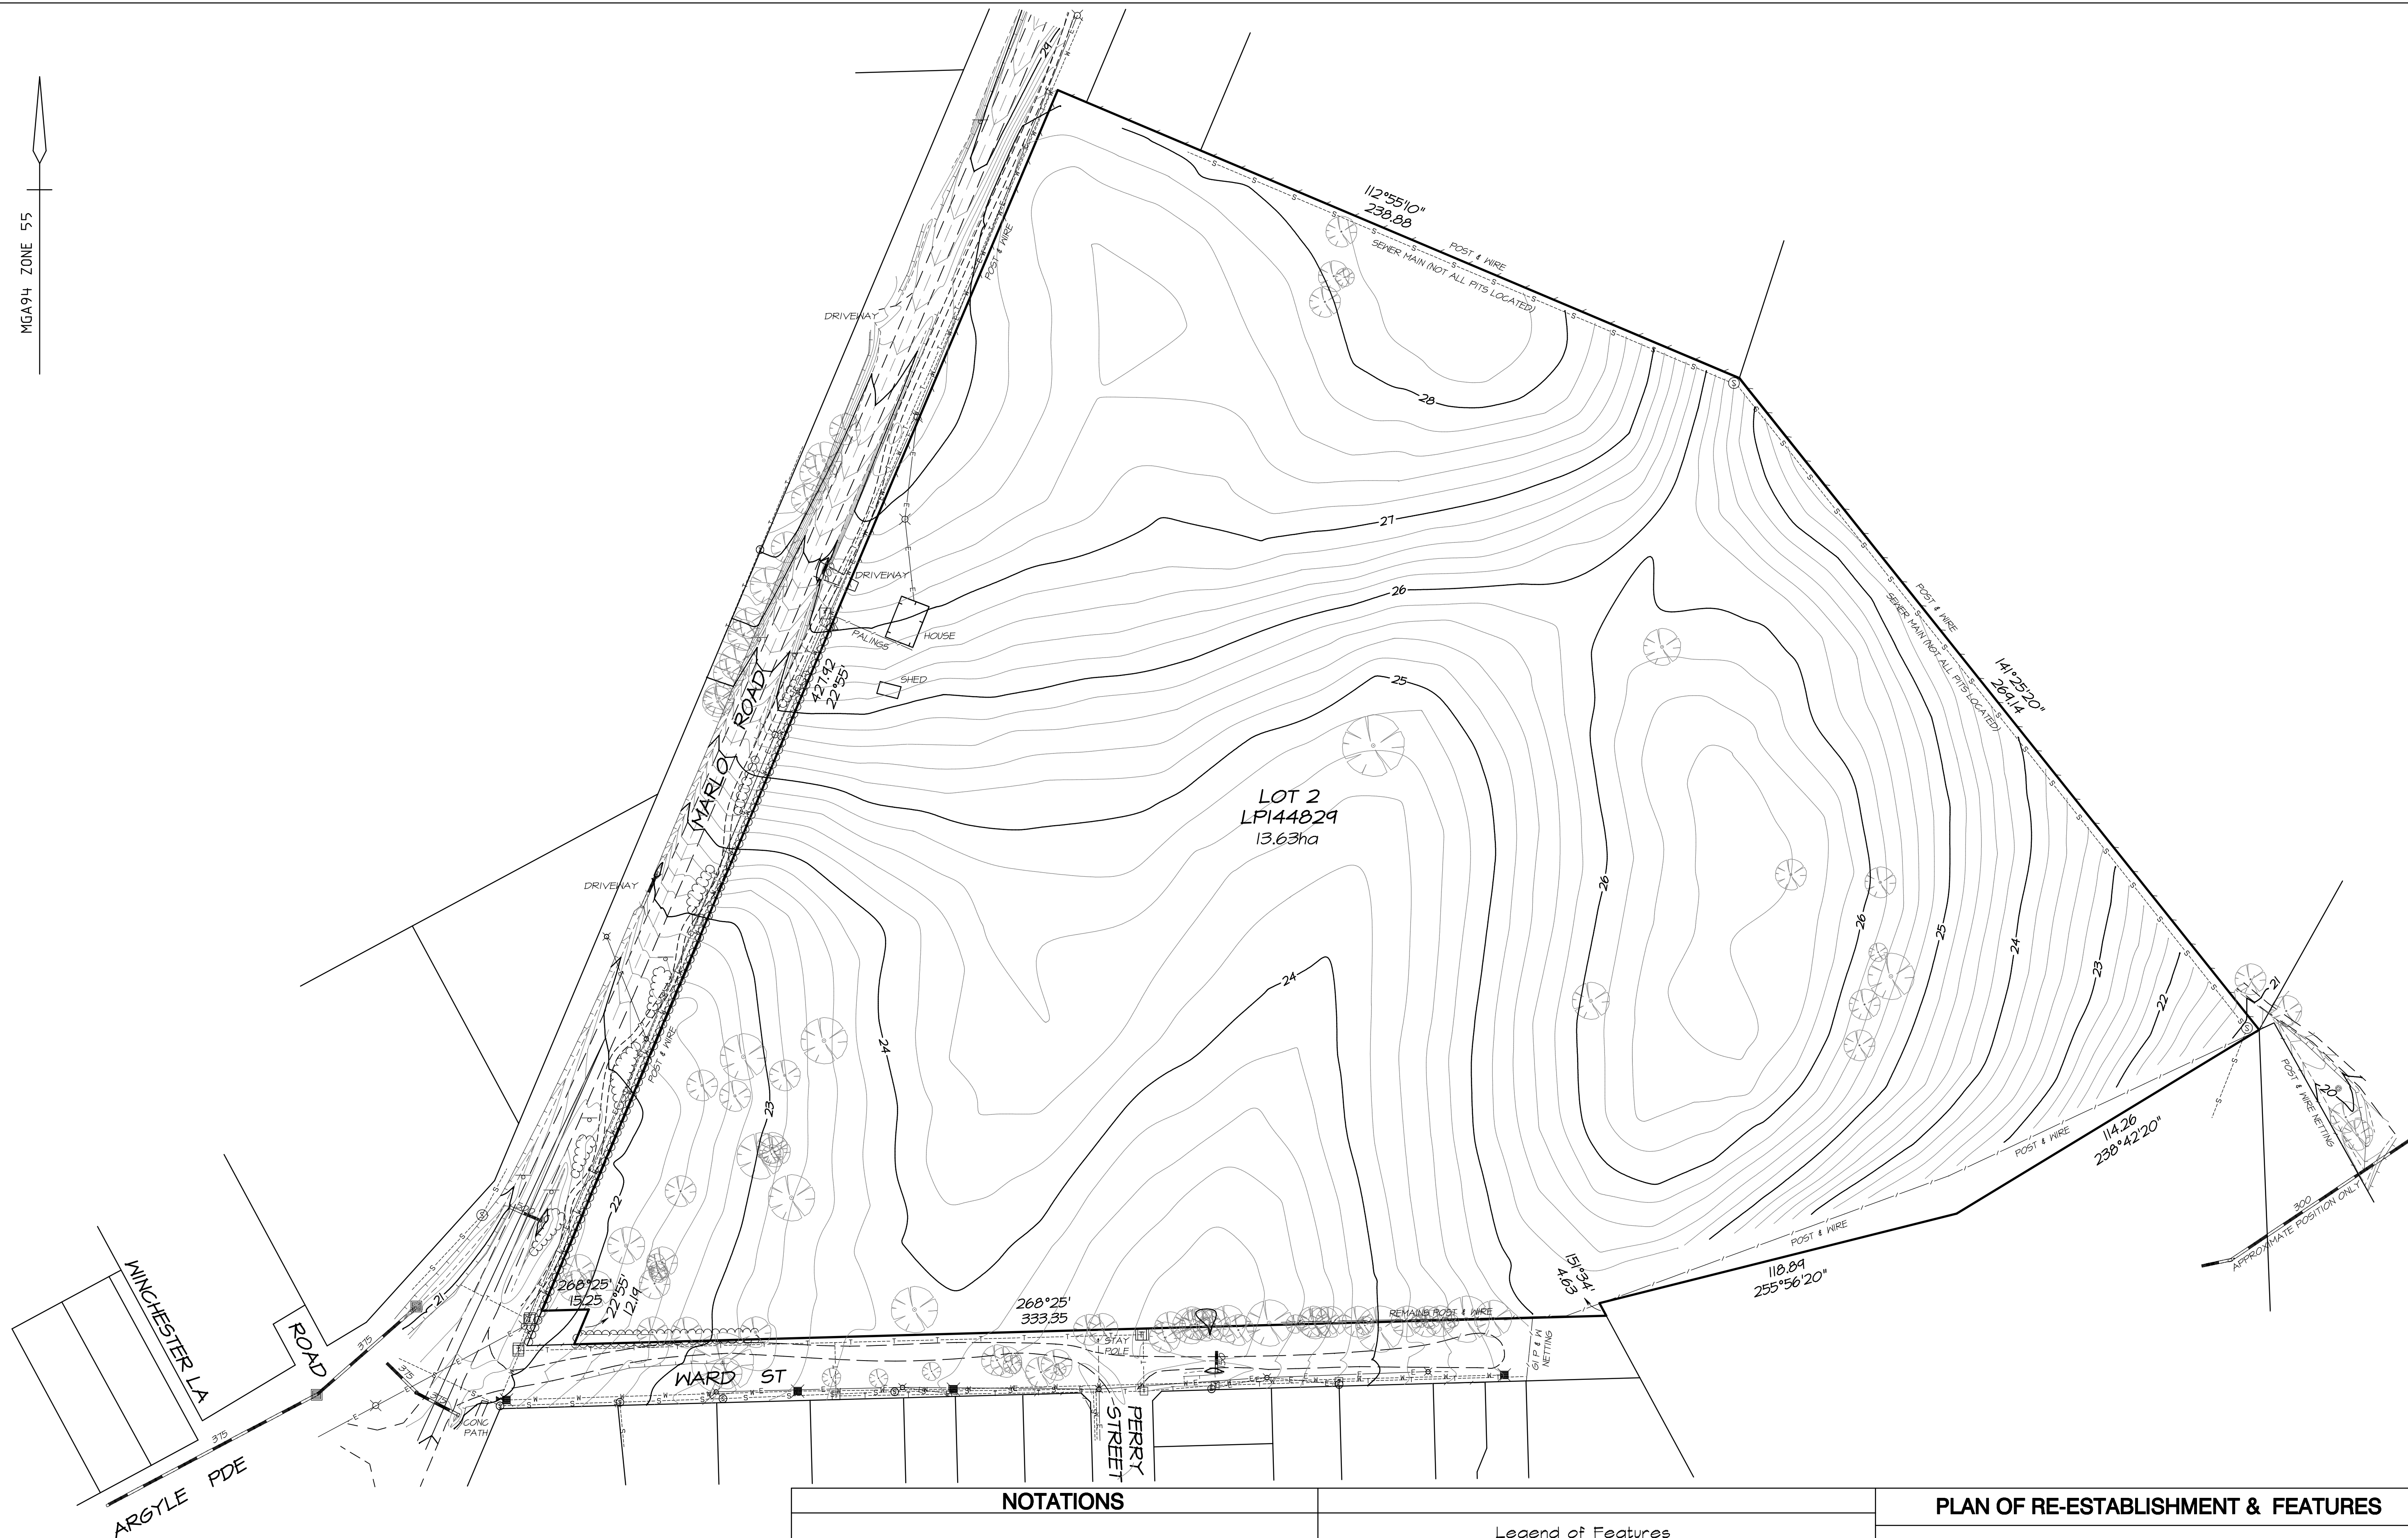
Plan of Re-establishment and Features

NOTATIONS		
RE-ESTABLISHMENT DATUM MGA94 VIDE PS717022T		
HEIGHTS ARE TO AHD - DATUM VIDE PM 358 (RL12.305m)		
CONTOUR INTERVAL : 0.2m		
DATE OF SURVEY : 16/07/2015		
Crowther & Sadler Pty Ltd. LICENSED SURVEYORS & TOWN PLANNERS 162 MACLEOD STREET, BAIRNSDALE, VIC., 3875 TELEPHONE (03) 5182 5011	SURVEYORS REF. 16664	SCALE @ A1 1 : 1000
