# Native Vegetation Removal Report

NVRR ID: 319\_20240617\_464

**Address:** 12 PUNT ROAD JOHNSONVILLE 3902

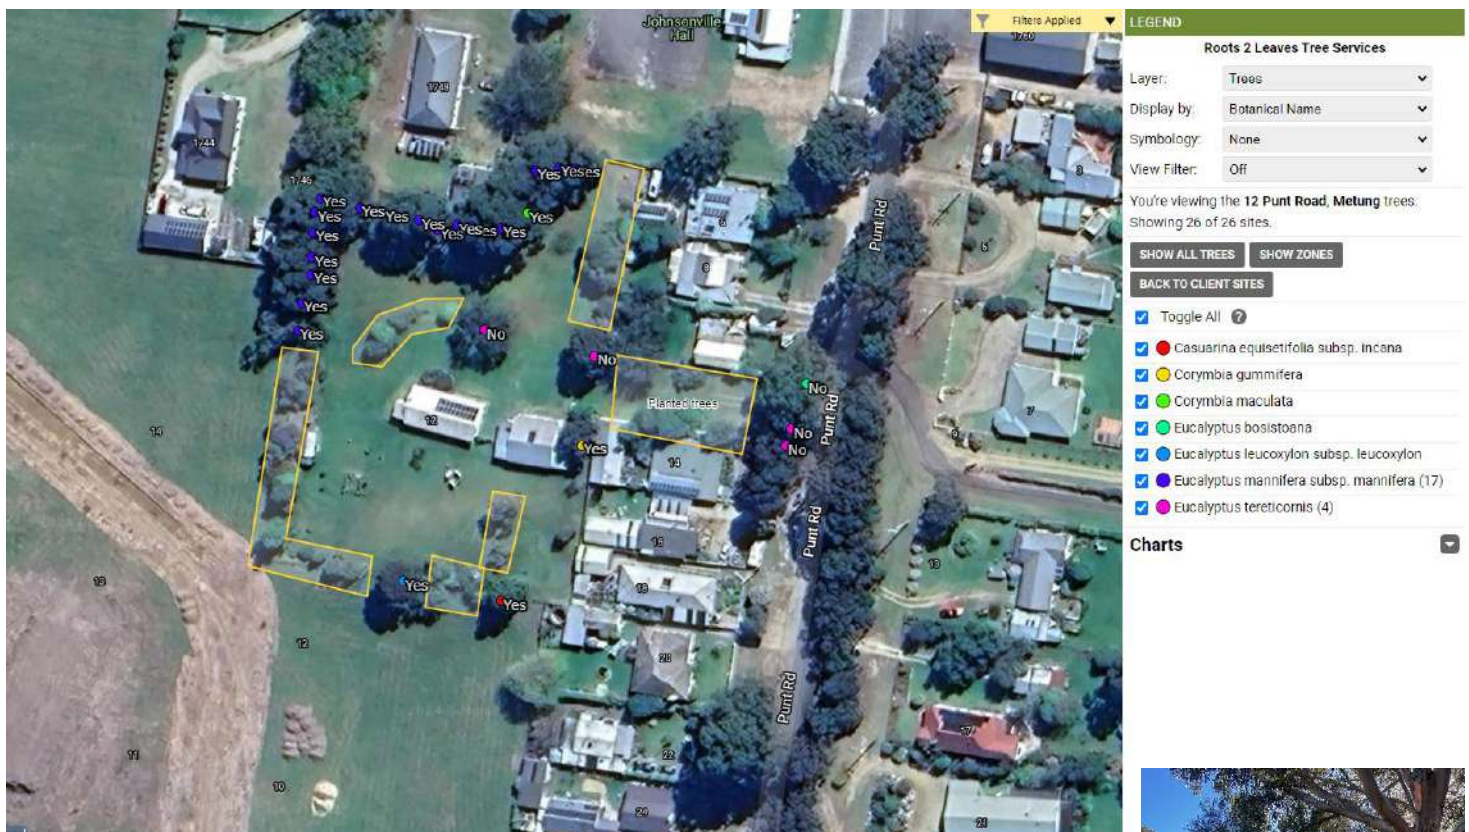
Due to the species types, location, fence row plantings and other contributing factors it has been determined that off the trees that had data collected it is likely that only 5 a Native grown tree. The map below shows "yes" for planted trees and "no" for naturally growing trees.

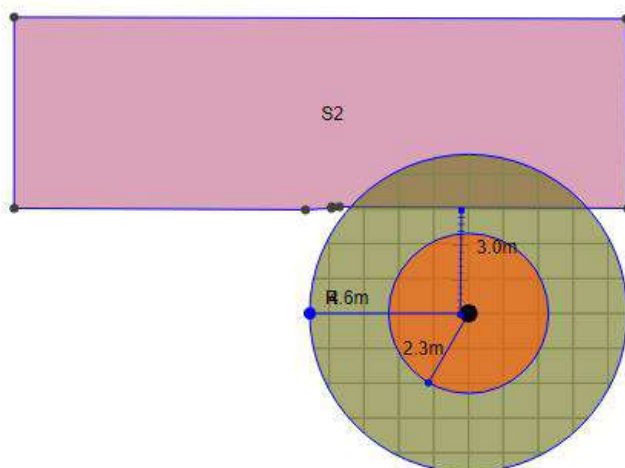
S2  
 Encroachment: 10.8  
 Encroachment area: 7.1 m<sup>2</sup>

image 4 Tree 25 showing a total encroachment of 10.8%

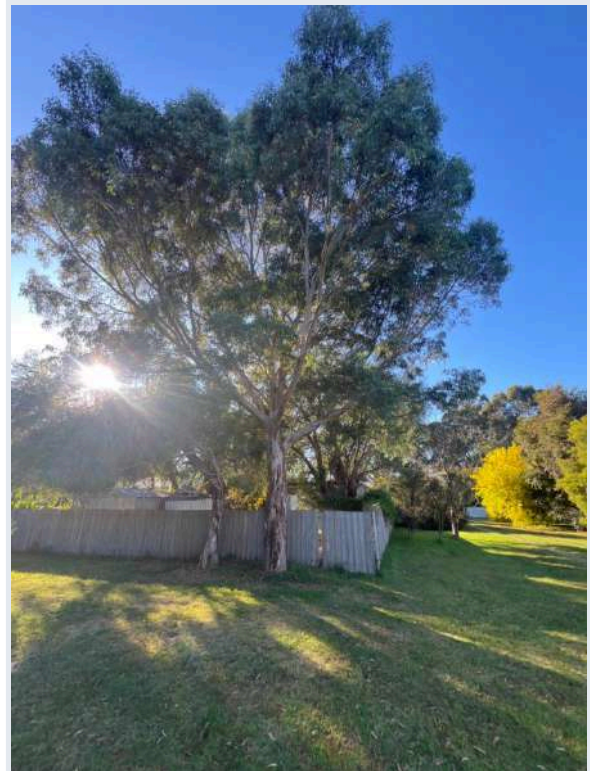
Botanical Name:	Eucalyptus tereticornis
Common Name:	Forest Red Gum
Genus:	Myrtaceae
Health:	Fair
Structure:	Fair
Status:	Alive
Number of Stems (Multi Calc):	1
DBH [cm]:	64
Tree Height (Estimated) [m]:	12
Canopy Spread [m]:	8
Tree Protection Zone (TPZ) [m]:	7.68
Structural Root Zone (SRZ) [m]:	2.83
Useful Life Expectancy:	11-20 years
Risk Rating:	
Priority of Works:	
Recommended Works:	
Last Modified:	12/05/2024
Notes:

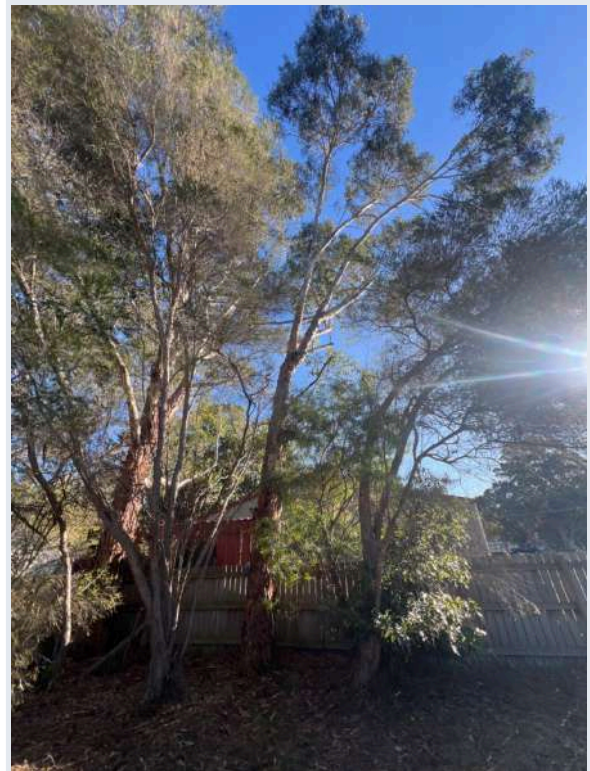
## Brittle Gum Tree ID #2

Botanical Name:	Eucalyptus mannifera subsp. mannifera
Common Name:	Brittle Gum
Genus:	
Health:	Fair
Structure:	Poor
Status:	Alive
Number of Stems (Multi Calc):	1
DBH [cm]:	51
Tree Height (Estimated) [m]:	14
Canopy Spread [m]:	6
Tree Protection Zone (TPZ) [m]:	6.12
Structural Root Zone (SRZ) [m]:	2.61
Useful Life Expectancy:	6-10 years
Risk Rating:	
Priority of Works:	
Recommended Works:	
Last Modified:	12/05/2024
Notes:	Native species, likely planted

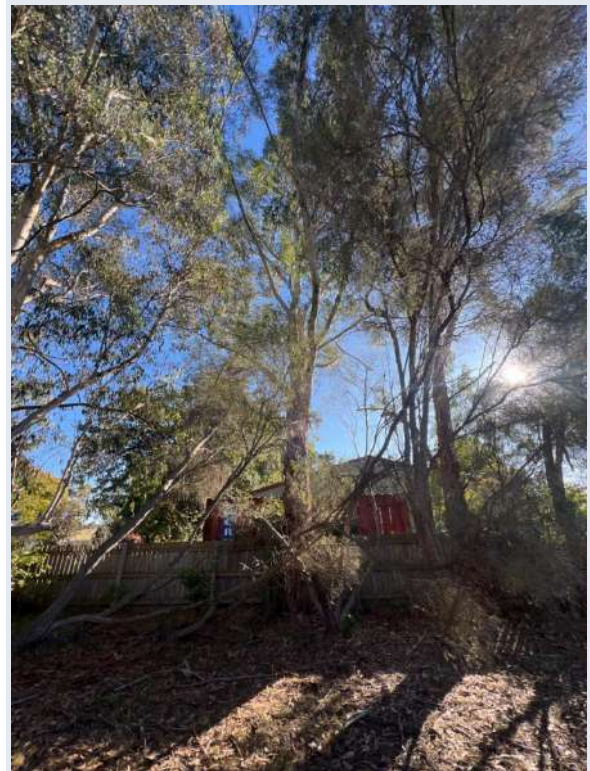
### Brittle Gum Tree ID #3

Botanical Name:	Eucalyptus mannifera subsp. mannifera
Common Name:	Brittle Gum
Genus:	
Health:	Fair
Structure:	Poor
Status:	Alive
Number of Stems (Multi Calc):	1
DBH [cm]:	77
Tree Height (Estimated) [m]:	14
Canopy Spread [m]:	8
Tree Protection Zone (TPZ) [m]:	9.24
Structural Root Zone (SRZ) [m]:	3.06
Useful Life Expectancy:	6-10 years
Risk Rating:	
Priority of Works:	
Recommended Works:	
Last Modified:	12/05/2024
Notes:	Native species, likely planted

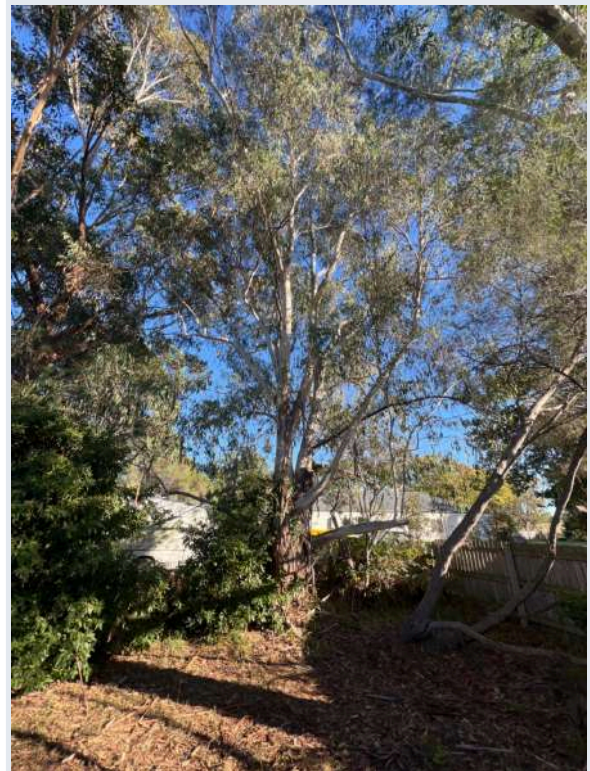
## Brittle Gum Tree ID #4

Botanical Name:	Eucalyptus mannifera subsp. mannifera
Common Name:	Brittle Gum
Genus:	
Health:	Fair
Structure:	Poor
Status:	Alive
Number of Stems (Multi Calc):	1
DBH [cm]:	94
Tree Height (Estimated) [m]:	14
Canopy Spread [m]:	12
Tree Protection Zone (TPZ) [m]:	11.28
Structural Root Zone (SRZ) [m]:	3.3
Useful Life Expectancy:	6-10 years
Risk Rating:	
Priority of Works:	
Recommended Works:	
Last Modified:	12/05/2024
Notes:	Native species, likely planted

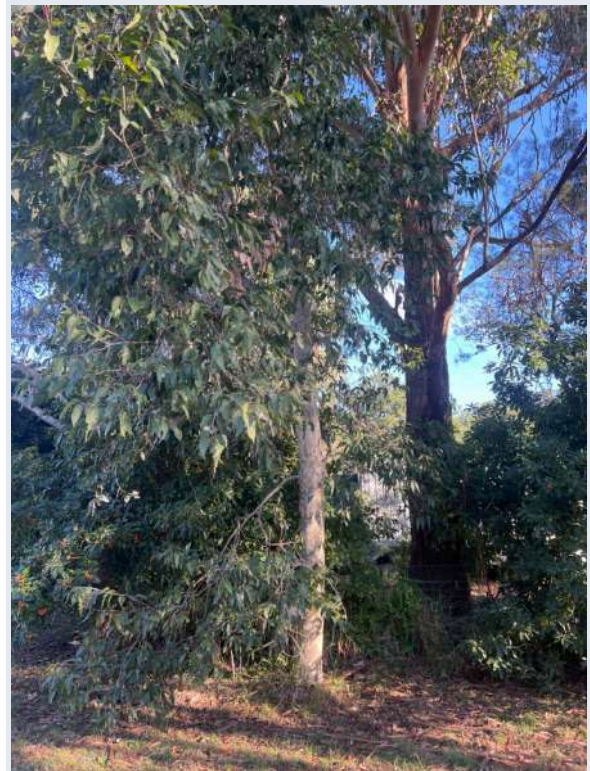
## Spotted Gum Tree ID #5

Botanical Name:	Corymbia maculata
Common Name:	Spotted Gum
Genus:	Corymbia
Health:	Fair
Structure:	Good
Status:	Alive
Number of Stems (Multi Calc):	1
DBH [cm]:	25
Tree Height (Estimated) [m]:	8
Canopy Spread [m]:	5
Tree Protection Zone (TPZ) [m]:	3
Structural Root Zone (SRZ) [m]:	1.97
Useful Life Expectancy:	11-20 years
Risk Rating:	
Priority of Works:	
Recommended Works:	
Last Modified:	12/05/2024
Notes:

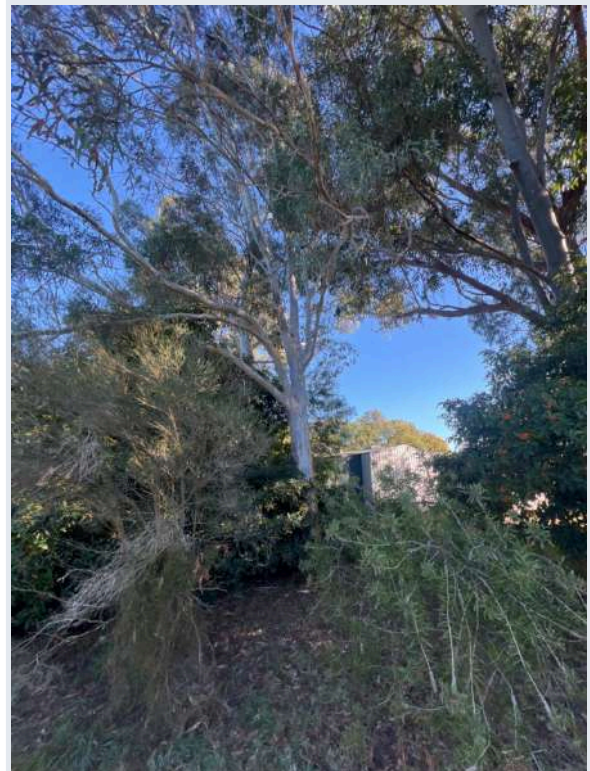
## Brittle Gum Tree ID #6

Botanical Name:	Eucalyptus mannifera subsp. mannifera
Common Name:	Brittle Gum
Genus:	
Health:	Fair
Structure:	Fair
Status:	Alive
Number of Stems (Multi Calc):	1
DBH [cm]:	43
Tree Height (Estimated) [m]:	14
Canopy Spread [m]:	8
Tree Protection Zone (TPZ) [m]:	5.16
Structural Root Zone (SRZ) [m]:	2.45
Useful Life Expectancy:	11-20 years
Risk Rating:	
Priority of Works:	
Recommended Works:	
Last Modified:	12/05/2024
Notes:

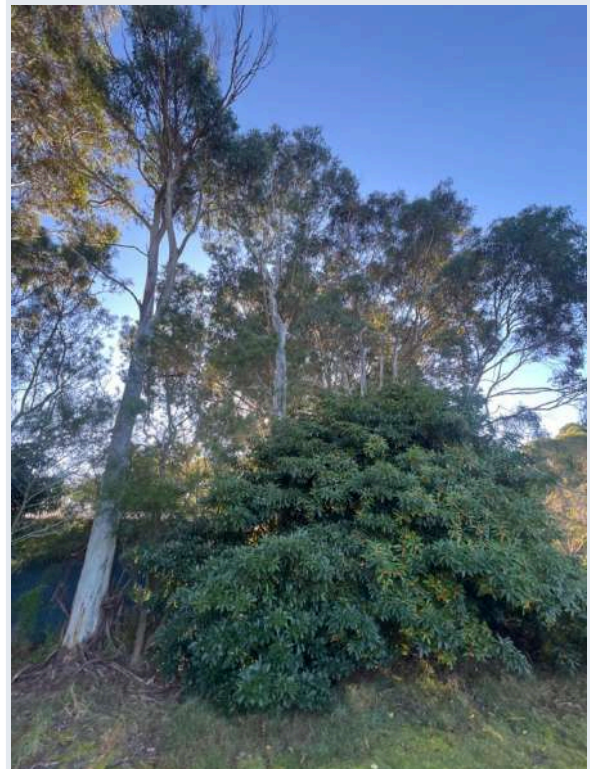
## Brittle Gum Tree ID #7

Botanical Name:	Eucalyptus mannifera subsp. mannifera
Common Name:	Brittle Gum
Genus:	
Health:	Fair
Structure:	Fair
Status:	Alive
Number of Stems (Multi Calc):	1
DBH [cm]:	54
Tree Height (Estimated) [m]:	14
Canopy Spread [m]:	6
Tree Protection Zone (TPZ) [m]:	6.48
Structural Root Zone (SRZ) [m]:	2.63
Useful Life Expectancy:	11-20 years
Risk Rating:	
Priority of Works:	
Recommended Works:	
Last Modified:	12/05/2024
Notes:
